LEVEL 2 REPLACEMENT RESERVE REPORT FY 2023 RUSSELL TOWNSHIP

RUSSELL TOWNSHIP

REPLACEMENT RESERVE REPORT

NOVELTY, OHIO
September 6, 2022
Revised December 8, 2022
Revised February 14, 2023

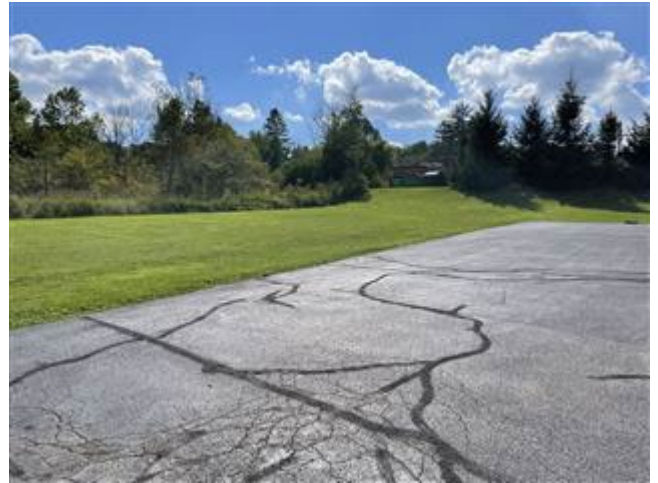
Parking Areas. The building features parking areas and drive lanes constructed of asphalt pavement. The pavements are in fair condition.

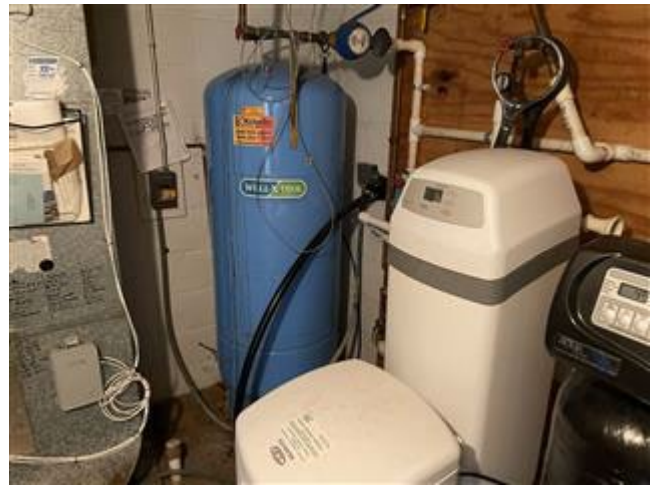
Well and Water Softener. The building features a ground water well and septic system. We consider the system to include the well casing, well pump, and piping. These items are concealed underground and were not reviewed but we understand they are in good operating condition. The system also includes a water softener system which includes a water softener system, brine tank, and pressure tank. The water softener is reported to be in good condition.

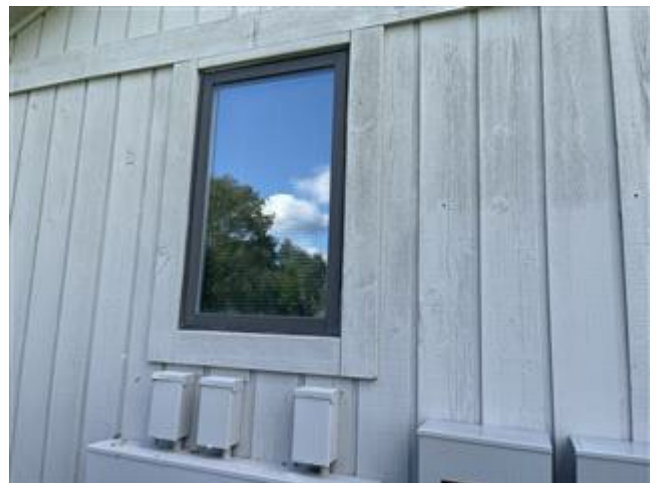
Windows. The community maintains the windows of the facility. The windows are generally in good condition.

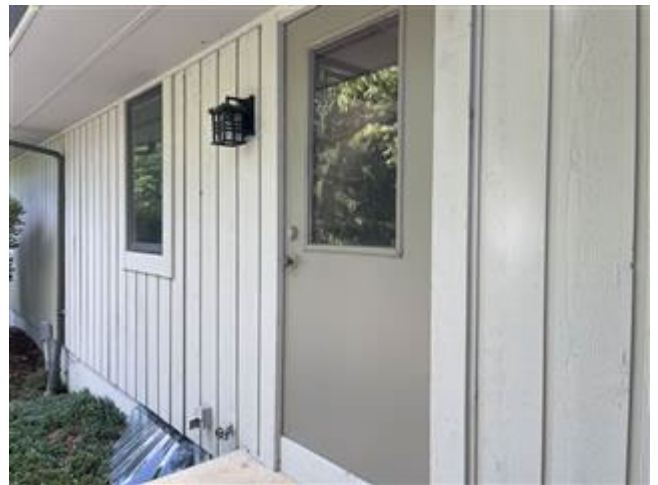
Exterior Doors. The Community maintains the exterior doors of the community building.

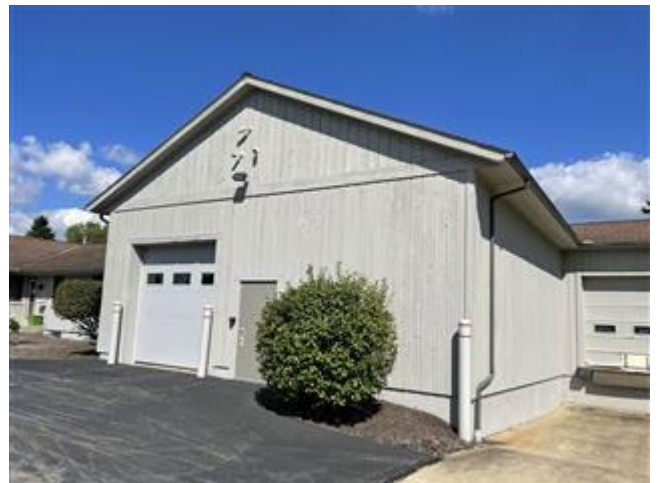
Overhead Doors. The building features 2 overhead doors. One door is new and in good condition, the other door is deteriorated and needs to be replaced.

Overhead doors should be maintained to the extent that they fully open and fully close. All tracks and rollers operate in a smooth continuous cycle free of binding and stops. Safety features such as stops, return sensors, a close tension should be checked periodically.

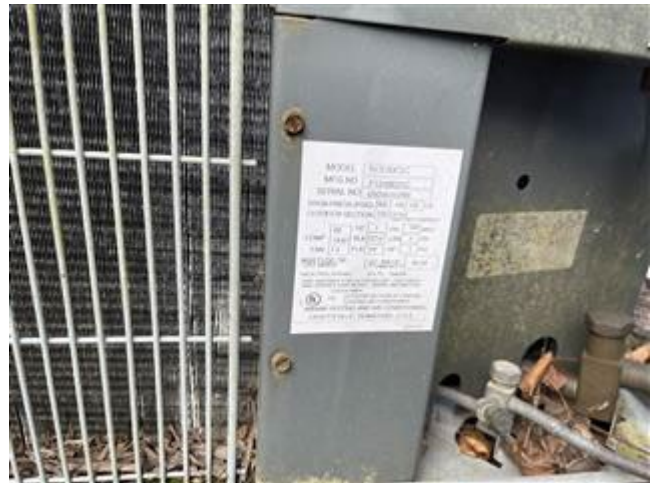
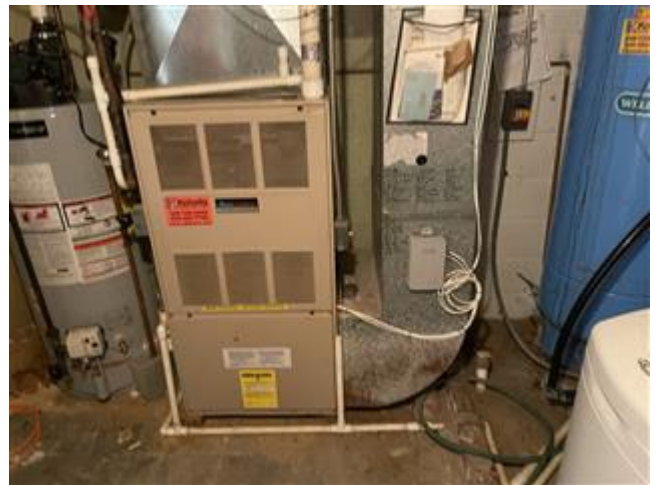
HVAC Systems. The heating ventilation and air conditioning (HVAC) of the facility are provided by furnace/compressor split systems. The HVAC is in good working order. Detailed inspection and testing of these systems are beyond the scope of this study.

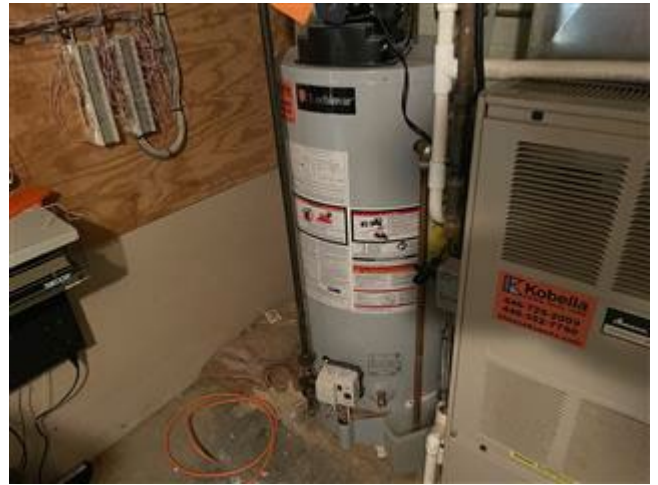
Domestic Hot Water. Domestic hot water is provided by a residential water heater tank which is in good condition.

Typically these types of systems have a service life of 12-15 years. This system should be serviced periodically to provide the most reliable service.

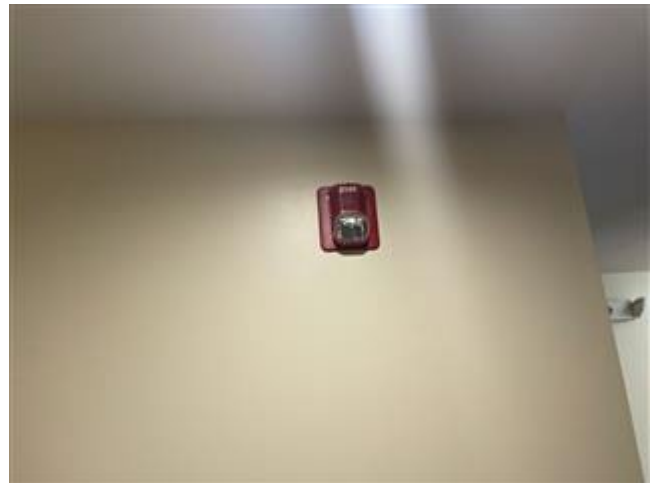
Fire Alarm Control Panel (FACP). The FACP provides the function of central processing and notifying channel for emergencies. Every device in the building is programmed into the FACP. Furthermore, the FACP is initiate the alarm. Please note the type of alarm is determined by the system settings. The Association should review how the system is programmed with the system engineer.

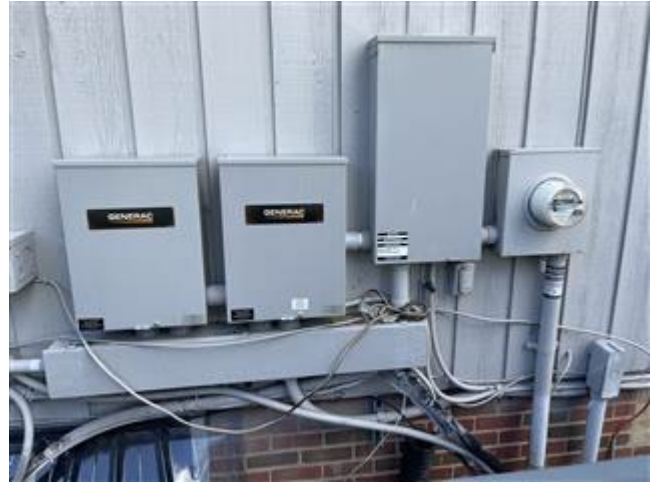
Emergency Generator. The facility features an emergency generator. The system operates on standby until needed. The generator includes a natural gas generator, voltage generator, transfer switches, and an enclosure.

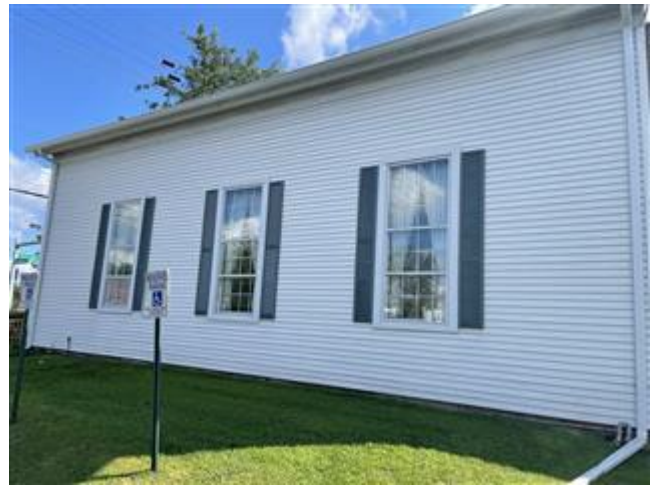
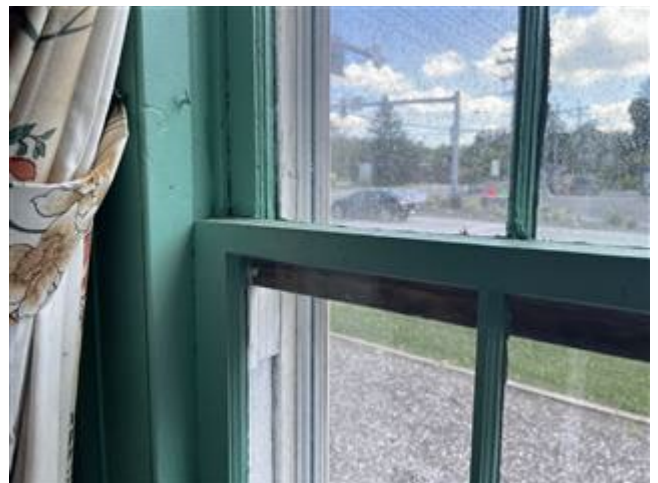
Windows. The Township maintains the windows of the facility. The windows are historic wood and glass and are generally in good condition.

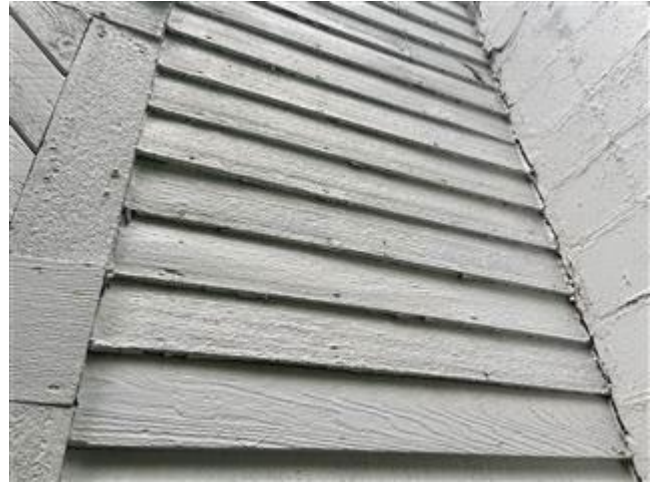
Siding and Trim. The building is sided in wood clapboards. The building exterior is in good condition.

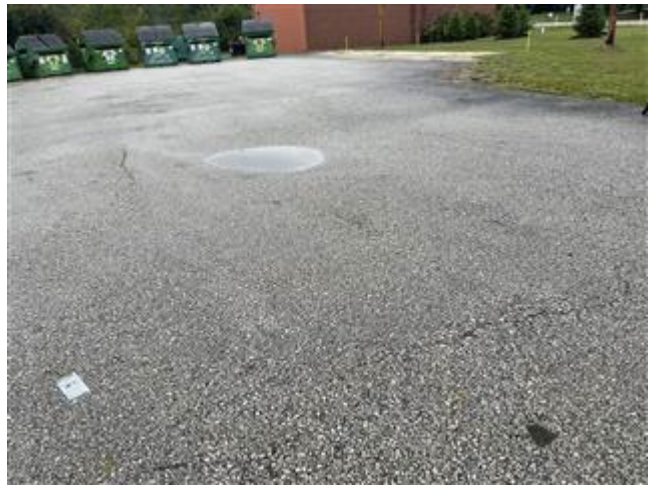
The Township plans to add lighting, fencing, and some other features to the recycle area.

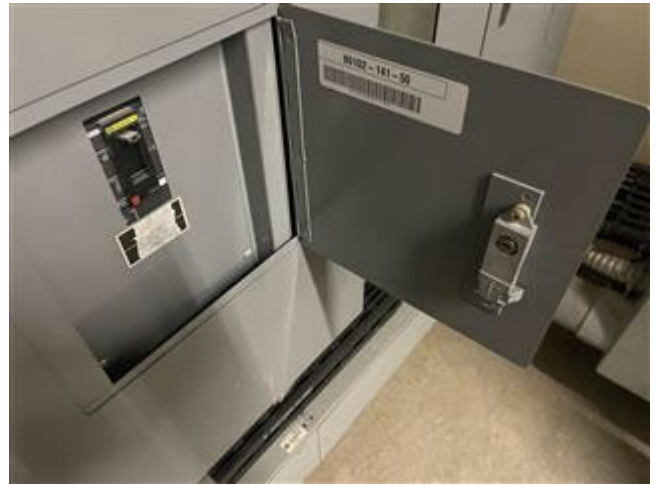
The overall condition of the switchgear is good. We understand that replacement parts are still available for the equipment. As the switchgear continues to age, obtaining replacement parts can be expected to become more difficult. When parts no longer are available or when the condition of the switchgear deteriorates sufficiently, the Association will have to replace or upgrade the existing equipment. Therefore, we have included funding in the Reserve Analysis for distribution panel replacement on an incremental basis.

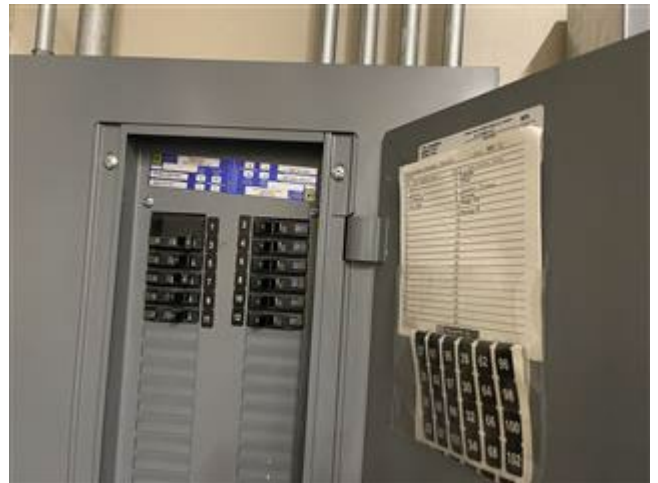
The overall condition of the distribution panels is good. As the distribution panel's age, obtaining replacement parts can be expected to become more difficult. When parts no longer are available, the Association will have to replace some of the existing panels. The replacement will have to be performed on an incremental basis, panel by panel. Therefore, we have included funding in the Reserve Analysis for distribution panel replacement on an incremental basis.

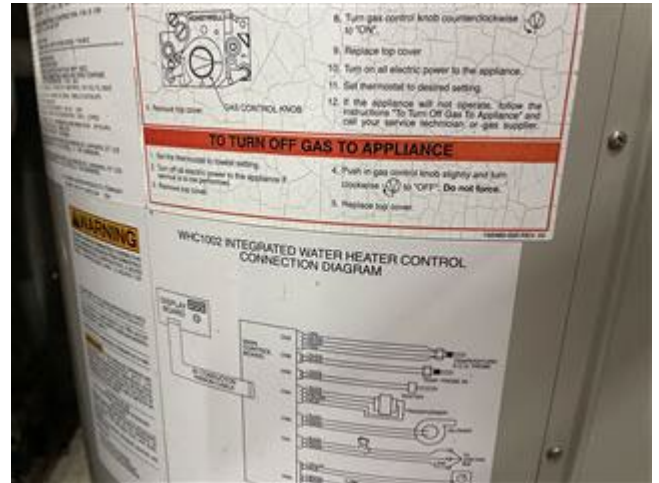
Domestic Hot Water. Domestic hot water is provided by a water heater tank which is in good condition.

Typically these types of systems have a service life of 12-15 years. This system should be serviced periodically to provide the most reliable service.

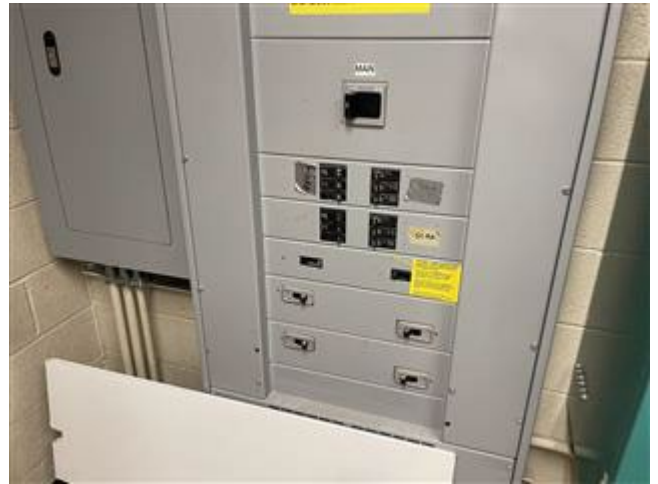
The overall condition of the switchgear is good. We understand that replacement parts are still available for the equipment. As the switchgear continues to age, obtaining replacement parts can be expected to become more difficult. When parts no longer are available or when the condition of the switchgear deteriorates sufficiently, the Association will have to replace or upgrade the existing equipment. Therefore, we have included funding in the Reserve Analysis for distribution panel replacement on an incremental basis.

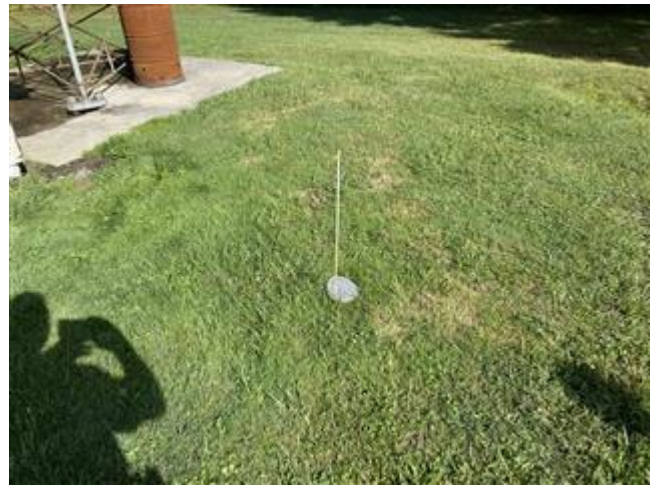
Septic System. The building features a septic system. The system includes a box, pump, valve, and leach bed. The system was concealed underground and not reviewed but is reported to be in good condition.
