LEVEL 2 REPLACEMENT RESERVE REPORT FY 2023 RUSSELL TOWNSHIP

RUSSELL TOWNSHIP

REPLACEMENT RESERVE REPORT

NOVELTY, OHIO
September 6, 2022
Revised December 8, 2022
Revised February 14, 2023

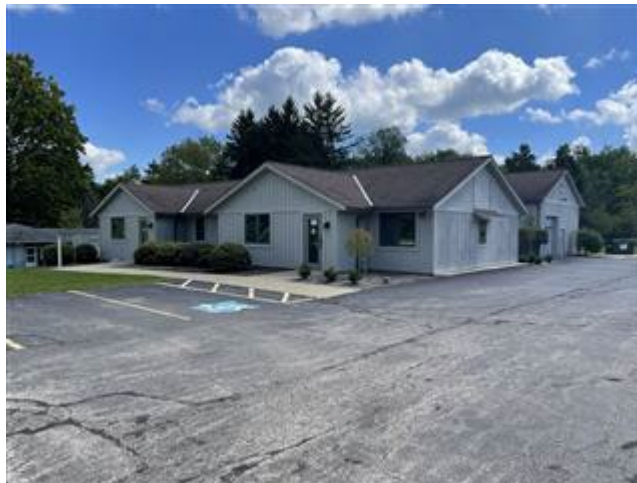
Entry Monument and Signage. The building features an entry monument. The monument is in good condition.

The monument sign is made of wood board and are in good condition. To keep the monument fresh and appealing, we recommend replacement every 10 to 15 years.

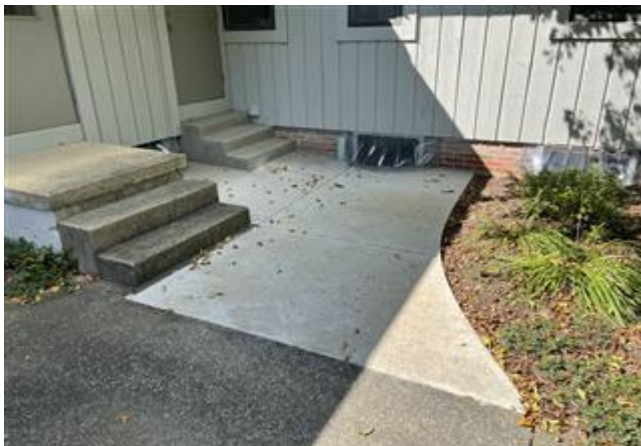
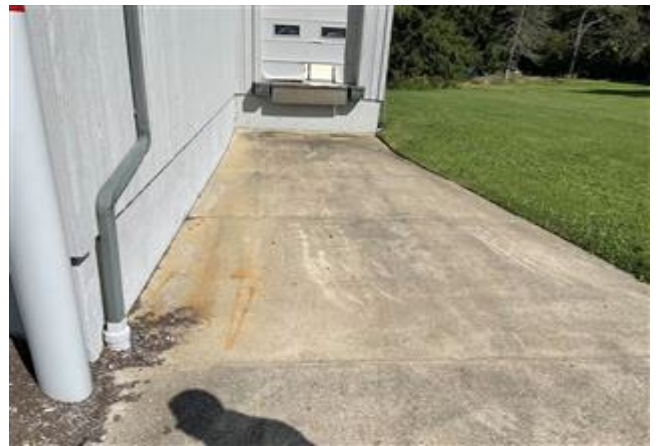
Concrete Work. The concrete work includes the sidewalks, leadwalks, stairs, stoops, and other flatwork. The overall condition of the concrete work is fair with areas of defects consistent with the age of the installation.

Because it is highly unlikely that all of the concrete components will fail and require replacement in the period of the study, we have programmed funds for the replacement of these inventories and spread the funds over an extended timeframe to reflect the incremental nature of this work.

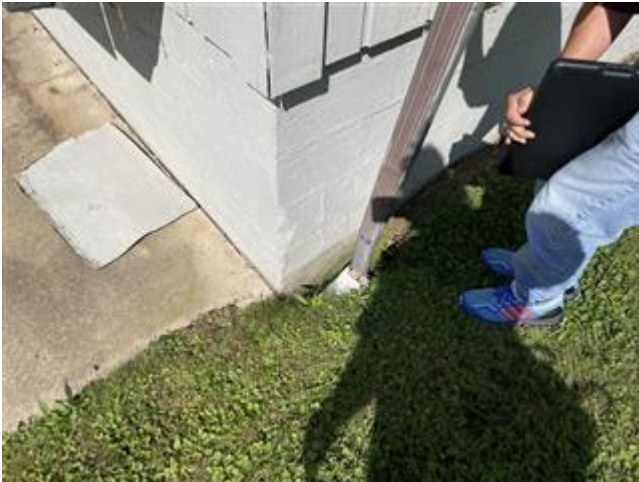
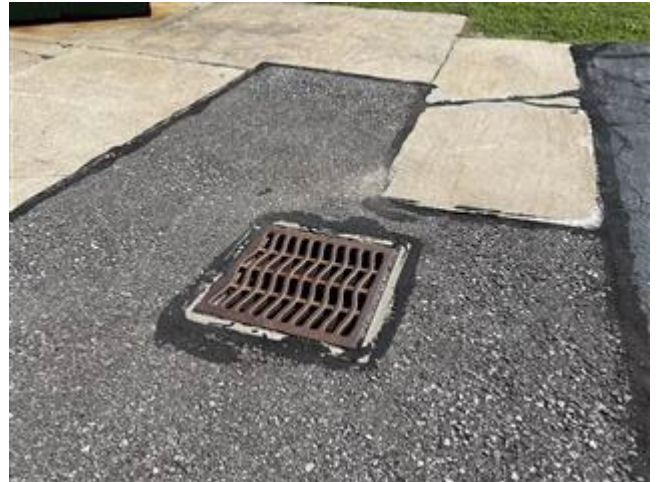
Stormwater Management. We have included an allowance for stormwater management. This allowance is intended to address drainage issues, wet areas, inlets, structures, etc.

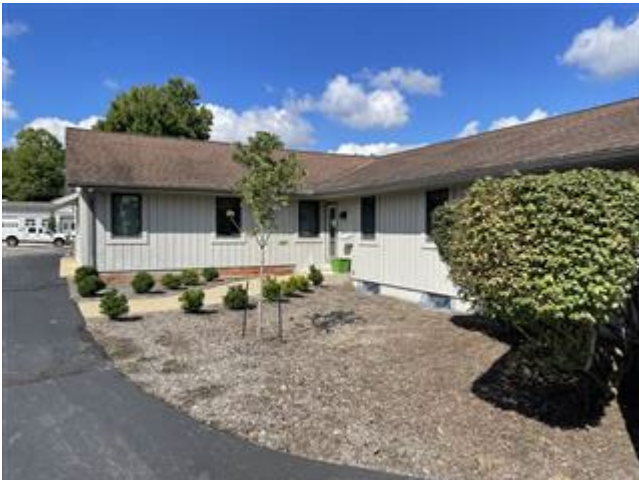
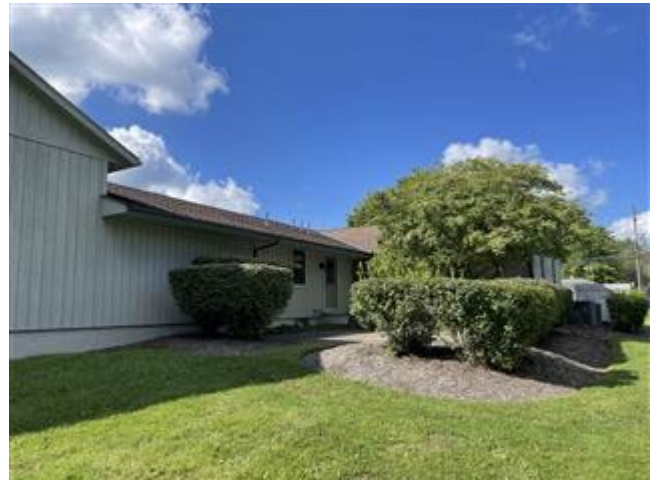
Foundation Plantings. The building features rooted woody plants that are designed to support soil integrity, provide shade, add to the aesthetic appeal of the site, and at times conceal utilities.

This study includes an allowance to perform the replacement of individual trees or shrubs. The understanding that trees would be cut down, removed, stump ground, and a new tree planted in its place. The allowance is not intended for planting annuals, seasonal flowers, mulch, or landscaping services.

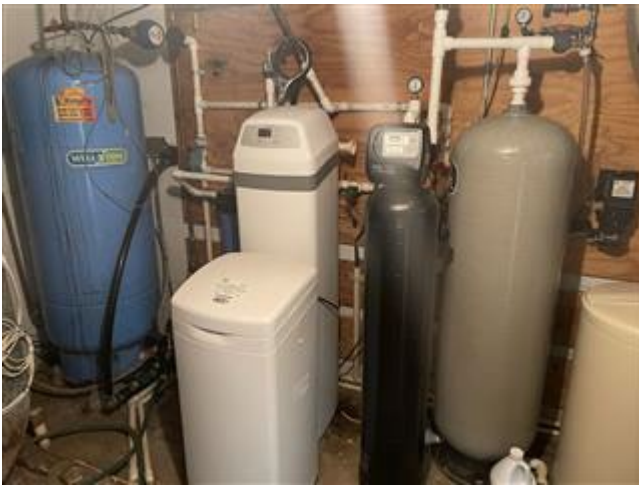
Well and Water Softener. The building features a ground water well and septic system. We consider the system to include the well casing, well pump, and piping. These items are concealed underground and were not reviewed but we understand they are in good operating condition. The system also includes a water softener system which includes a water softener system, brine tank, and pressure tank. The water softener is reported to be in good condition.

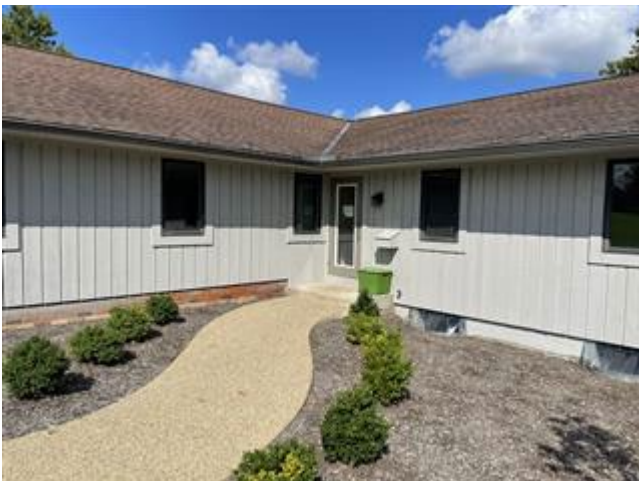
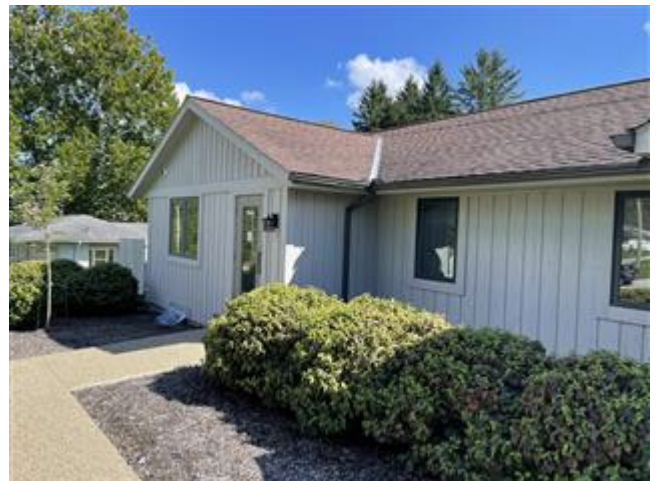
Building Roofing. The building features a pitched structure that is roofed in asphalt shingles. The roofing is in good condition.

Access to the roof was not provided at the time of inspection. The roofing was observed from the ground level.

Annual inspections are recommended, with cleaning, repair, and mitigation of vegetation performed as needed. Access, inspection, and repair work should be performed by contractors and personnel with the appropriate access equipment who are experienced in the types of roofing used for the facility.

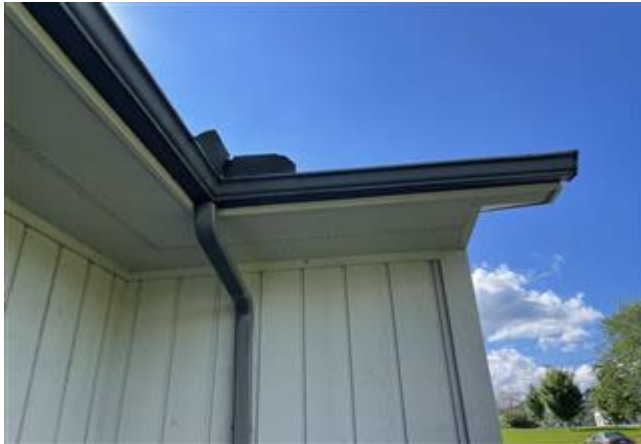
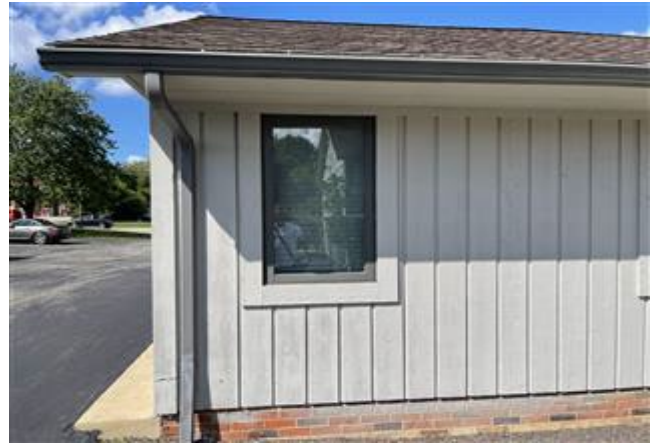
Gutters and Downspouts. The building features aluminum gutters and downspouts. The gutters and downspouts are in fair condition.

It is recommended that all gutters be cleaned at least twice each year. If there are a large number of trees located close to a building, consider installing a gutter debris shield that will let water into the gutters but will filter out leaves, twigs, and other debris.

It is recommended that gutters and downspouts be installed on all buildings. It is also recommended that the discharge from the downspouts be extended at least ten feet away from the foundations.

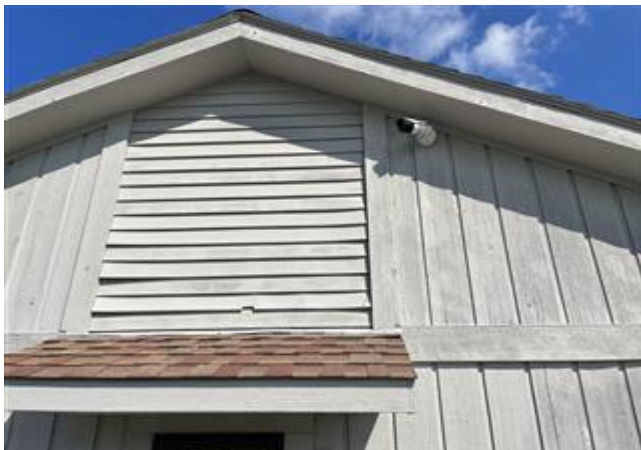
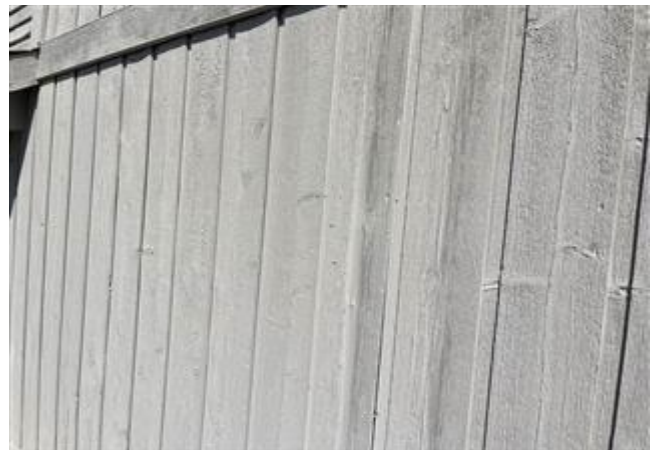
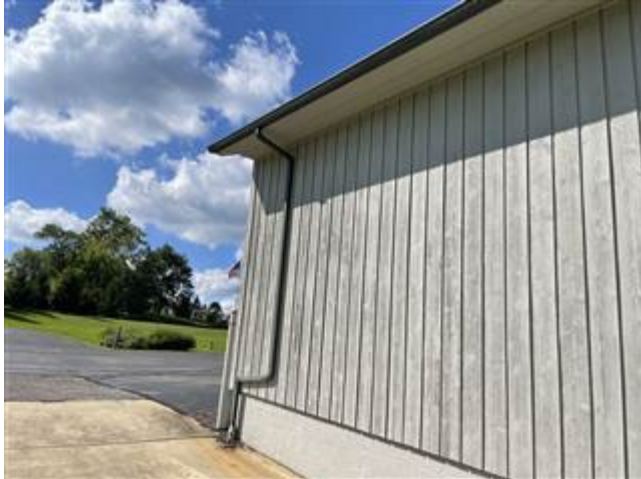
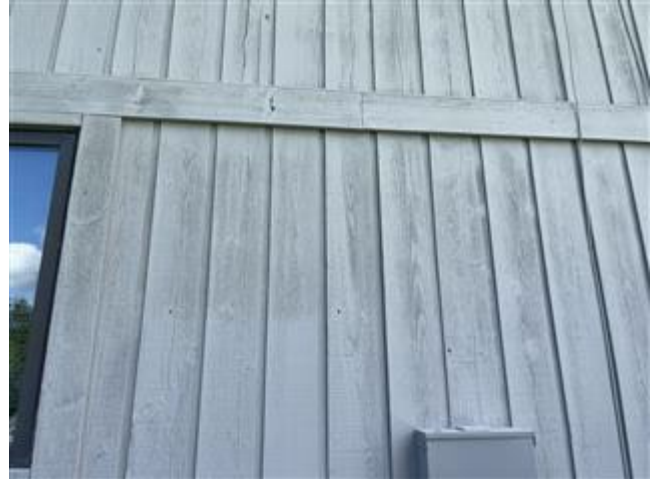
Siding and Trim. The building is sided in wood t-111 or plank and batten wood. The building exterior was just painted and is in fair condition with moderate weathering. We have estimated that these exteriors will be replaced with cement fiber boards.

Periodic inspection of trim, wrap, and sheathing should be conducted. The Association may discover that concealed damage is present at the underlying sheathing and building structure. Structural repairs and latent damage are not accounted for in this study.

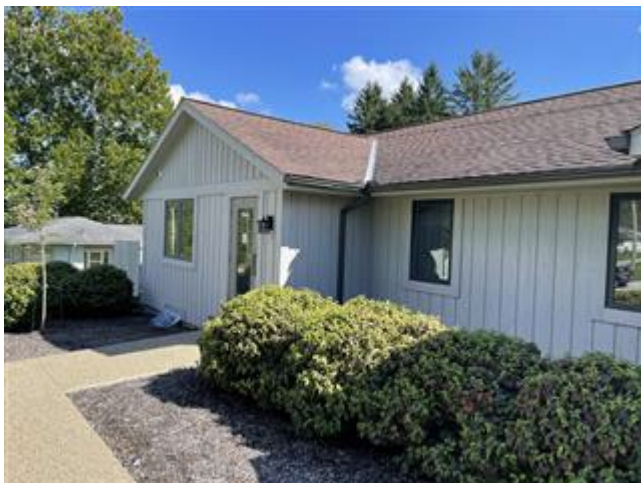
Windows. The community maintains the windows of the facility. The windows are generally in good condition.

In general, we recommend coordinating the replacement of the window units with other exterior work, such as siding and roof replacements. The weather tightness of the building envelope often requires wraps, transitional flashing, and caulking that should be performed in coordination with each other. Warranties and advantages in 'economy of scale' can often result in lower overall replacement costs and results that are more reliable. Lastly, coordinated replacements offer the opportunity to correct initial construction defects and improve the effectiveness of details with improved construction techniques and materials.

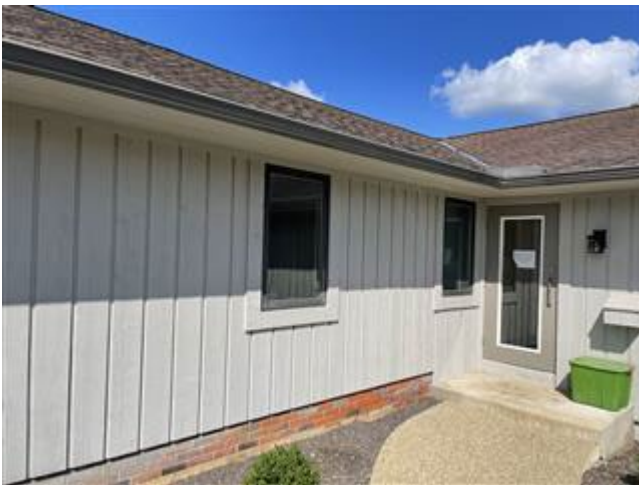
Exterior Doors. The Community maintains the exterior doors of the community building.

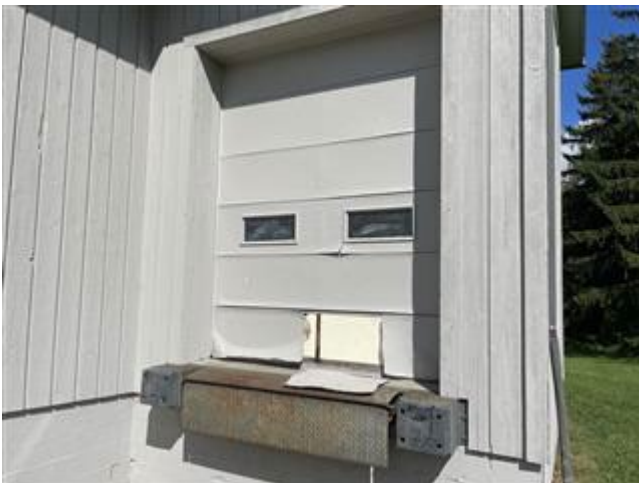
Overhead Doors. The building features 2 overhead doors. One door is new and in good condition, the other door is deteriorated and needs to be replaced.

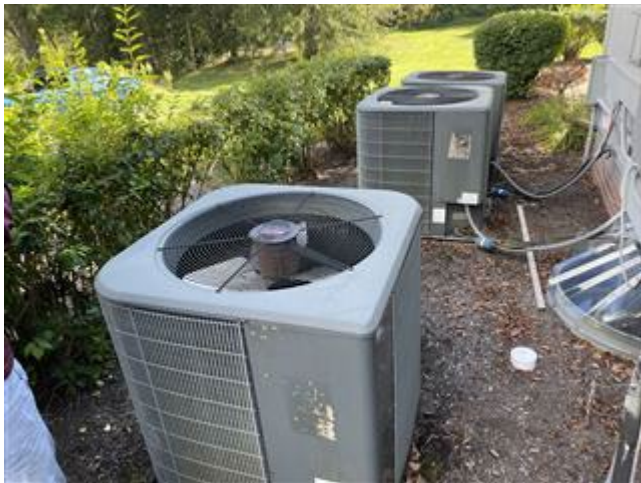
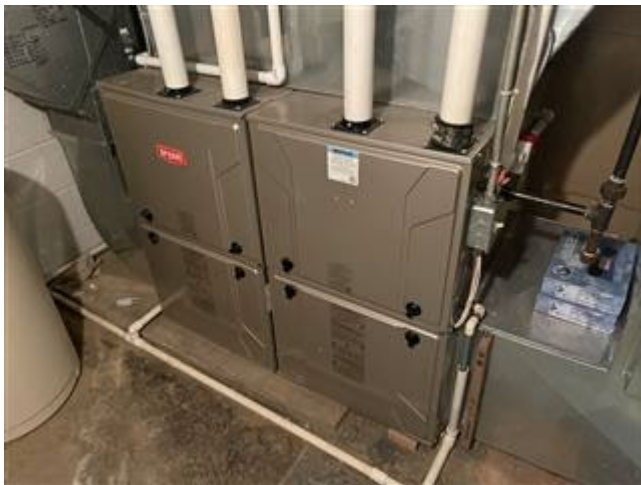
HVAC Systems. The heating ventilation and air conditioning (HVAC) of the facility are provided by furnace/compressor split systems. The HVAC is in good working order. Detailed inspection and testing of these systems are beyond the scope of this study.

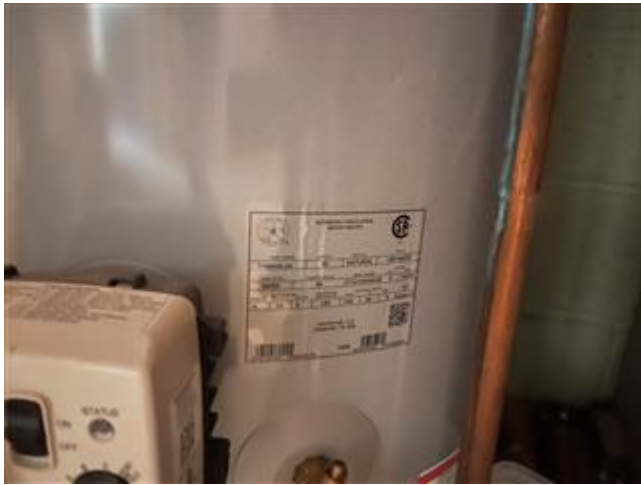
Domestic Hot Water. Domestic hot water is provided by a residential water heater tank which is in good condition.

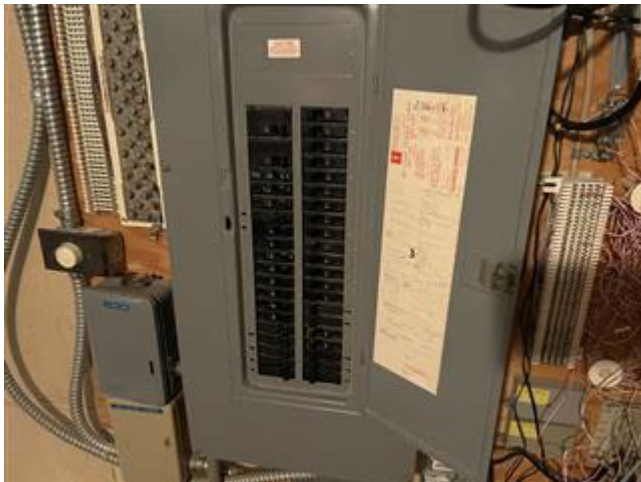
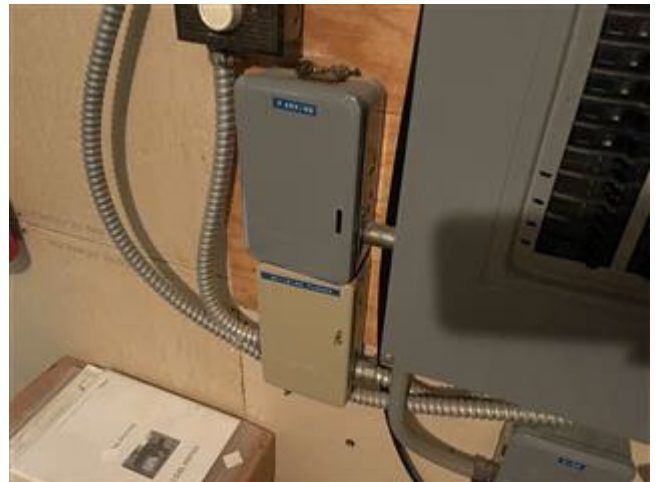
Building Electrical Service. Electrical service enters the building via the vault which is maintained by the utility company. This includes the meter, feed lines, conduits, and buss ducts.

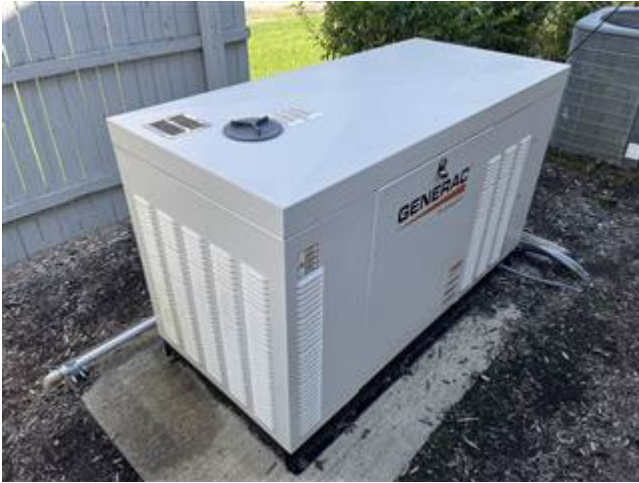
Emergency Generator. The facility features an emergency generator. The system operates on standby until needed. The generator includes a natural gas generator, voltage generator, transfer switches, and an enclosure.

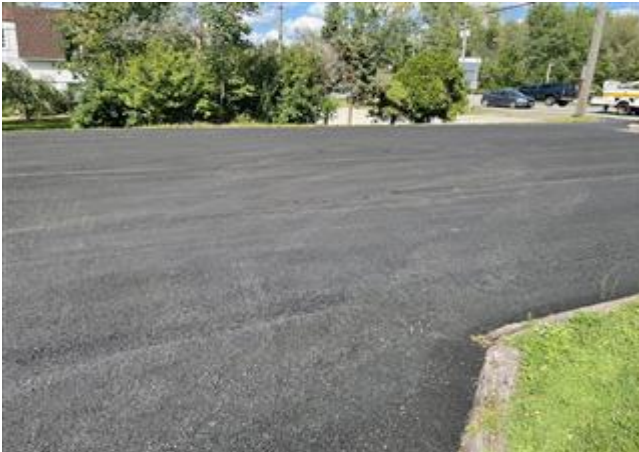
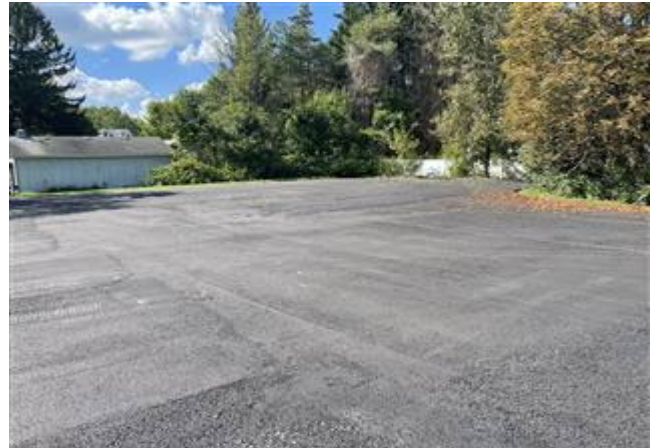
Tar and Chip Pavement. The parking areas and drive lanes include tar and chip pavements. Generally, tar and chip provide an economical way to pave areas with light traffic. The tar and chip will eventually become a hardened surface from vehicle traffic.

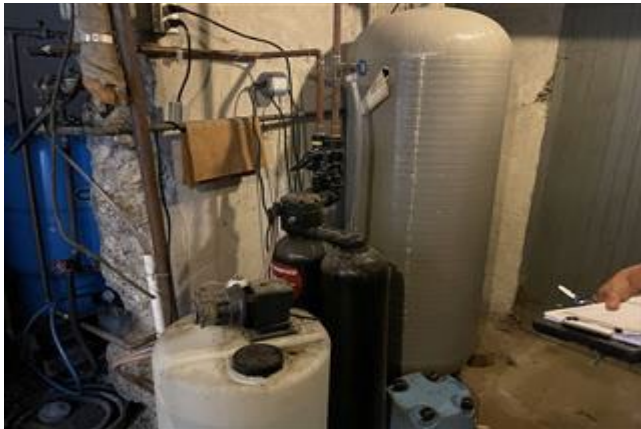
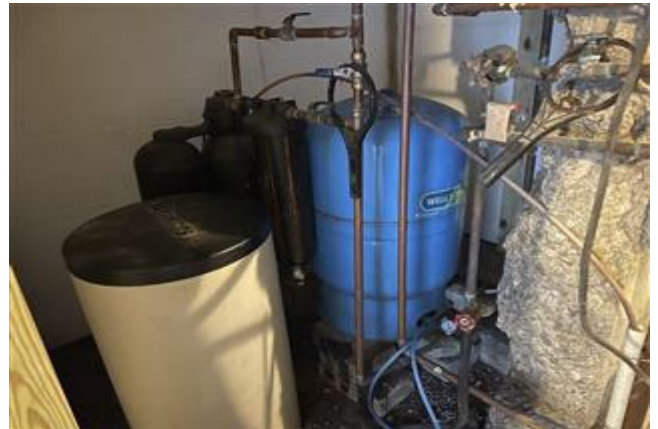
Well and Water Softener. The building features a ground water well and septic system. We consider the system to include the well casing, well pump, and piping. These items are concealed underground and were not reviewed but we understand they are in good operating condition. The system also includes a water softener system which includes a water softener system, brine tank, and pressure tank. The water softener is reported to be in good condition.

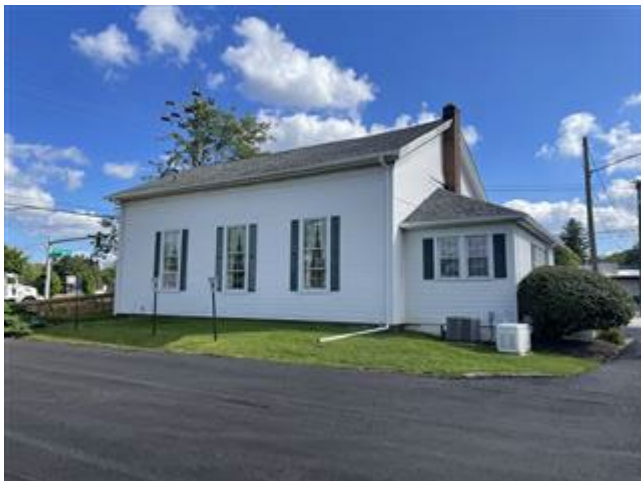
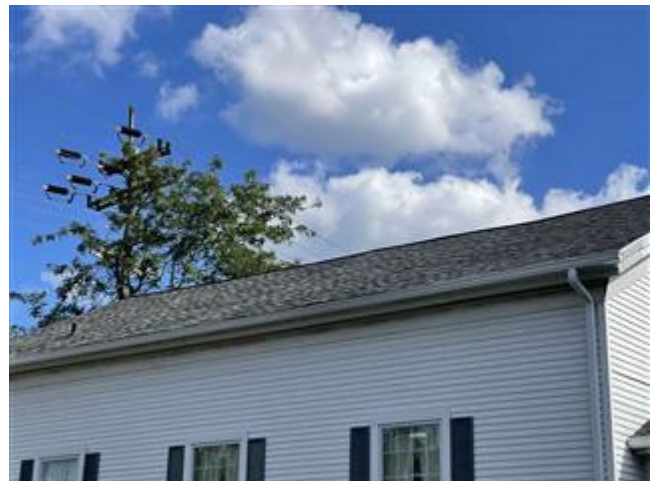
Building Roofing. The building features a pitched structure that is roofed in asphalt shingles. The roofing is in good condition.

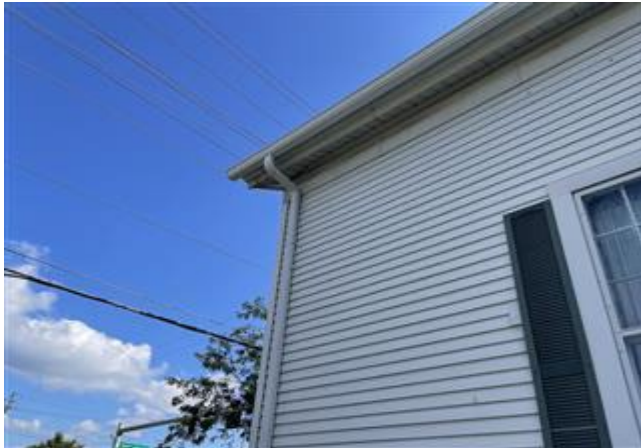
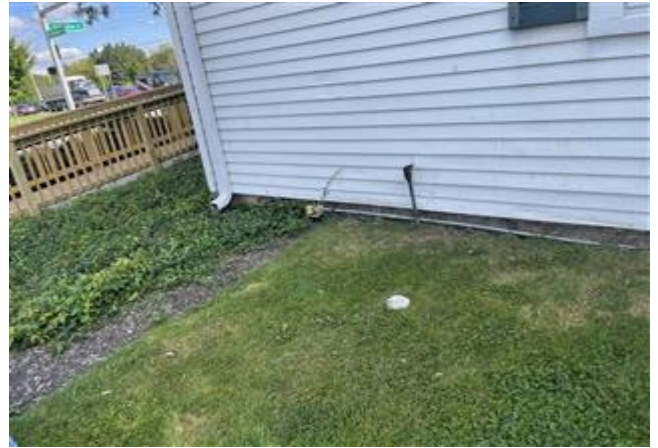
Gutters and Downspouts. The building features aluminum gutters and downspouts. The gutters and downspouts are in good condition.

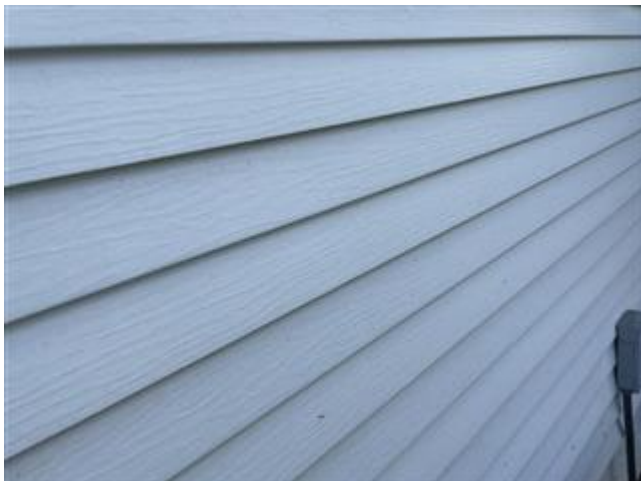
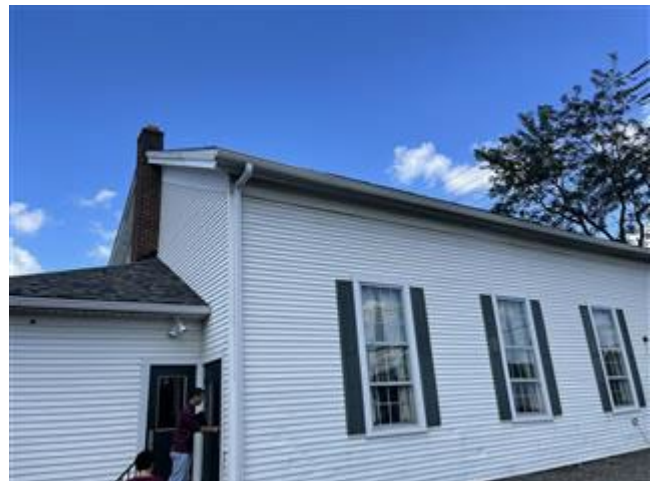
Siding and Trim. The building is sided aluminum siding or clapboards. The building exterior is in good condition. We have estimated that these exteriors will be replaced with cement fiber boards.

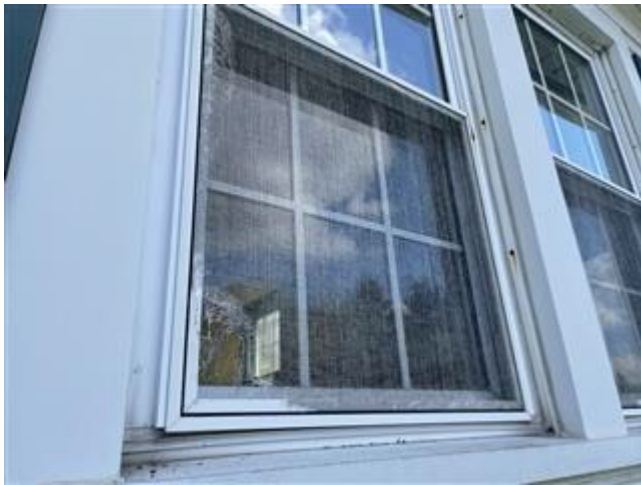
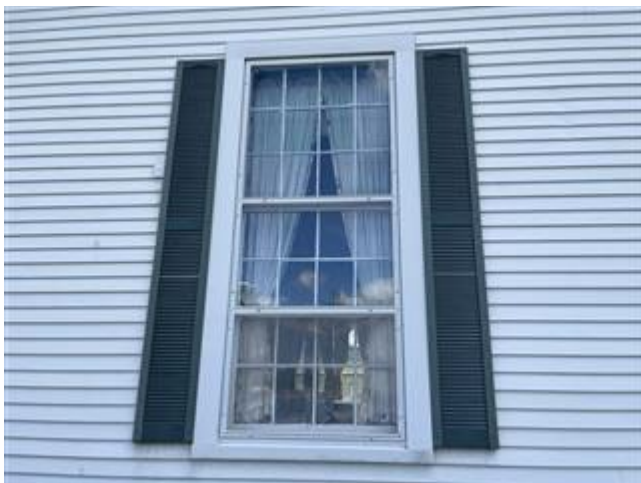
Windows. The Township maintains the windows of the facility. The windows are historic wood and glass and are generally in good condition.

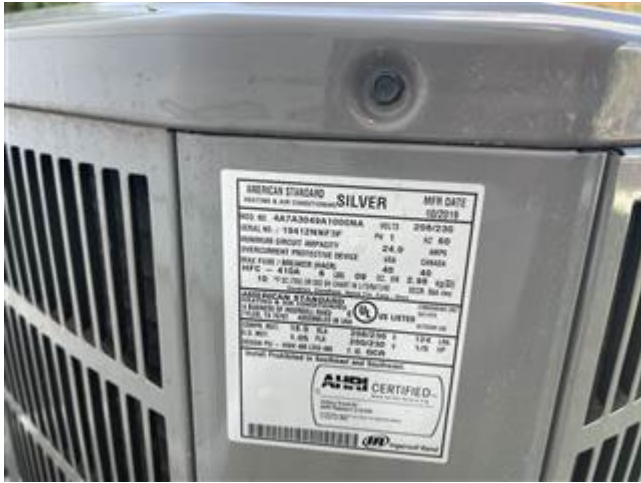
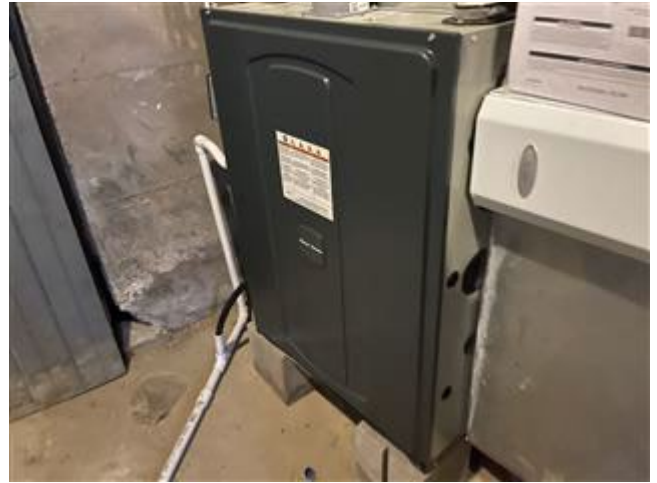
HVAC Systems. The heating ventilation and air conditioning (HVAC) of the facility are provided by furnace/compressor split systems. The HVAC is in good working order. Detailed inspection and testing of these systems are beyond the scope of this study.

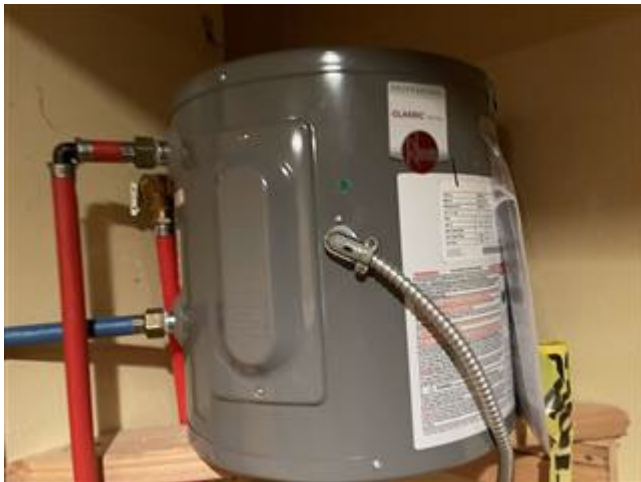
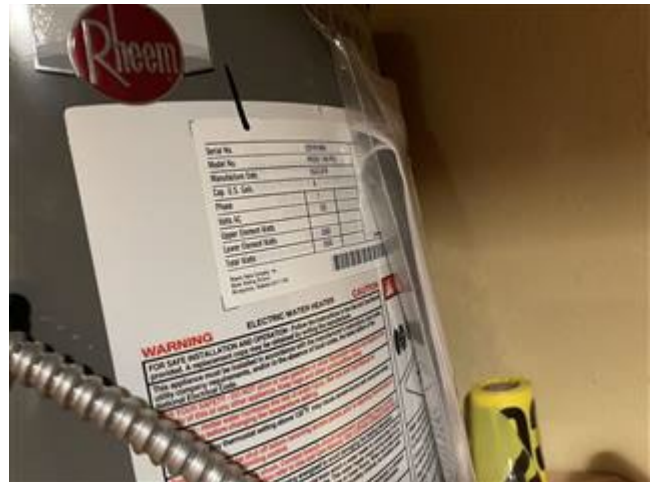
Domestic Hot Water. Domestic hot water is provided by a water heater tank which is in good condition.

Typically these types of systems have a service life of 12-15 years. This system should be serviced periodically to provide the most reliable service.

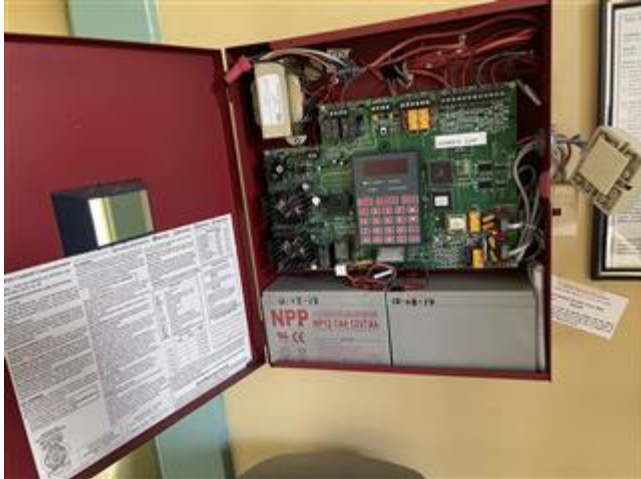
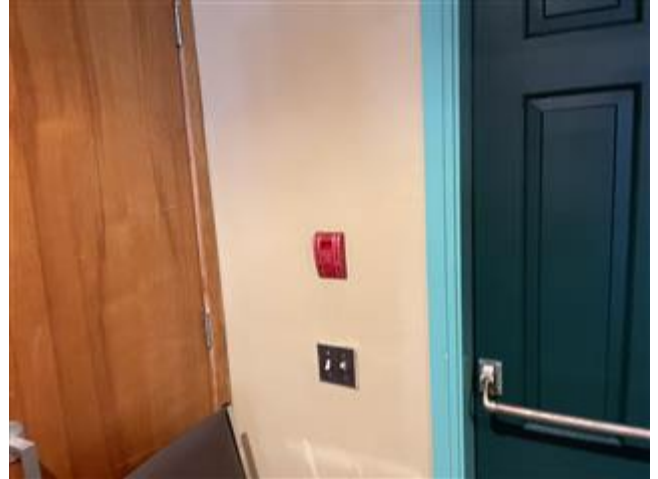
Fire Safety Systems. The facility includes a fire safety system to notify the occupants in the event of a fire. The system includes a fire alarm panel, smoke detectors, speakers, strobes, emergency pulls, a sprinkler, and a pressure pump system.

Fire Sprinkler. The building does not have a fire sprinkler.

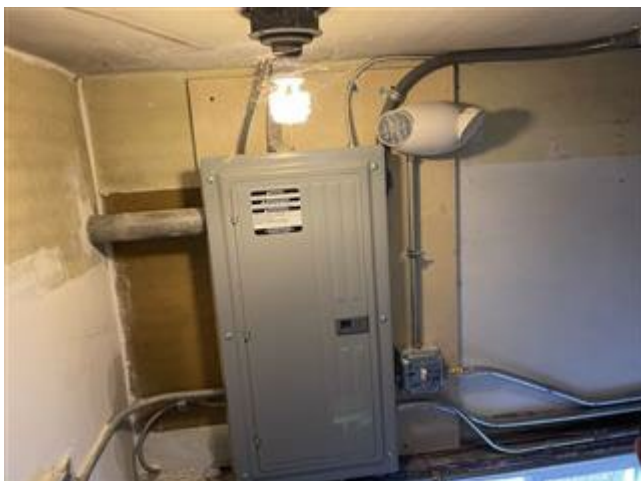
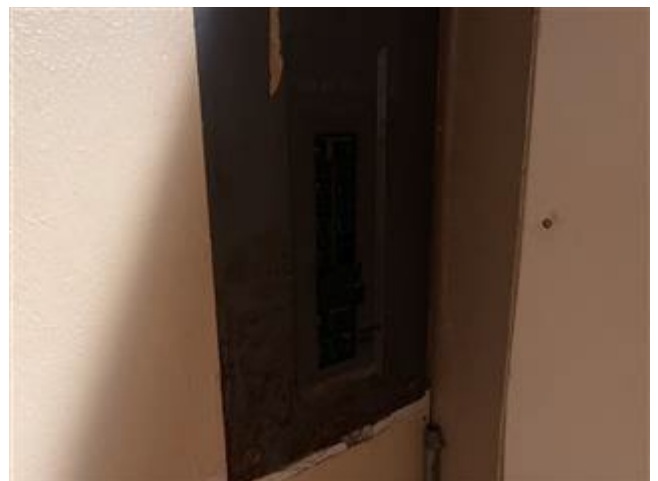
Electrical Distribution Panels. The building's electrical systems feature a number of electrical distribution panels located throughout the facility. These panels separate the building's electrical power into separate identifiable circuits. All panels track back to the service and have panel schedules identifying the circuits within the breaker panel. Some of these panels date to the original construction of the building and have a rated service life of 50 years or more.

The overall condition of the distribution panels is good. As the distribution panel's age, obtaining replacement parts can be expected to become more difficult. When parts no longer are available, the Association will have to replace some of the existing panels. The replacement will have to be performed on an incremental basis, panel by panel. Therefore, we have included funding in the Reserve Analysis for distribution panel replacement on an incremental basis.

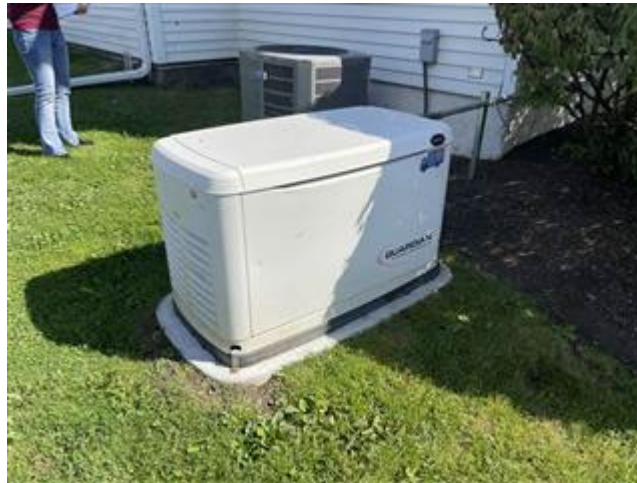
Emergency Generator. The facility features an emergency generator. The system operates on standby until needed. The generator includes a natural gas engine, a voltage generator, a control panel, and an enclosure.

The generator power is distributed to Automatic Transfer Switch (ATS) which powers designated panels. These panels are typically emergency panels that service necessary building features and safety features such as lighting, fire alarm, and elevators. Generators should be exercised regularly. Regular maintenance is required to keep the system functional.

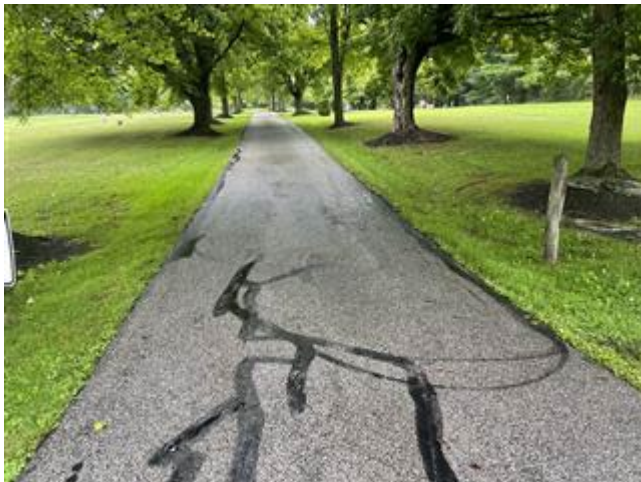
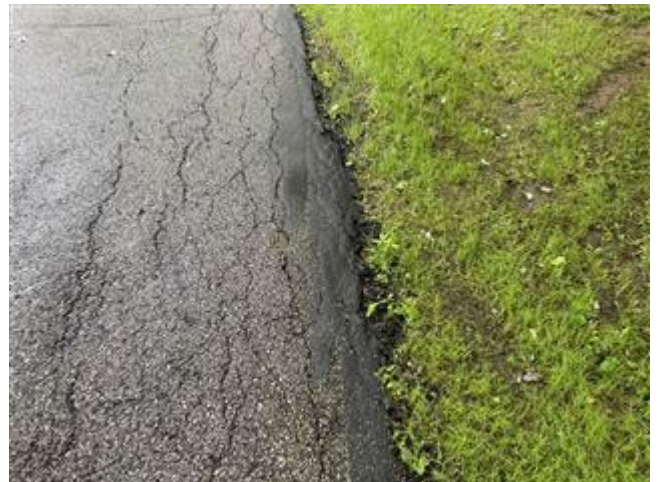
Parking Areas. The building features parking areas and drive lanes constructed of asphalt pavement. The pavements are in good condition.

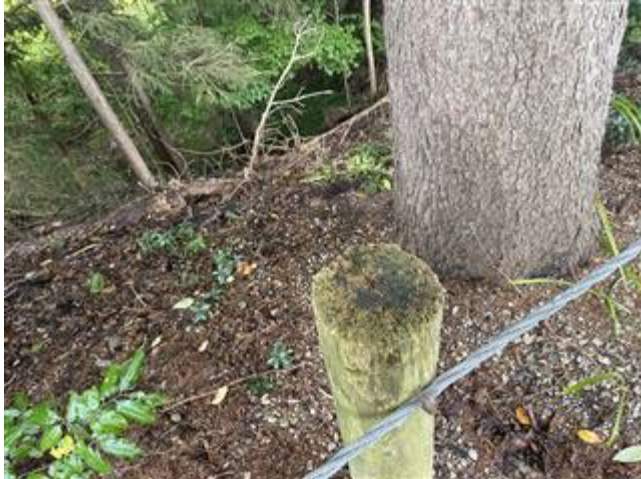
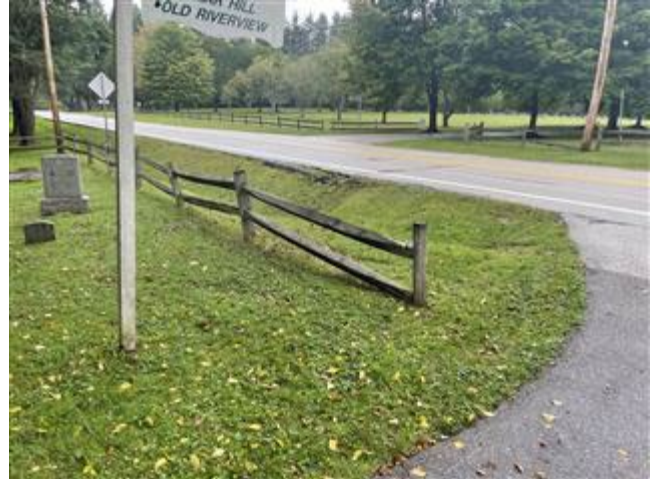
Stormwater Management. We have included an allowance for stormwater management. This allowance is intended to address drainage issues, wet areas, inlets, structures, etc.

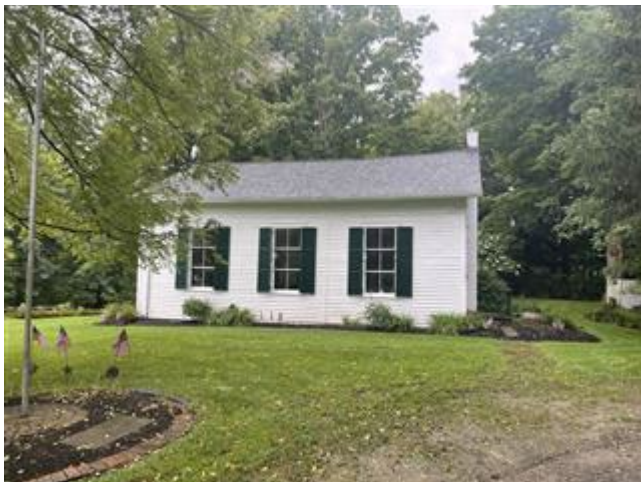
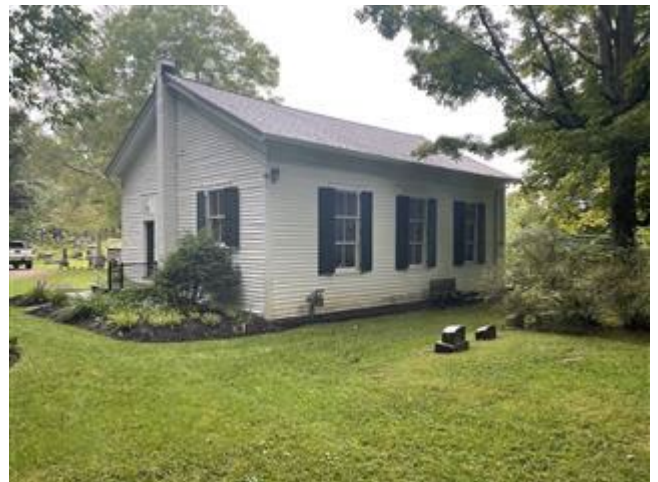
Building Roofing. The building features a pitched structure that is roofed in asphalt shingles. The roofing is in good condition.

The building features a pitched structure that is roofed in metal roofing. The roofing is new and in good condition.

The building features a flat roofing system. The roofing consists of a Built-Up Roofing system (BUR). The roofing is in fair condition.

Annual inspections are recommended, with cleaning, repair, and mitigation of vegetation performed as needed. Access, inspection, and repair work should be performed by contractors and personnel with the appropriate access equipment who are experienced in the types of roofing used for the facility.

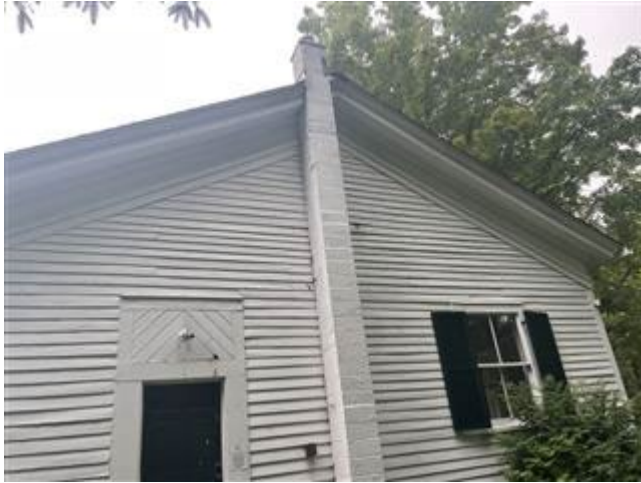
Siding and Trim. The building is sided in wood clapboards. The building exterior is in good condition.

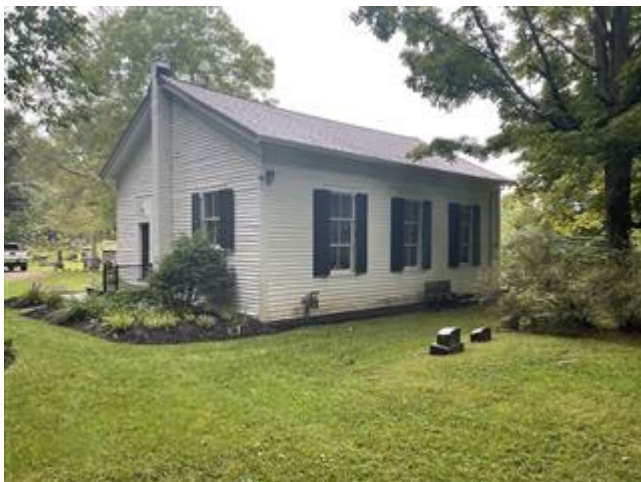
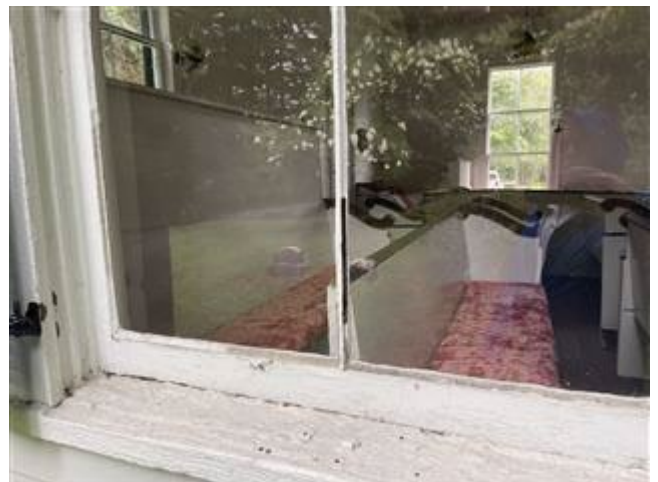
Windows. The Township maintains the windows of the facility. The windows are generally in good condition.

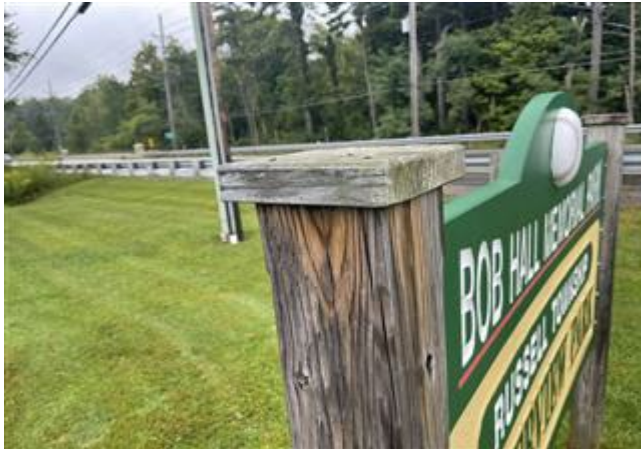
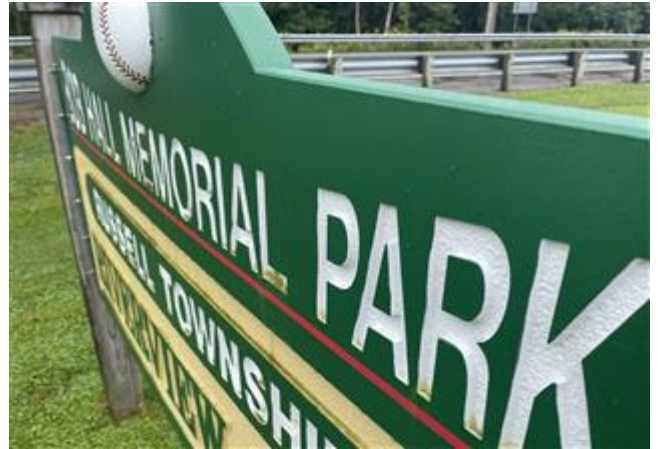
Entry Monument and Signage. The building features an entry monument. The monument is in good condition.

We recommend re-pointing and replacement of defective areas of the masonry as needed. The Association may want to consider applying a coating of Siloxane or other appropriate breathable sealants to mitigate water penetration and further degradation of the masonry work.

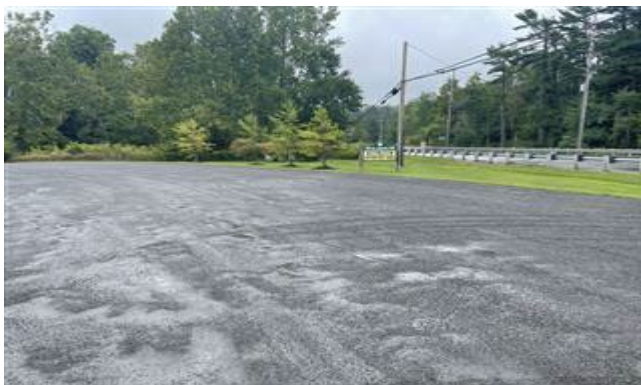
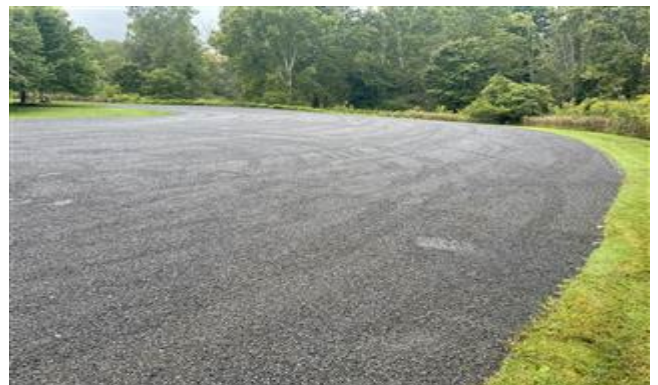
Tar and Chip. The parking areas and drive lanes include tar and chip pavements. Generally tar and chip provides an economical way to pave areas with light traffic. The tar and chip will eventually become a hardened surface from vehicle traffic.

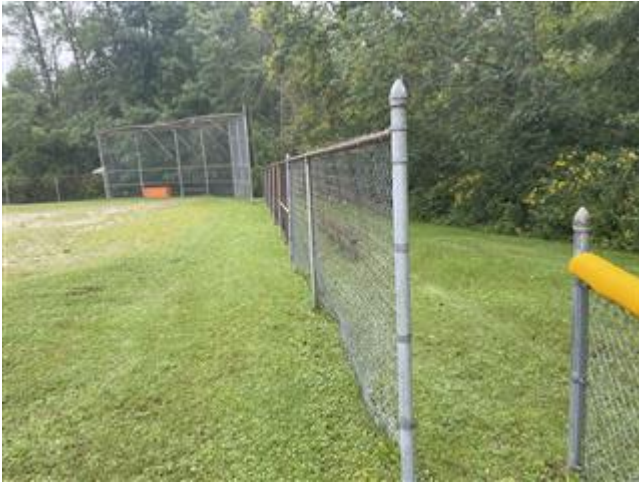
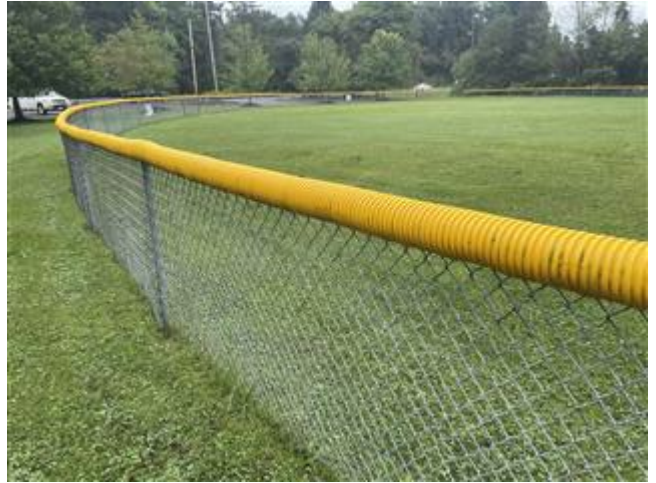
Baseball Fence. The Bob Hall Memorial Field features a baseball fence. This includes outfield fence and a back stop.

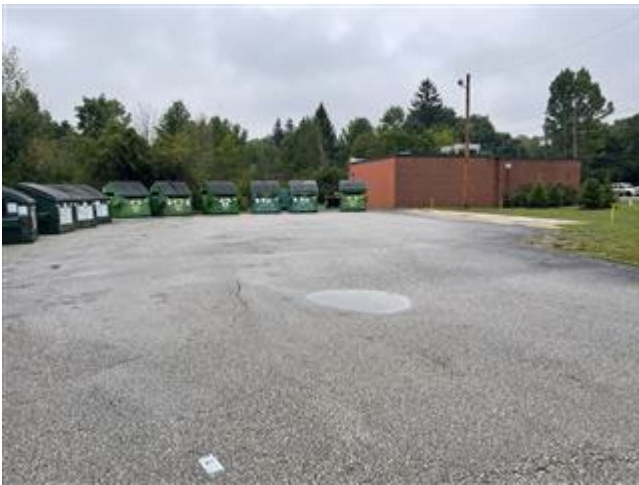
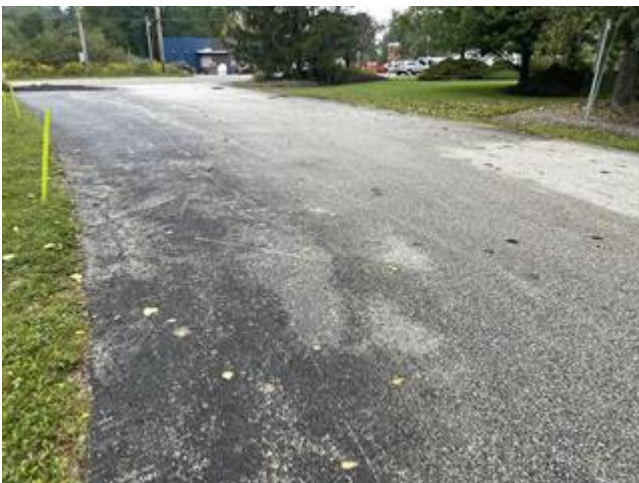
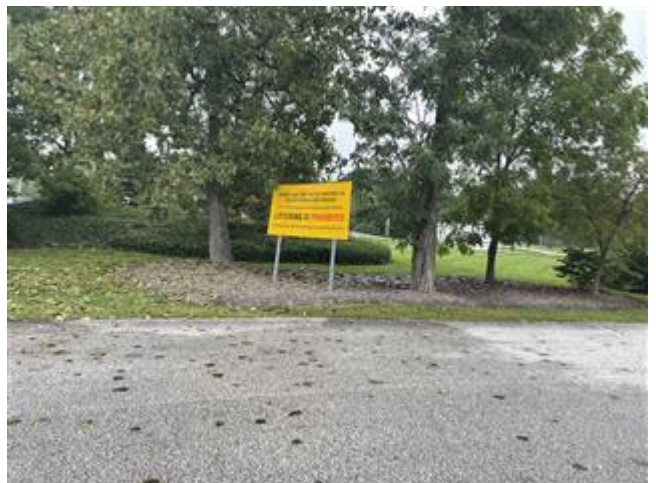
Asphalt Pavement. The Township features a recycle area that includes asphalt pavement. In general, the Association's asphalt pavements are in poor condition.
