LEVEL 2 REPLACEMENT RESERVE REPORT FY 2023 RUSSELL TOWNSHIP

RUSSELL TOWNSHIP

REPLACEMENT RESERVE REPORT

NOVELTY, OHIO
September 6, 2022
Revised December 8, 2022
Revised February 14, 2023

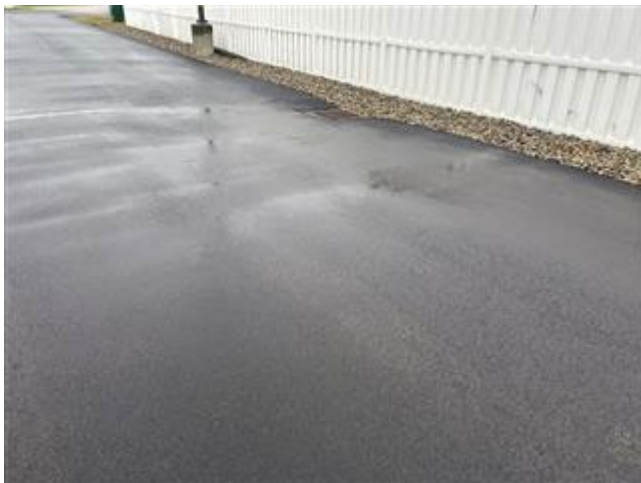
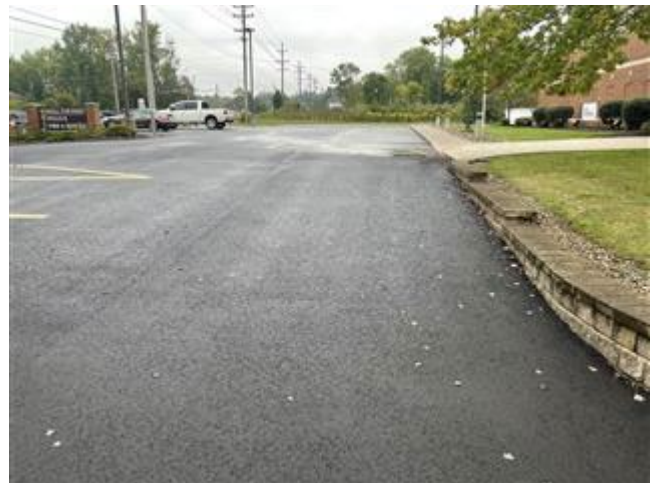
Parking Areas. The building features parking areas and drive lanes constructed of asphalt pavement. The pavements are new and in good condition.

- **Open Cracks.** There are multiple locations where open cracks are allowing water to penetrate to the asphalt base and the bearing soils beneath. Over time, water will erode the base and accelerate the deterioration of the asphalt pavement. If cracks extend to the base and bearing materials, remove the damaged areas, and replace defective materials. As a part of normal maintenance, clean and fill all other cracks.

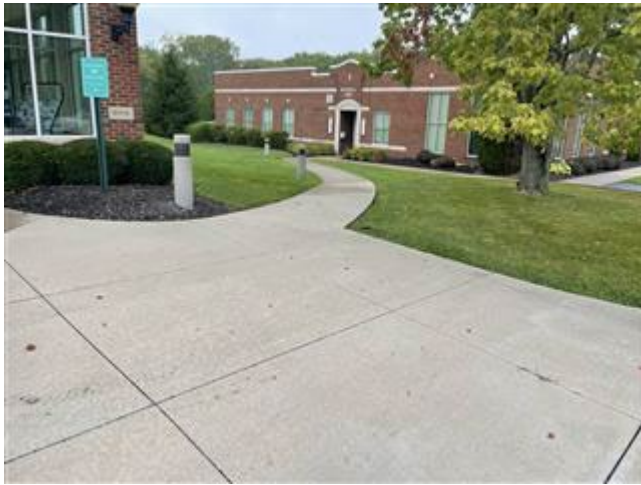
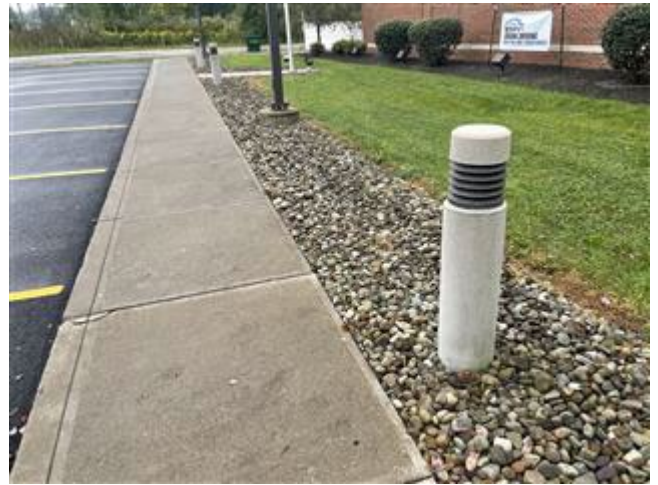
Concrete Work. The concrete work includes the community curb and gutter, sidewalks, leadwalks, stairs, stoops, and other flatwork. We have modeled for curb replacement when the asphalt pavement is overlaid. The overall condition of the concrete work is fair with areas of defects consistent with the age of the installation.

Because it is highly unlikely that all of the concrete components will fail and require replacement in the period of the study, we have programmed funds for the replacement of these inventories and spread the funds over an extended timeframe to reflect the incremental nature of this work.

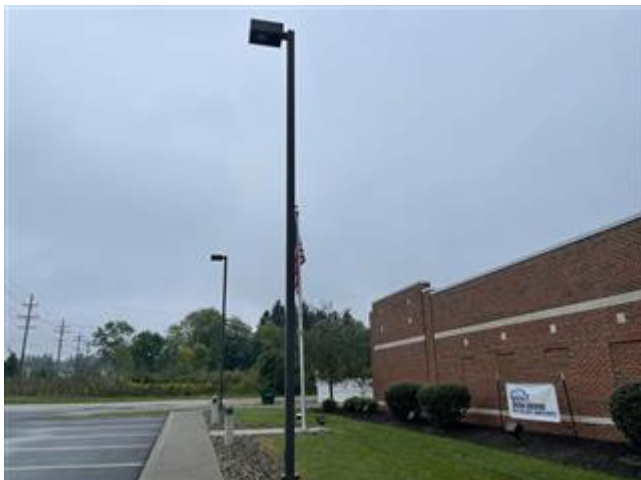
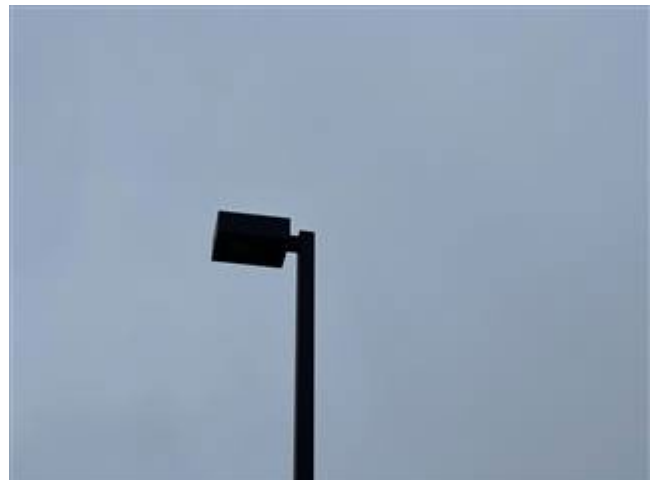
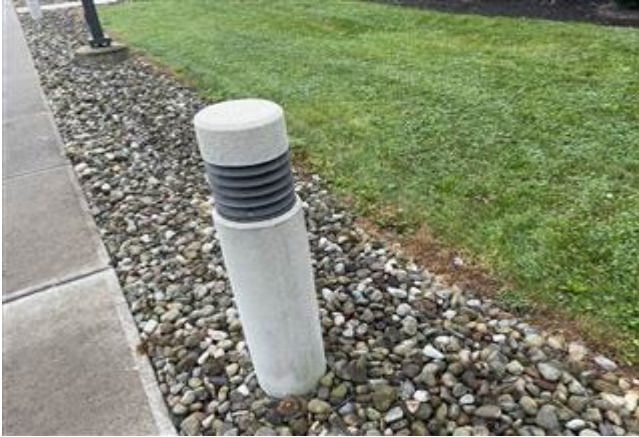
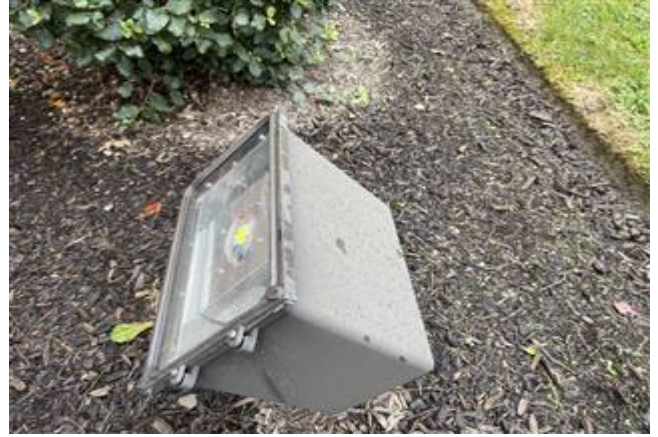
Site Lighting. The building features site lighting that includes post lamps, ground mounted lights, bollards, and building lights. The lights were not on at the time of our site visit, but we understand they are in good operating condition.

This study assumes the replacement of the light fixtures every 15 to 20 years, and pole replacement every 30 to 40 years. When the light poles are replaced, we assume that the underground wiring will also be replaced.

When a whole-scale lighting replacement project is called for, we recommend consulting with a lighting design expert. Many municipalities have design codes, guidelines, and restrictions when it comes to exterior illumination.

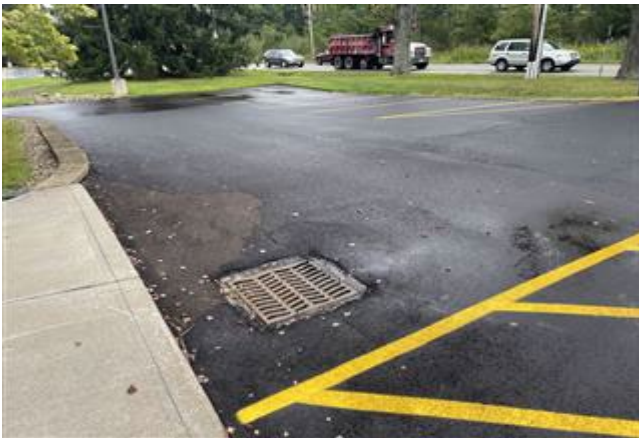
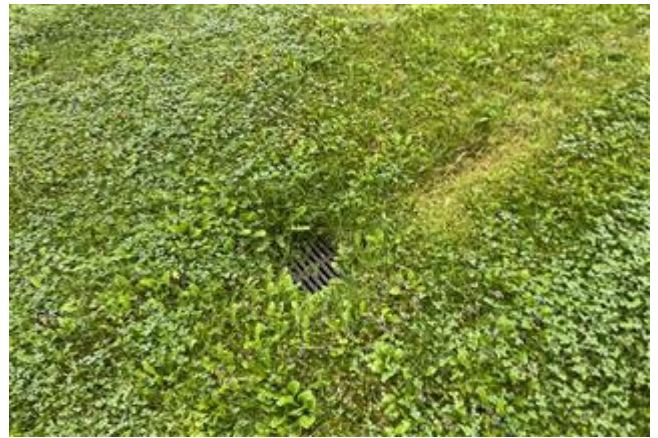
Stormwater Management. We have included an allowance for stormwater management. This allowance is intended to address drainage issues, wet areas, inlets, structures, etc.

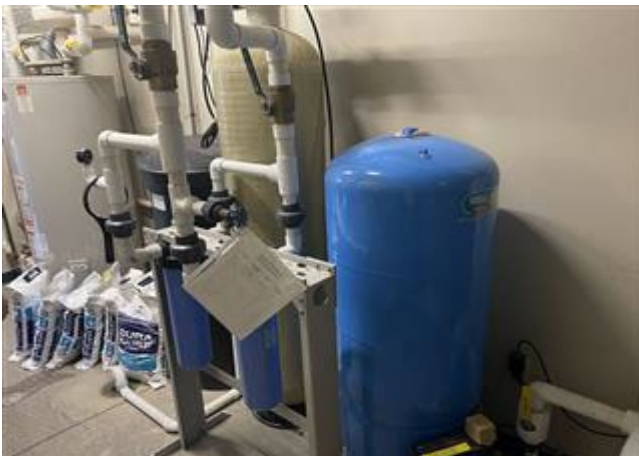
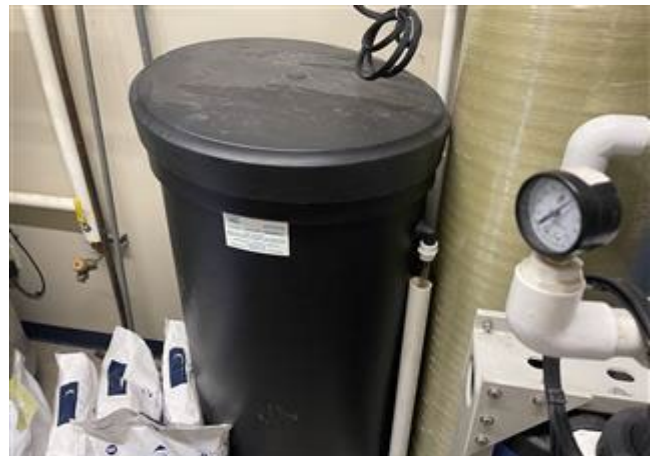
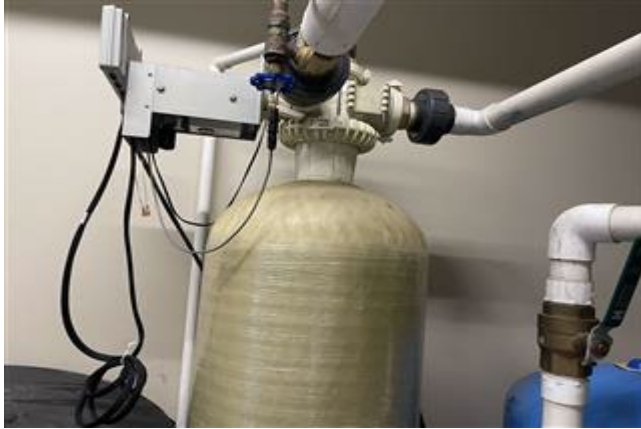
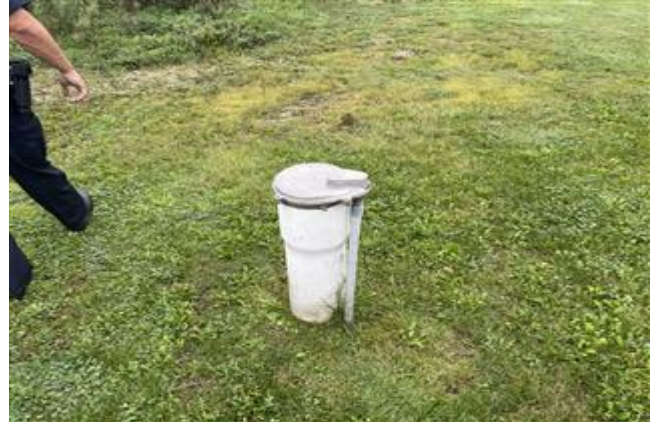
Well and Water Softener. The building features a groundwater well and septic system. We consider the system to include the well casing, well pump, and piping. These items are concealed underground and were not reviewed but we understand they are in good operating condition. The system also includes a water softener system which includes a water softener system, brine tank, and pressure tank. The water softener is reported to be in good condition.

Septic System. The building features a septic system. The system includes a box, pump, valve, and leach bed. The system was concealed underground and not reviewed but is reported to be in good condition.

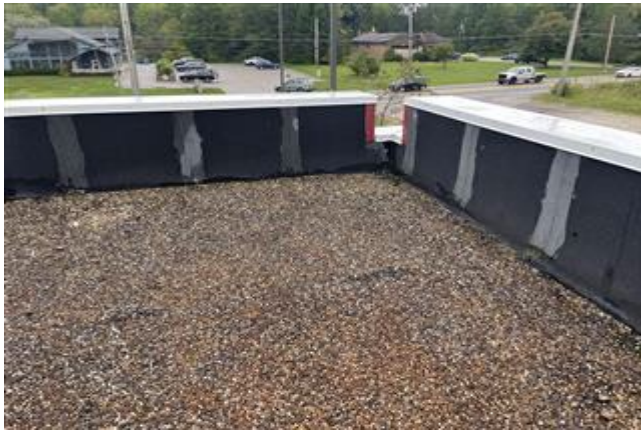
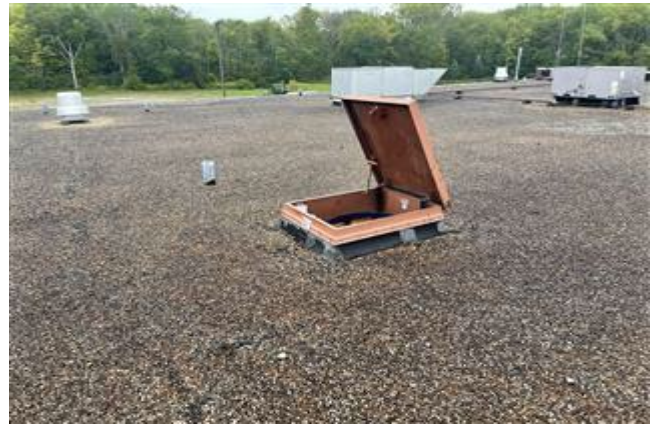
Building Roofing. The building features a flat roofing system. The roofing consists of a Built-Up Roofing system (BUR). The roofing is in fair condition.

Annual inspections are recommended, with cleaning, repair, and mitigation of vegetation performed as needed. Access, inspection, and repair work should be performed by contractors and personnel with the appropriate access equipment who are experienced in the types of roofing used for the facility.

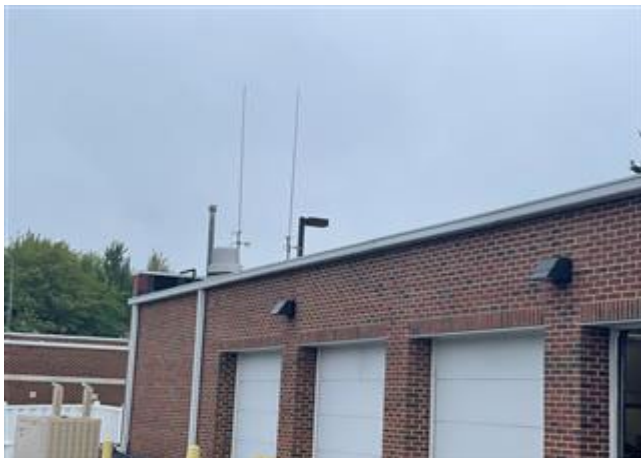
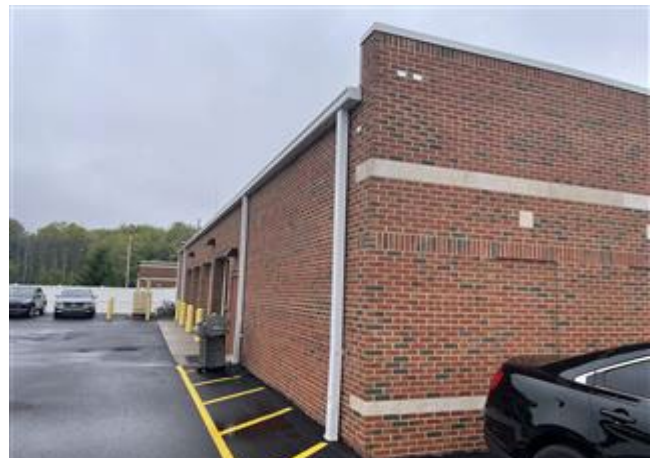
Gutters and Downspouts. The building features aluminum gutters and downspouts. The gutters and downspouts are in good condition.

It is recommended that all gutters be cleaned at least twice each year. If there are a large number of trees located close to a building, consider installing a gutter debris shield that will let water into the gutters but will filter out leaves, twigs, and other debris.

It is recommended that gutters and downspouts be installed on all buildings. It is also recommended that the discharge from the downspouts be extended at least ten feet away from the foundations.

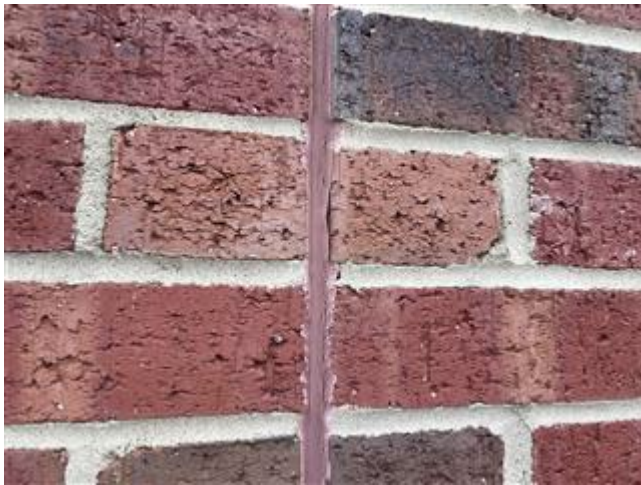
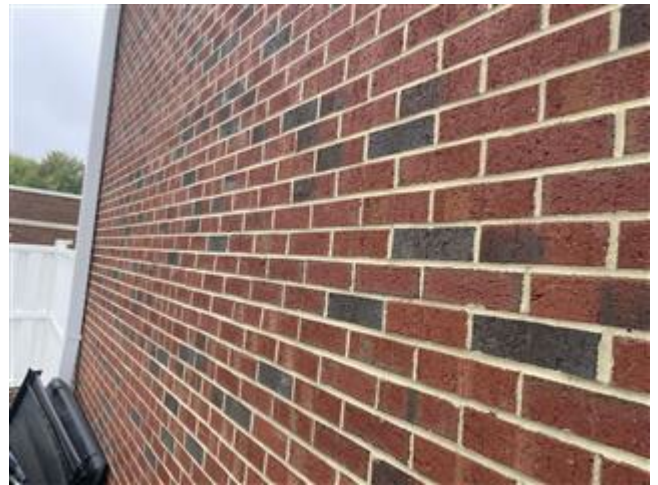
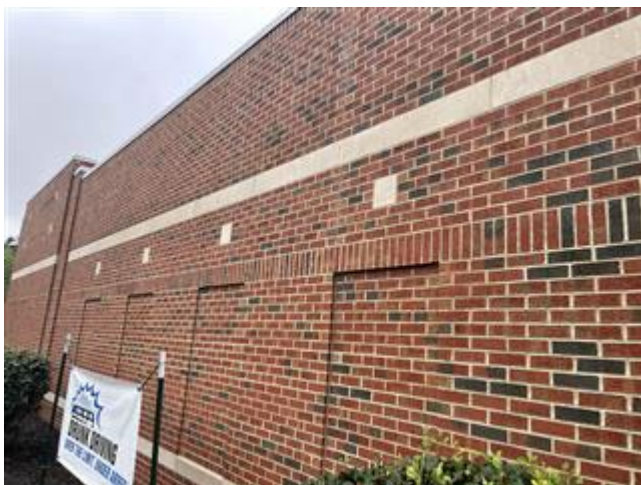
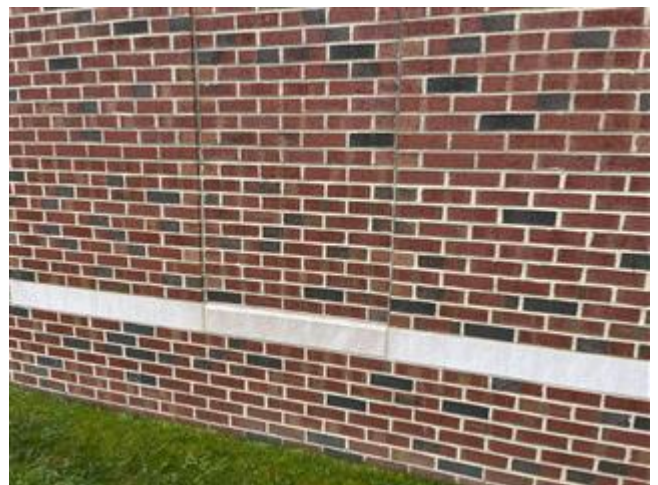
Masonry. The building is clad in brick masonry with mortar joints. The brick masonry is in good condition.

Brick masonry is used as the main exterior cladding of the building. As masonry weathers, the mortar joints will become damaged by water penetration. As additional water gains access to the joints, repeated freeze-thaw cycles gradually increase the damage to the mortar joints. If allowed to progress, even the masonry units such as brick can have their surfaces affected and masonry units can become loose.

Periodic repointing and local replacement of damaged masonry units will limit the damage done by moisture penetration. For this study, we assume that 10% of the masonry will require repointing every 10 years after approximately 30 years.

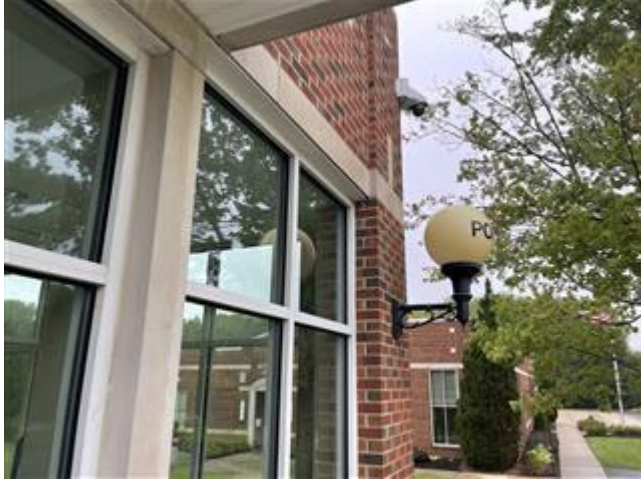
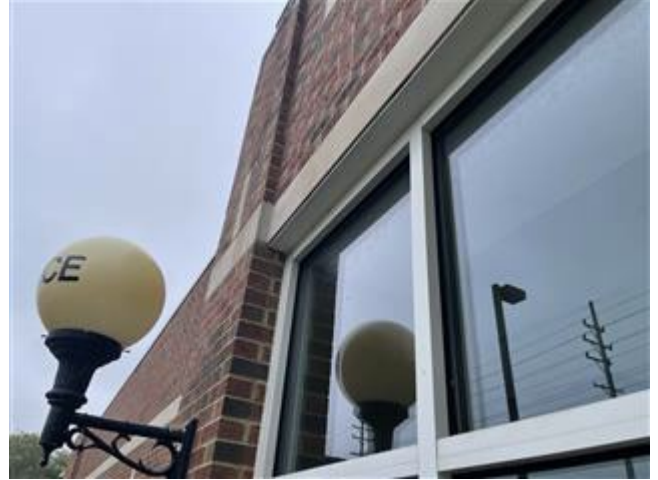
Windows. The community maintains the windows of the facility. The windows are generally in good condition.

In general, we recommend coordinating the replacement of the window units with other exterior work, such as siding and roof replacements. The weather tightness of the building envelope often requires wraps, transitional flashing, and caulking that should be performed in coordination with each other. Warranties and advantages in 'economy of scale' can often result in lower overall replacement costs and results that are more reliable. Lastly, coordinated replacements offer the opportunity to correct initial construction defects and improve the effectiveness of details with improved construction techniques and materials.

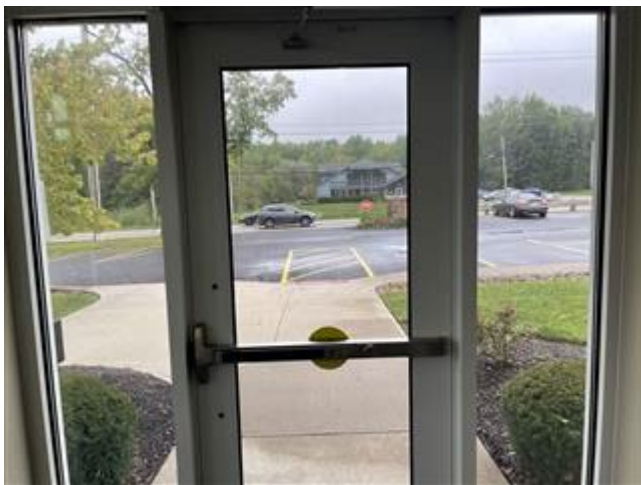
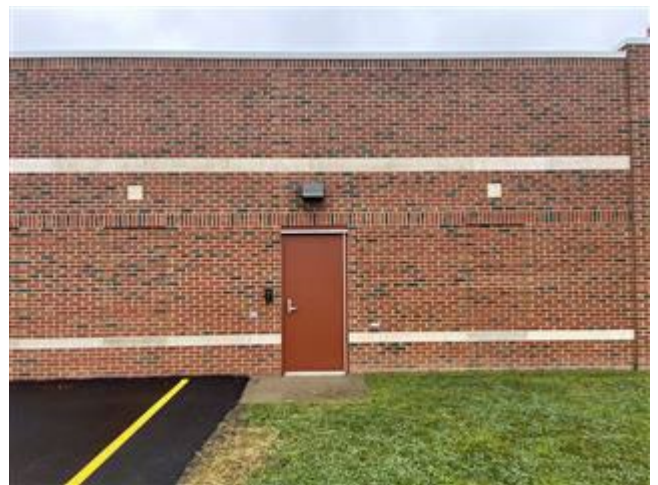
Exterior Doors. The Community maintains the exterior doors of the building.

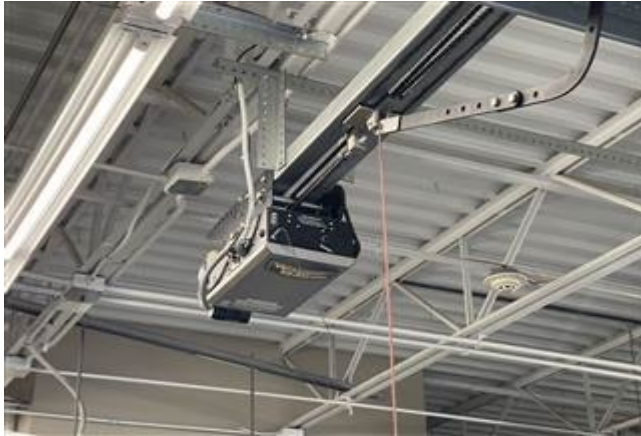
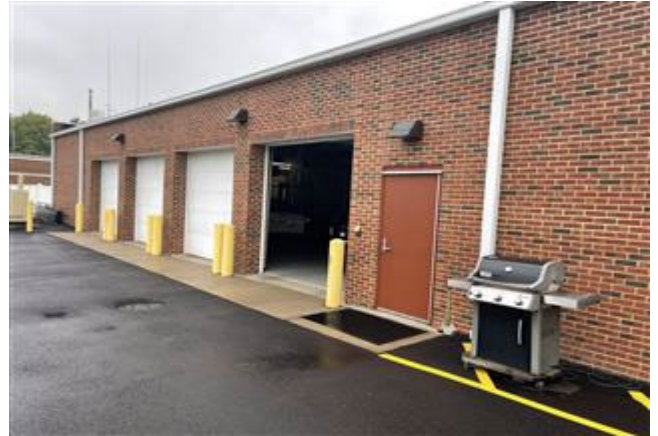
Overhead Doors. The building features overhead doors. The doors are in good working order.

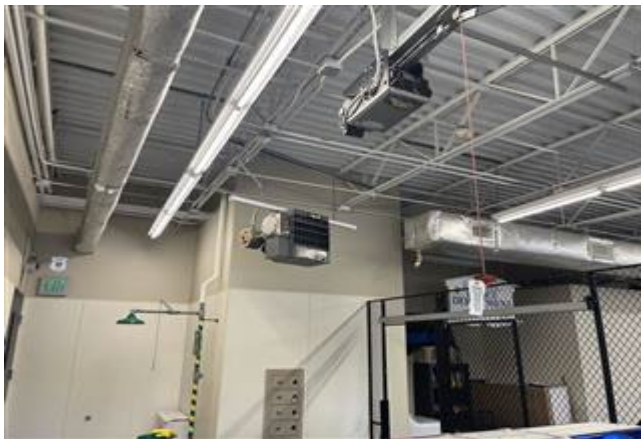
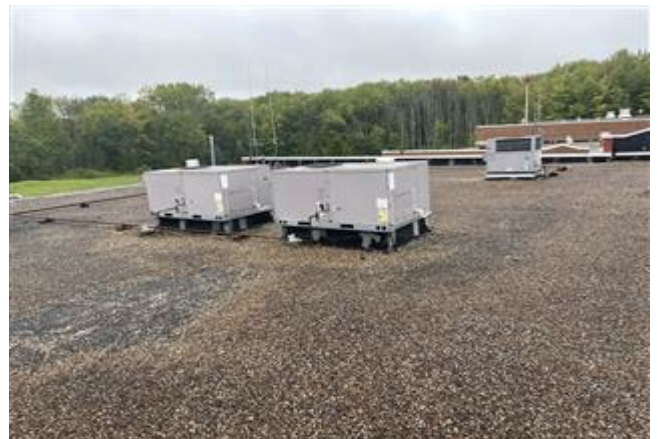
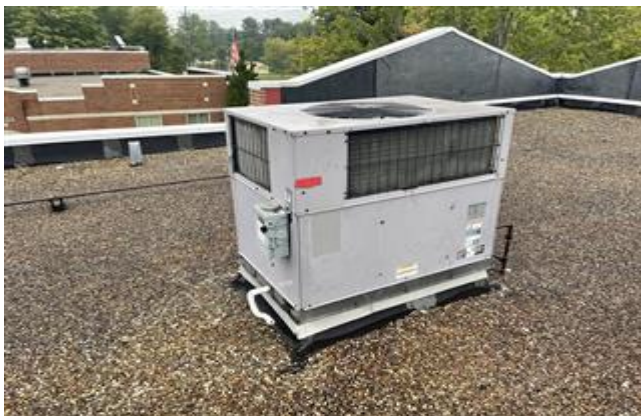
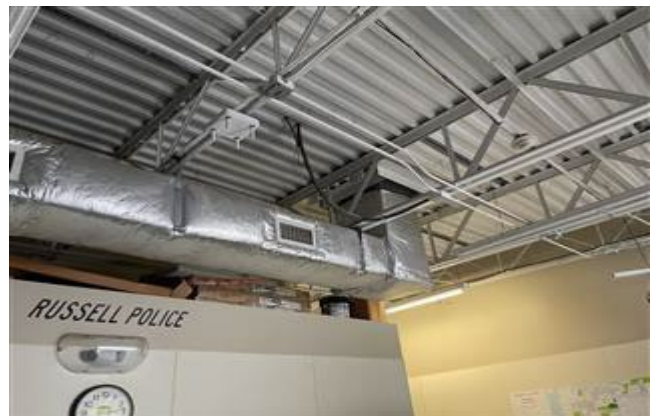
HVAC Systems. The heating ventilation and air conditioning (HVAC) of the facility are provided by furnace/compressor split systems. The HVAC is in good working order. Detailed inspection and testing of these systems are beyond the scope of this study.

Even though manufacturers continue to predict 15 to 20-year life cycles for HVAC equipment that uses these new refrigerants, this is not proven by historical data. We, therefore, recommend anticipating a normal economic life of 15 years for all HVAC equipment that uses pressurized refrigerants of these types.

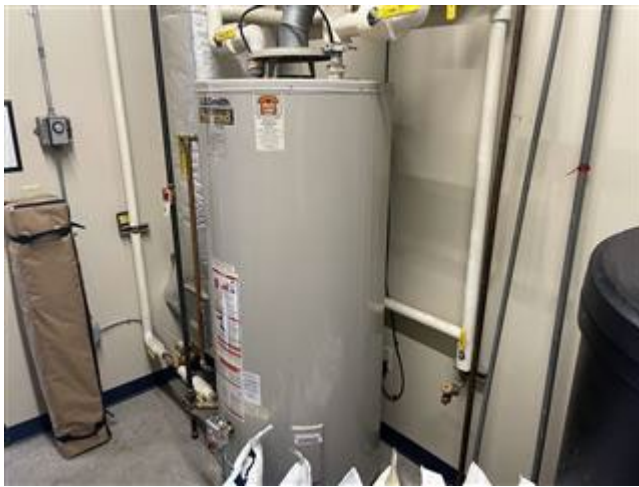
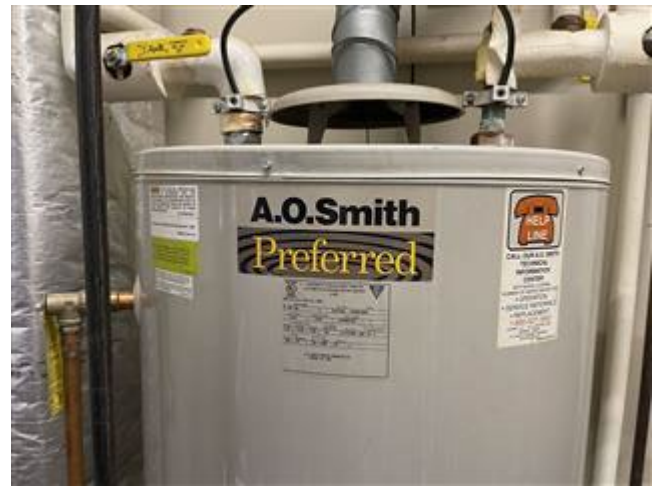
Domestic Hot Water. Domestic hot water is provided by a water heater tank which is in good condition.

Typically these types of systems have a service life of 12-15 years. This system should be serviced periodically to provide the most reliable service.

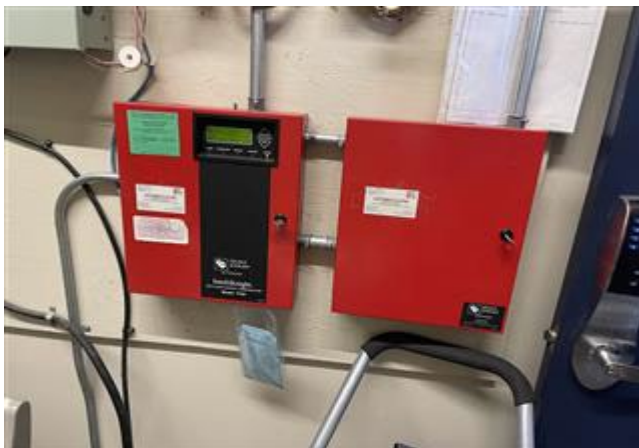
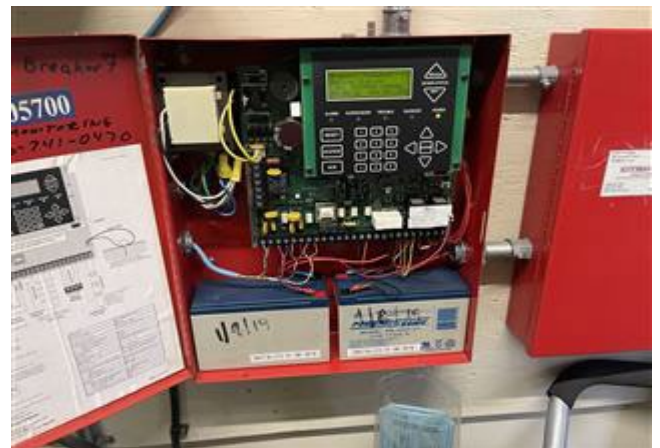
Fire Alarm Control Panel (FACP). The FACP provides the function of central processing and notifying channel for emergencies. Every device in the building is programmed into the FACP. Furthermore, the FACP is initiate the alarm. Please note the type of alarm is determined by the system settings. The Association should review how the system is programmed with the system engineer.

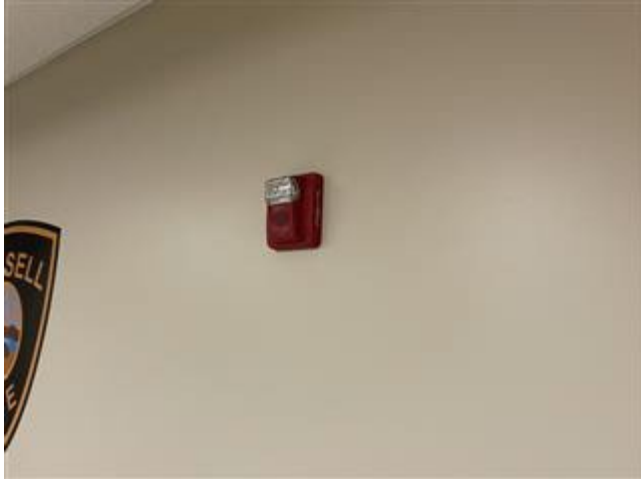
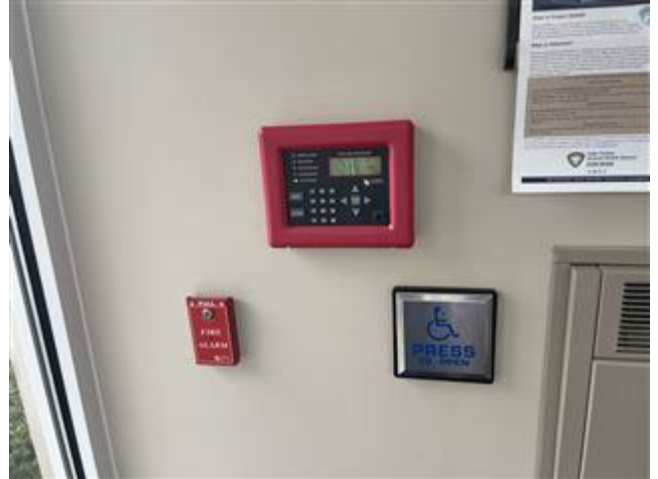
The fire alarm panel is an electronic device that programs and receives signals from the devices of the system.

Building fire alarm systems have a service life of 15 to 25 years. While the panels may continue to operate past this point, changes in fire safety technology and building fire safety codes tend to render them obsolete. In addition, manufacturers only support their systems for a limited period, typically about 15 years. After this time, it may be increasingly difficult to obtain replacement parts and service.

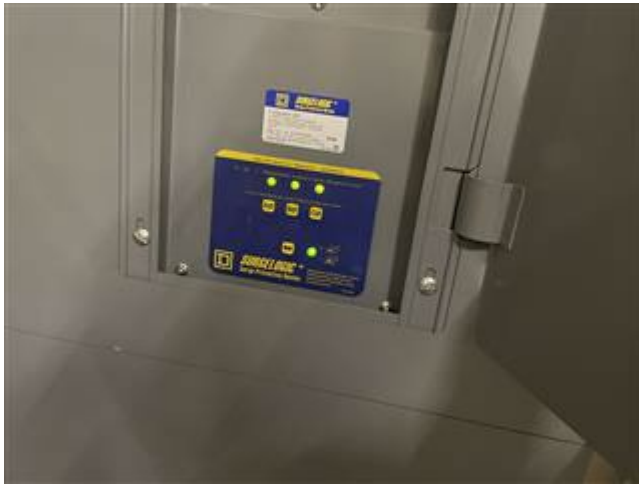
Electrical Switchgear. The electrical switchgear includes the ducts, switch boxes, disconnects, relays, fuses, and switches. The electrical switchgear dates to the original construction of the building. Electrical switchgear has a rated service life of 50 years or more. Electrical switchgear requires ongoing maintenance for proper operation and reliability.

The overall condition of the switchgear is good. We understand that replacement parts are still available for the equipment. As the switchgear continues to age, obtaining replacement parts can be expected to become more difficult. When parts no longer are available or when the condition of the switchgear deteriorates sufficiently, the Association will have to replace or upgrade the existing equipment. Therefore, we have included funding in the Reserve Analysis for distribution panel replacement on an incremental basis.

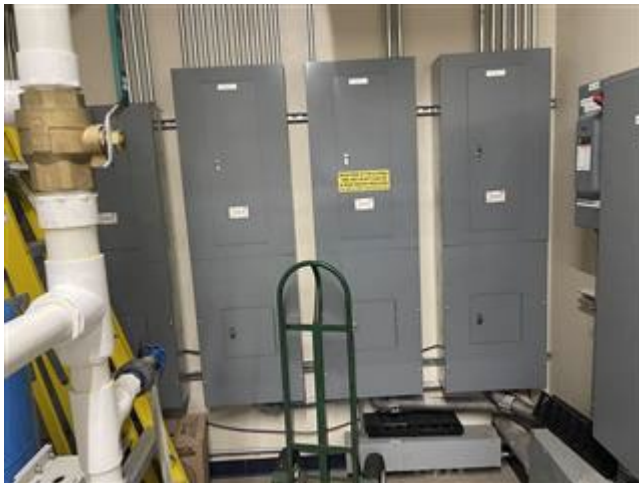
Electrical Distribution Panels. The building's electrical systems features a number of electrical distribution panels located throughout the facility. These panels separate the building's electrical power into separate identifiable circuits. All panels track back to the switchgear and have panel schedules identifying the circuits within the breaker panel. These panels date to the original construction of the building and have a rated service life of 50 years or more.

The overall condition of the distribution panels is good. As the distribution panel's age, obtaining replacement parts can be expected to become more difficult. When parts no longer are available, the Association will have to replace some of the existing panels. The replacement will have to be performed on an incremental basis, panel by panel. Therefore, we have included funding in the Reserve Analysis for distribution panel replacement on an incremental basis.

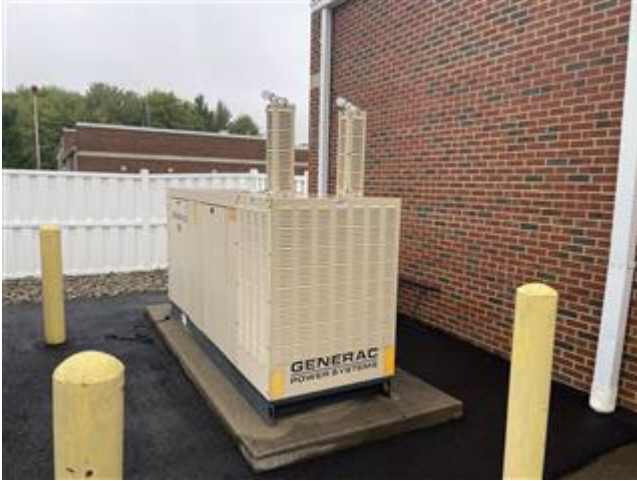
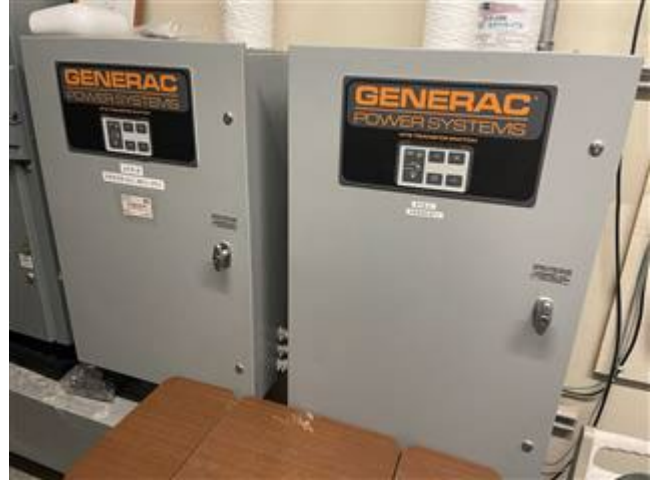
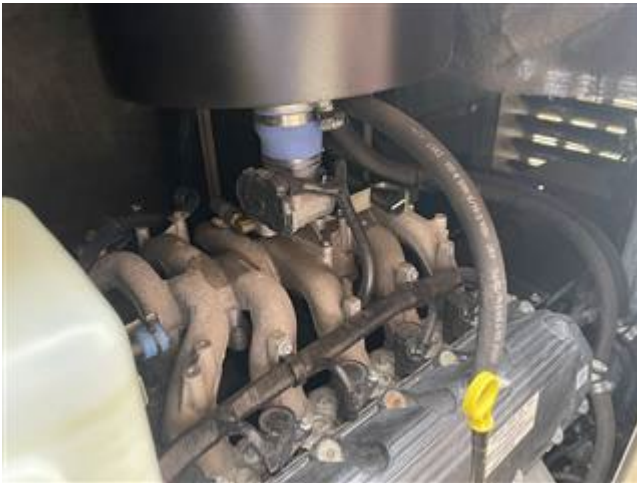
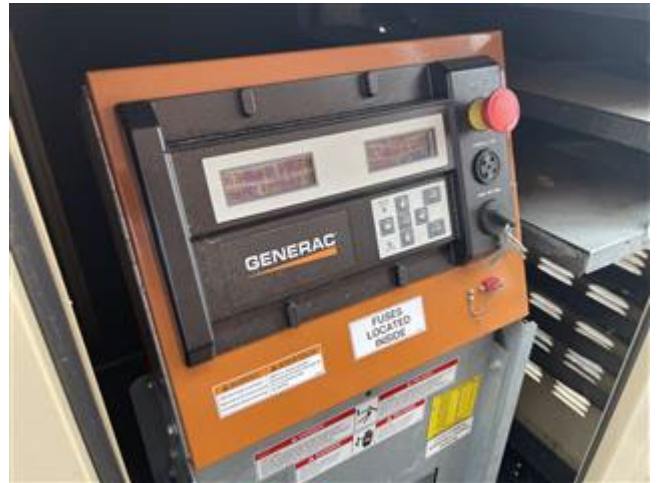
Emergency Generator. The facility features an emergency generator. The system operates on stand-by until needed. The generator includes a natural gas engine, voltage generator, control panel, and an enclosure.

The generator power is distributed to Automatic Transfer Switch (ATS) which powers designated panels. These panels are typically emergency panels that service necessary building features and safety features such as lighting, fire alarm, and elevators. Generators should be exercised regularly. Regular maintenance is required to keep the system functional.

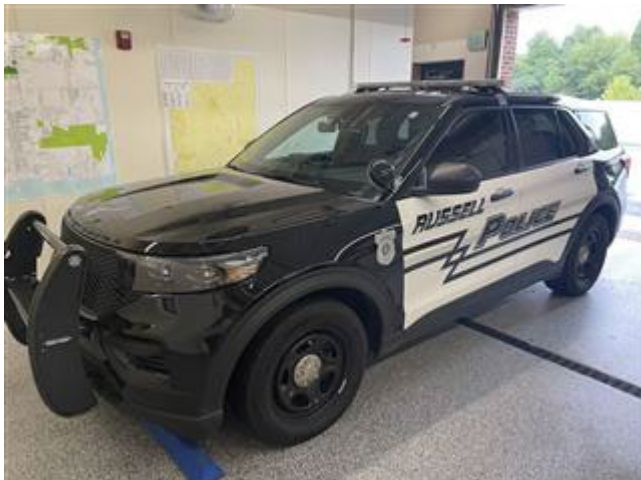
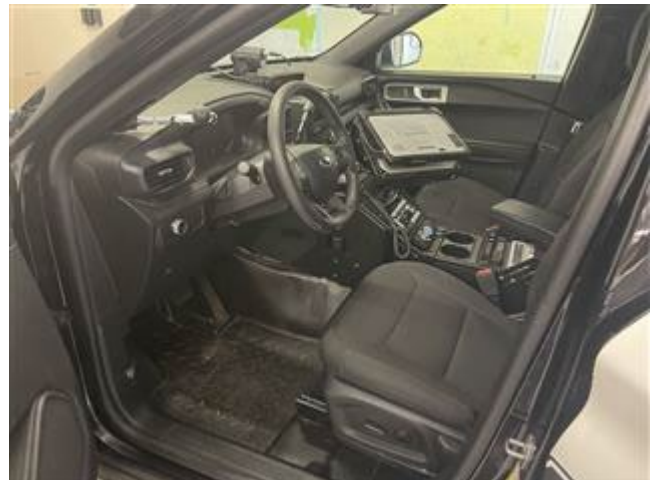
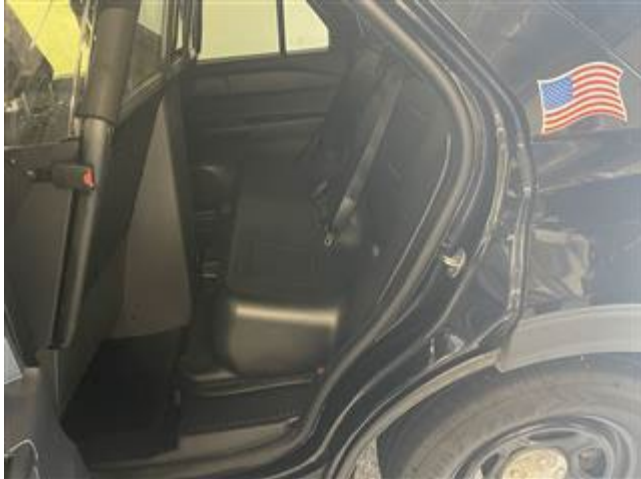
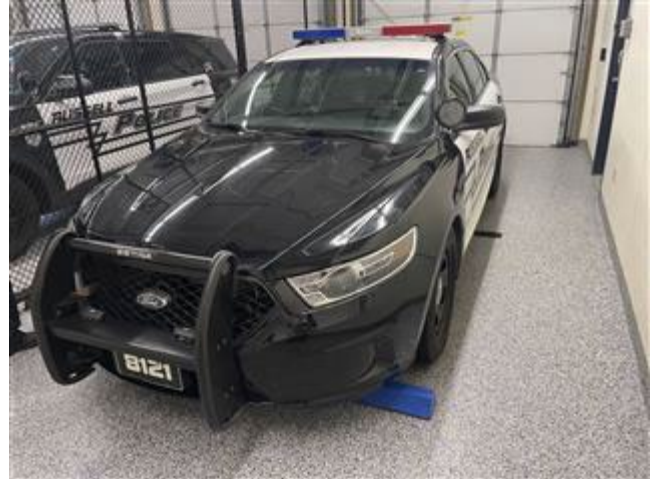
Vehicles. The Township features various vehicles to support Police Station activities.

The vehicles were not evaluated as part of this study. Vehicles are included in the inventory as indicated by the Township. The vehicles are replaced on a rotating schedule.

We have included computers, accessories, and fit out as new vehicles are rotated in.

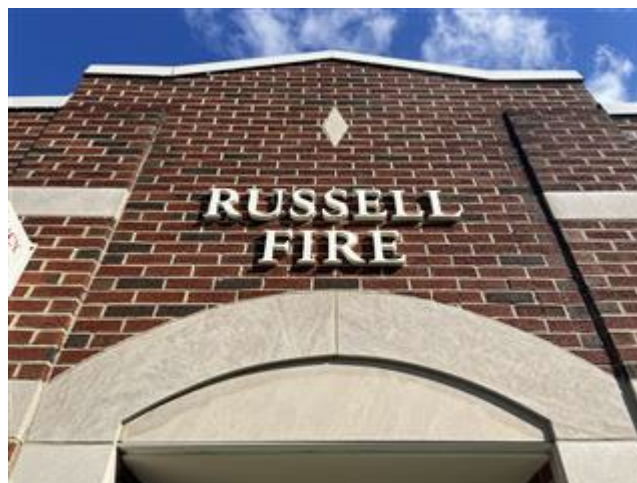
Entry Monument and Signage. The building features an entry monument. The monument is in good condition.

The monument/monuments is are made of wood/fiberboard/foam board and are in good/fair/poor condition, with damaged areas and weathering. To keep the monument fresh and appealing, we recommend replacement every 10 to 15 years.

We recommend re-pointing and replacement of defective areas of the masonry as needed. The Association may want to consider applying a coating of Siloxane or other appropriate breathable sealants to mitigate water penetration and further degradation of the masonry work.

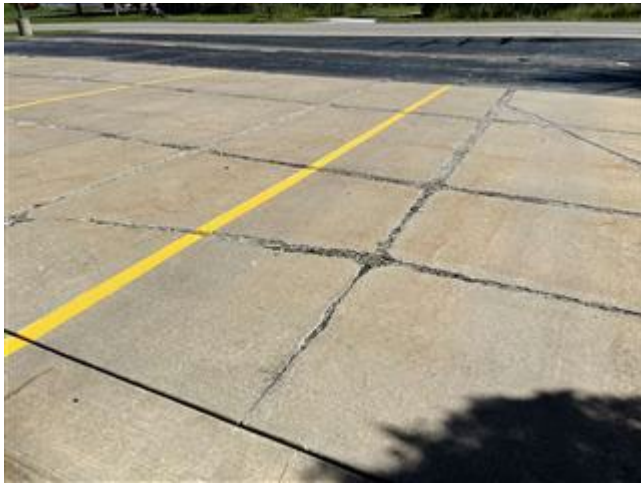
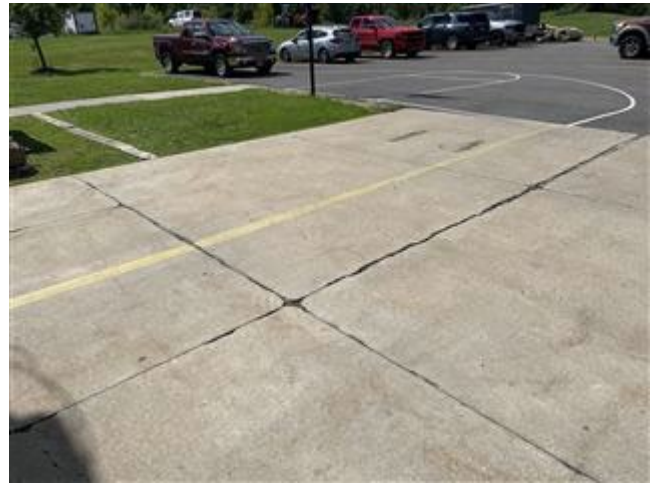
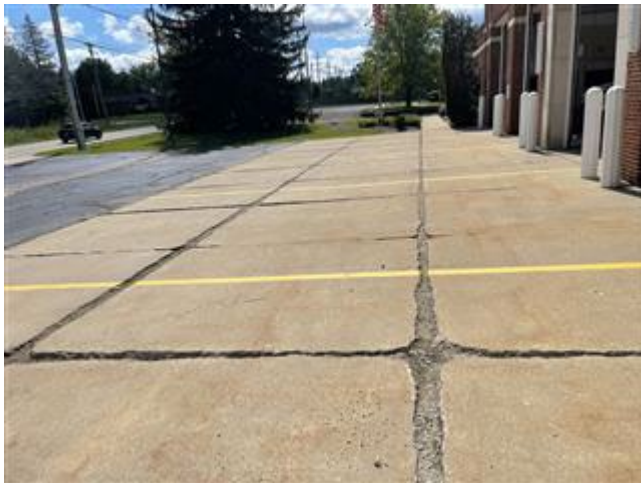
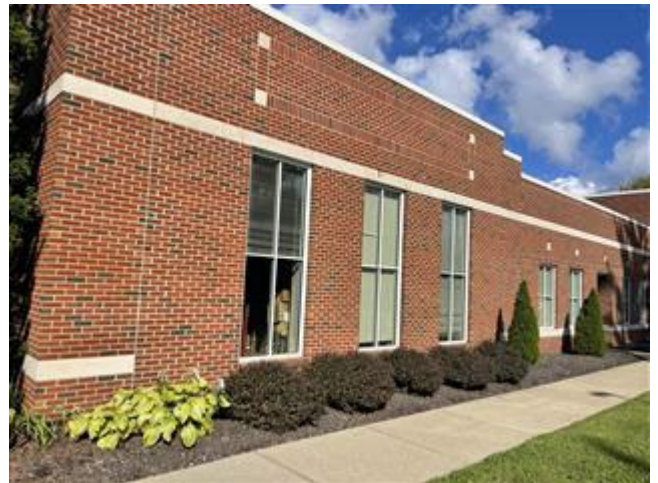
Concrete Work. The concrete work includes the community curb and gutter, sidewalks, leadwalks, stairs, stoops, and other flatwork. We have modeled for curb replacement when the asphalt pavement is overlaid. The overall condition of the concrete work is fair with areas of defects consistent with the age of the installation.

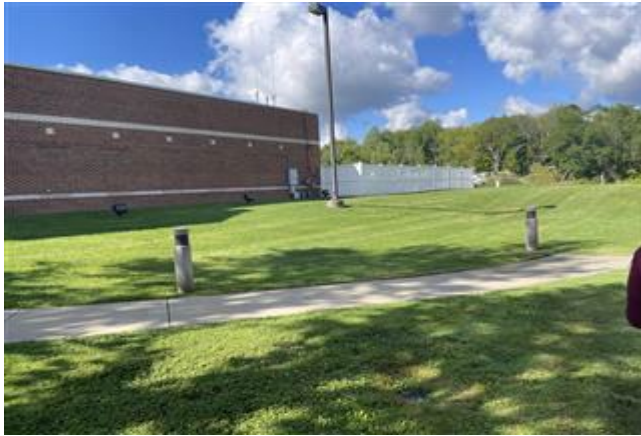
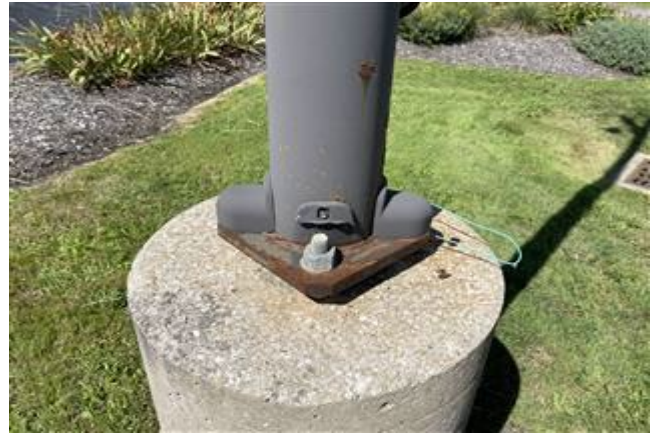
Site Lighting. The building features site lighting that includes post lamps, ground mounted lights, and building lights. The lights were not on at the time of our site visit, but we understand they are in good operating condition.

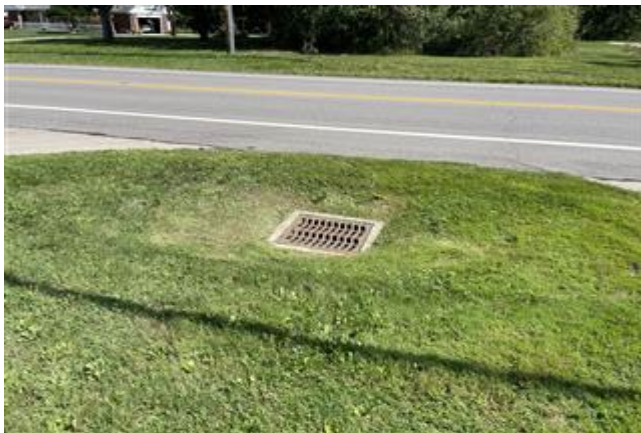
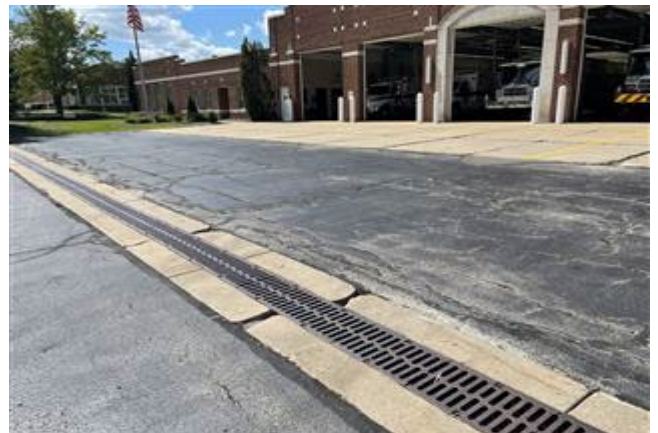
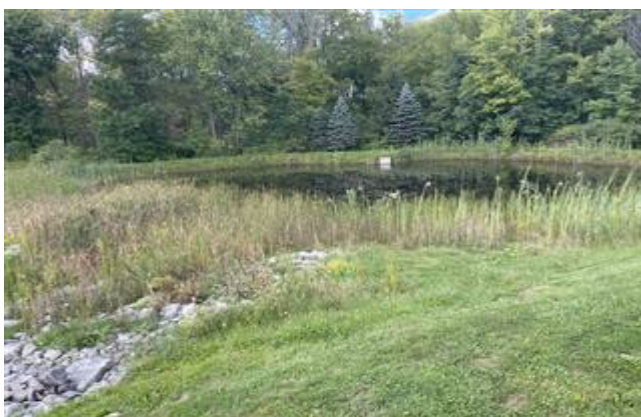
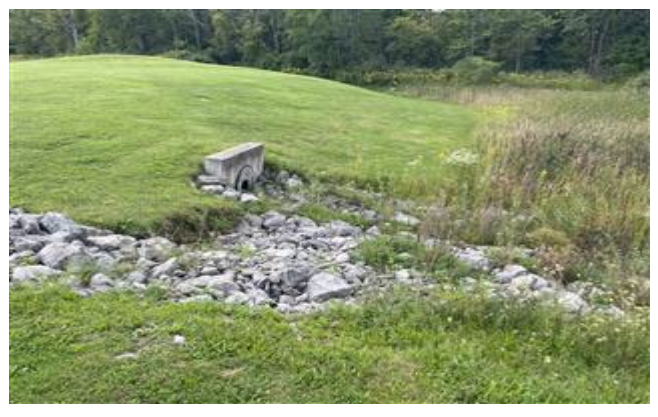
Stormwater Management. We have included an allowance for stormwater management. This allowance is intended to address drainage issues, wet areas, inlets, structures, etc.

We noted that the drop inlet located in front of the building near the road was not graded properly and is likely to not function properly.

We have included funding to expand the detention basin at the rear of the property.

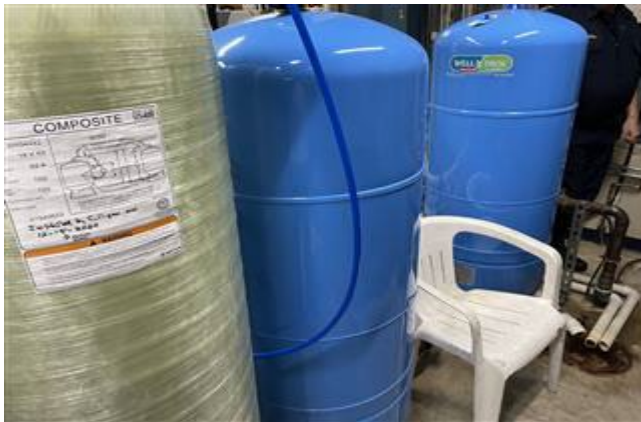
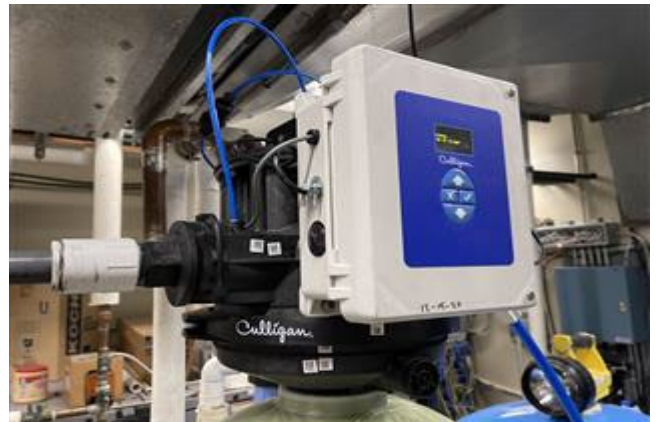
Well and Water Softener. The building features a groundwater well and septic system. We consider the system to include the well casing, well pump, and piping. These items are concealed underground and were not reviewed but we understand they are in good operating condition. The system also includes a water softener system which includes a water softener system, brine tank, and pressure tank. The water softener is reported to be in good condition.

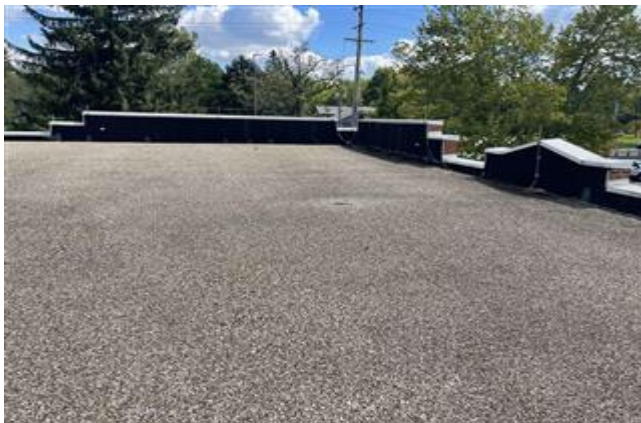
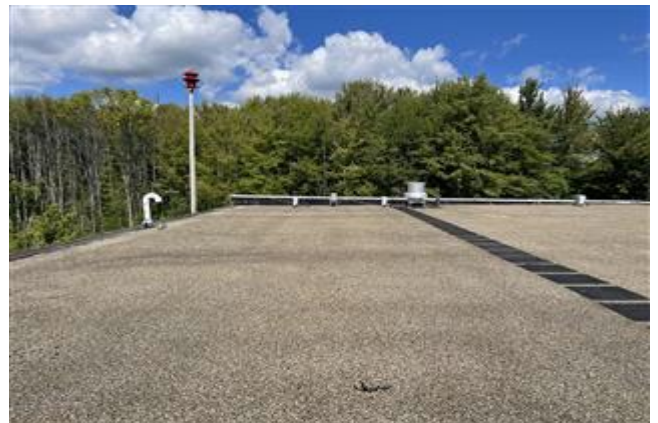
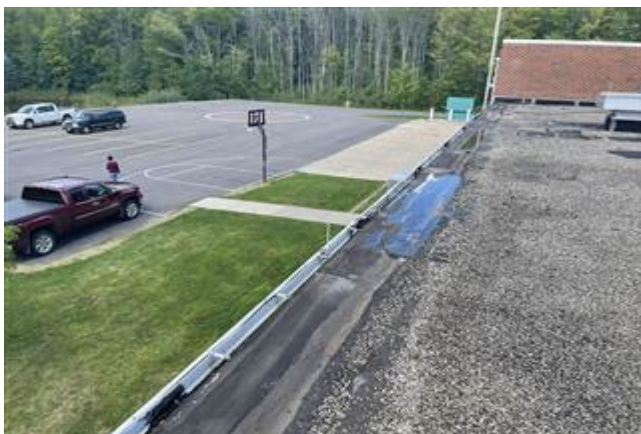
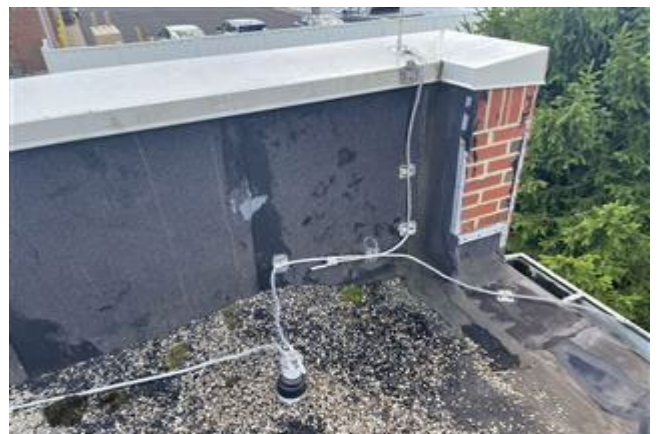
Building Roofing. The building features a flat roofing system. The roofing consists of a Built-Up Roofing system (BUR). The roofing is in fair condition.

Access to the roof was not provided at the time of inspection. The roofing was observed from the ground level.

Annual inspections are recommended, with cleaning, repair, and mitigation of vegetation performed as needed. Access, inspection, and repair work should be performed by contractors and personnel with the appropriate access equipment who are experienced in the types of roofing used for the facility.
