LEVEL 2 REPLACEMENT RESERVE REPORT FY 2023 RUSSELL TOWNSHIP

RUSSELL TOWNSHIP

REPLACEMENT RESERVE REPORT

NOVELTY, OHIO
September 6, 2022
Revised December 8, 2022
Revised February 14, 2023

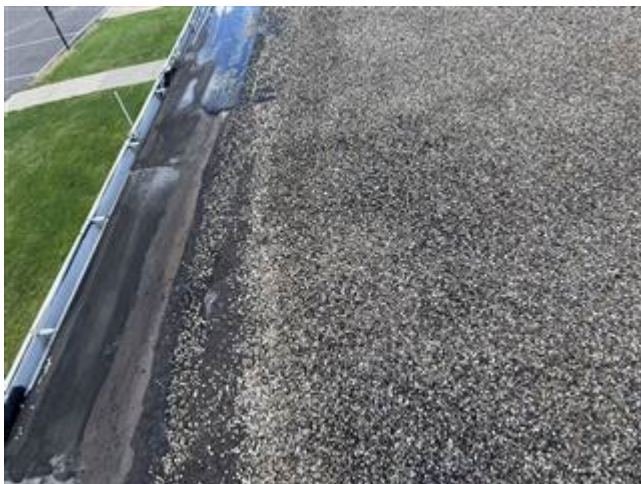
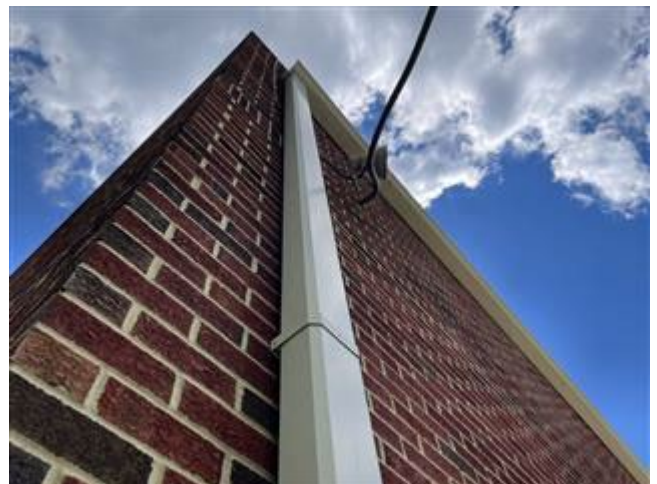
Gutters and Downspouts. The building features aluminum gutters and downspouts. The gutters and downspouts are in good condition.

It is recommended that all gutters be cleaned at least twice each year. If there are a large number of trees located close to a building, consider installing a gutter debris shield that will let water into the gutters but will filter out leaves, twigs, and other debris.

It is recommended that gutters and downspouts be installed on all buildings. It is also recommended that the discharge from the downspouts be extended at least ten feet away from the foundations.

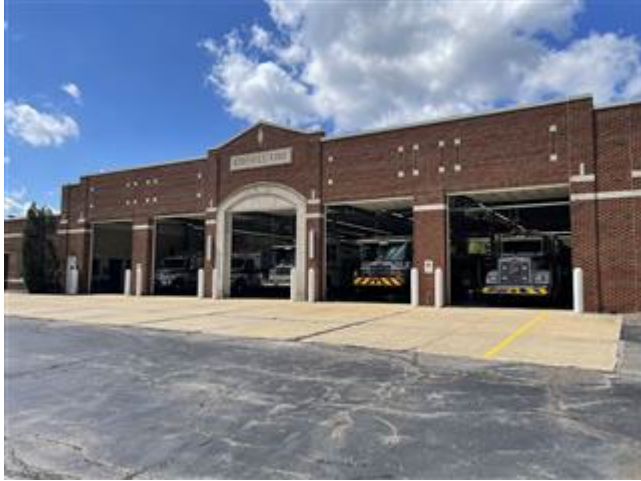
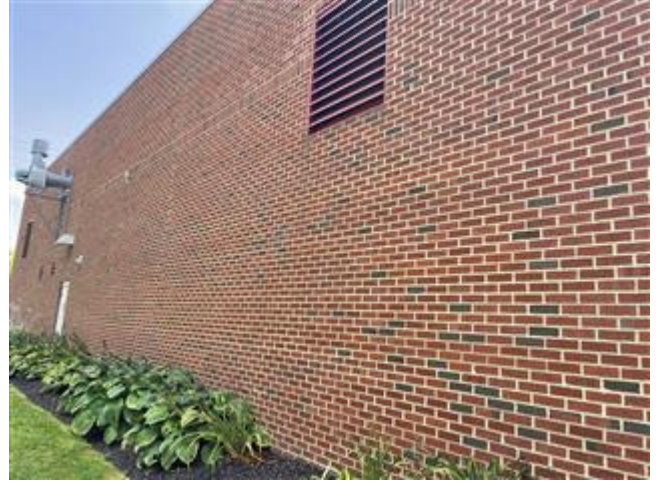
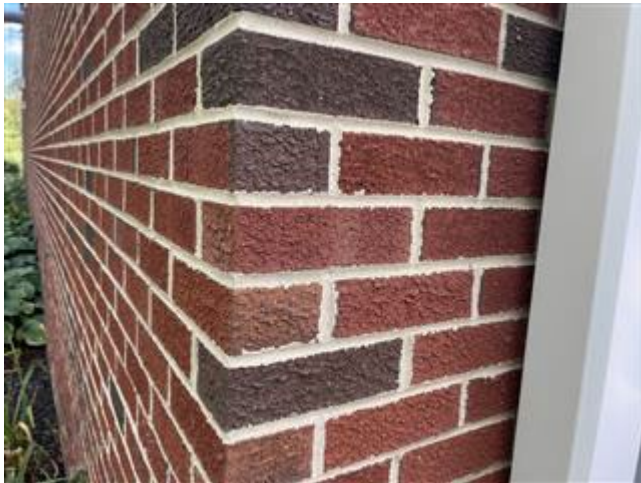
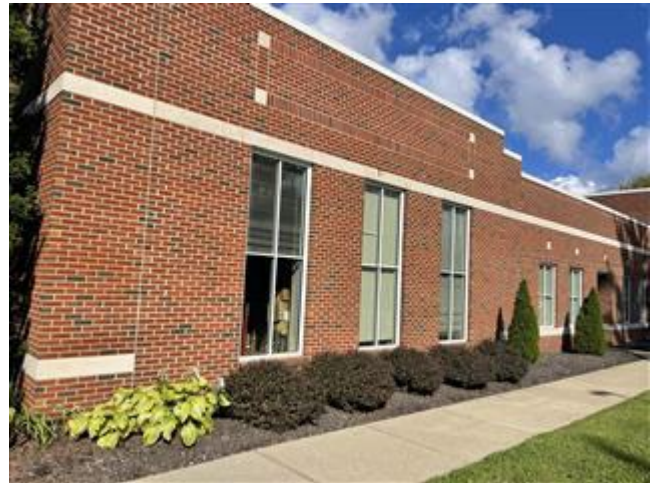
Masonry. The building is clad in brick masonry with mortar joints. The brick masonry is in good condition.

Brick masonry is used as the main exterior cladding of the building. As masonry weathers, the mortar joints will become damaged by water penetration. As additional water gains access to the joints, repeated freeze-thaw cycles gradually increase the damage to the mortar joints. If allowed to progress, even the masonry units such as brick can have their surfaces affected and masonry units can become loose.

Similar to other masonry components, we recommend repointing. Because weather and other conditions result in the slow deterioration of the mortar in the joints, we have included funding in the Reserve Analysis for repointing.

Periodic repointing and local replacement of damaged masonry units will limit the damage done by moisture penetration. For this study, we assume that 10% of the masonry will require repointing every 10 years after approximately 30 years.

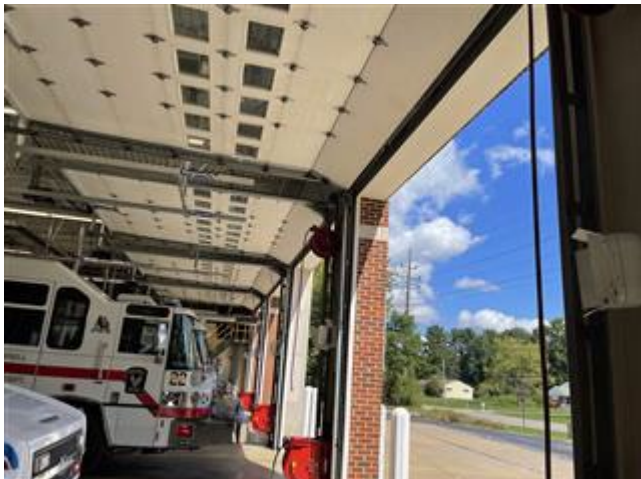
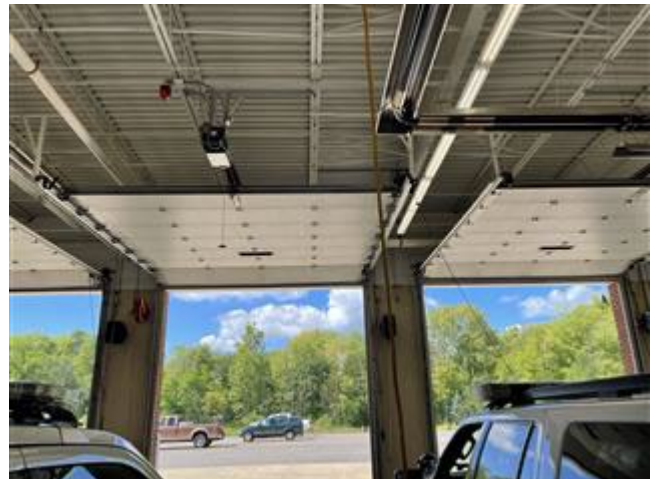
Overhead Doors. The building features overhead doors. The doors are in good working order.

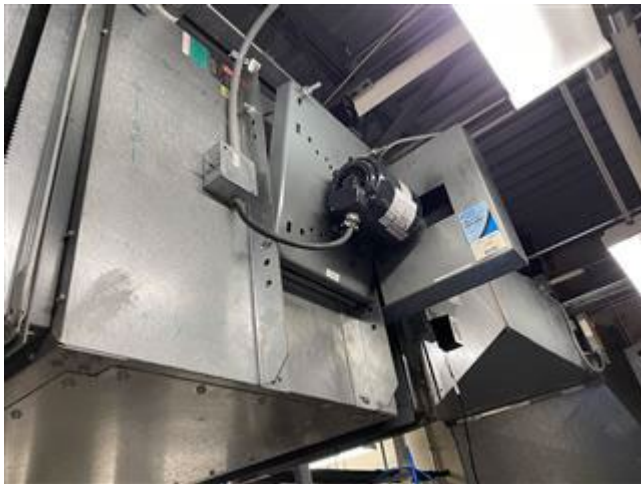
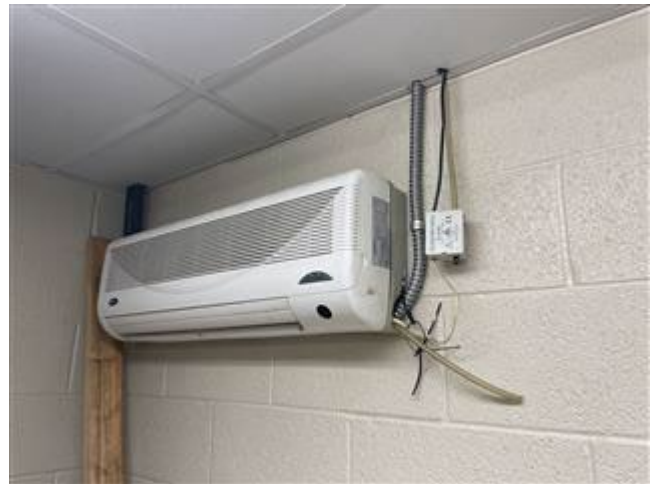
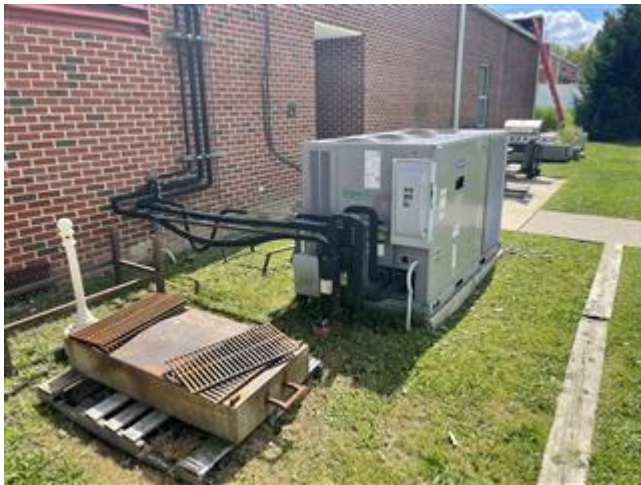
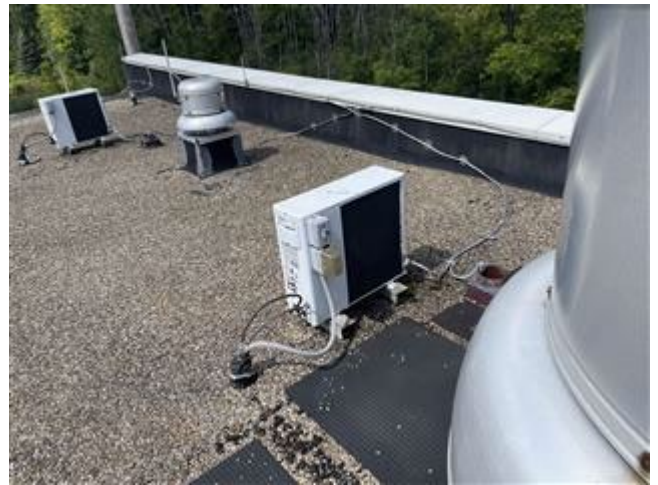
HVAC Systems. The heating ventilation and air conditioning (HVAC) of the facility are provided by furnace/compressor split systems. The HVAC is in good working order. Detailed inspection and testing of these systems are beyond the scope of this study.

See the EPA, HCFC Phase-out Schedule on our website at <http://mdareserves.com/resources/links/building-system>. Since most of the community's AC systems rely on the old R22 refrigerant, we assume that the HVAC replacement will include upgrading to the new refrigerant, which is likely to require the replacement of the entire system, including the compressor, coil, and line-set.

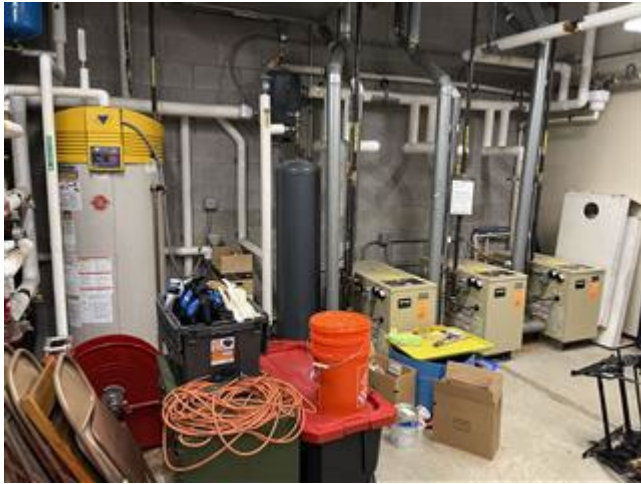
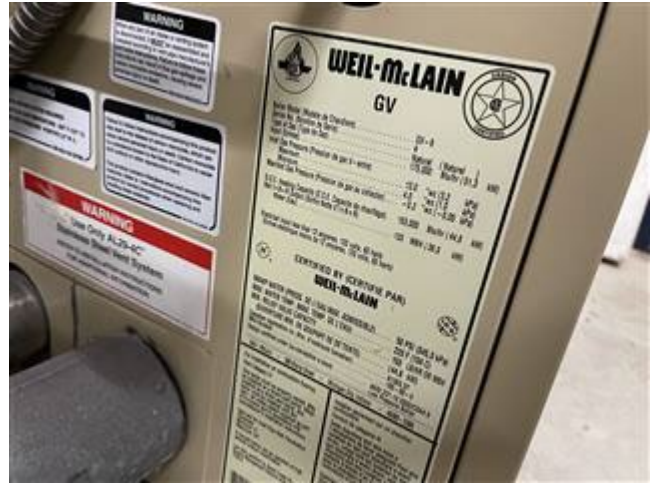
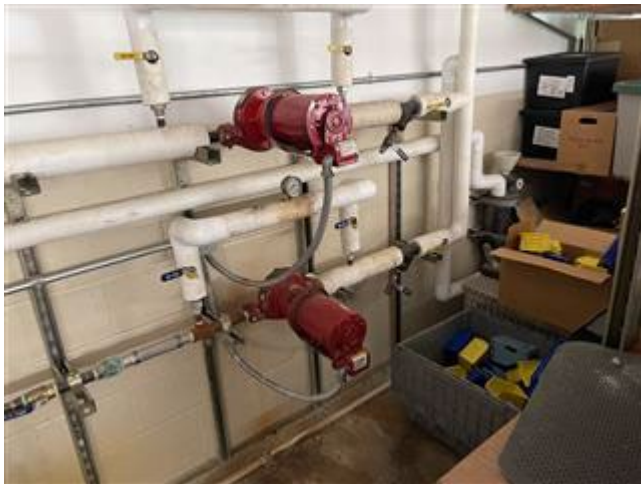
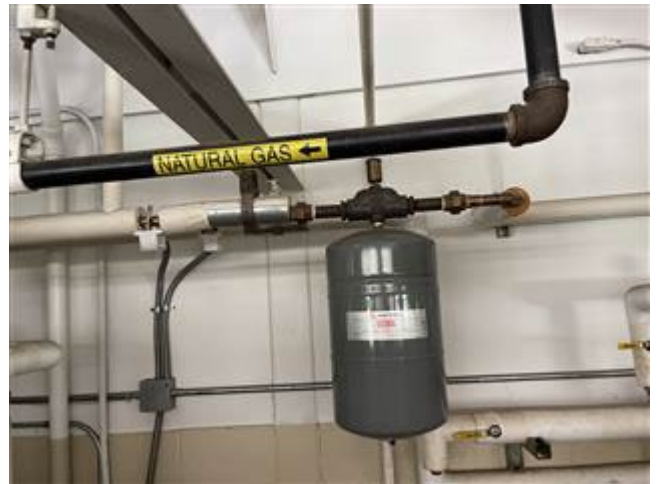
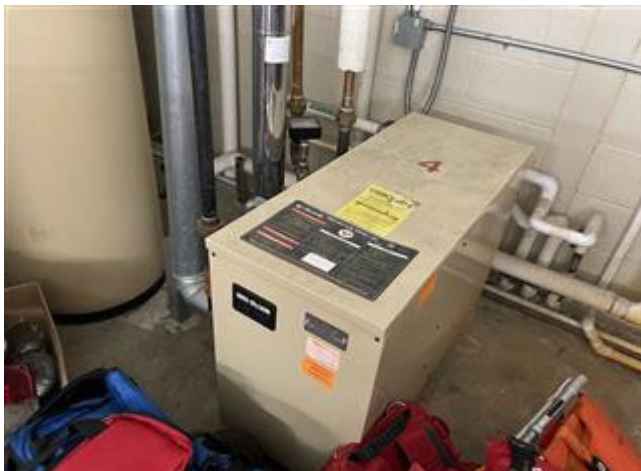
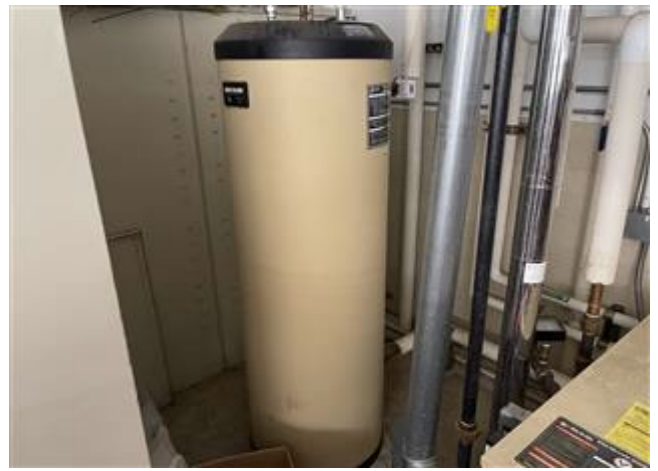
Boilers. The facility features multiple hot water boilers for heating.

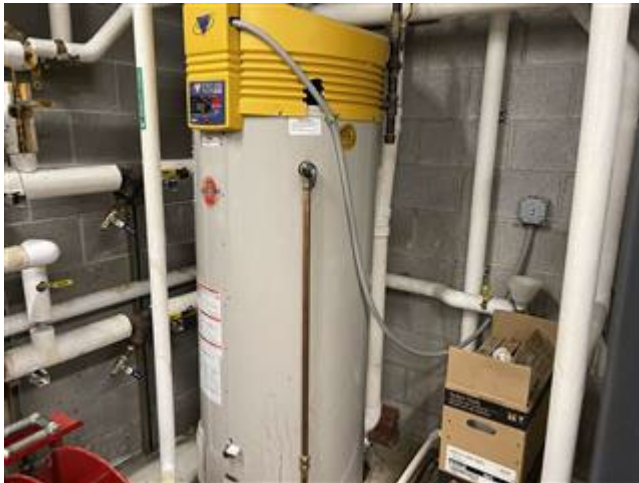
Domestic Hot Water. Domestic hot water is provided by a water heater tank which is in good condition.

Typically these types of systems have a service life of 12-15 years. This system should be serviced periodically to provide the most reliable service.

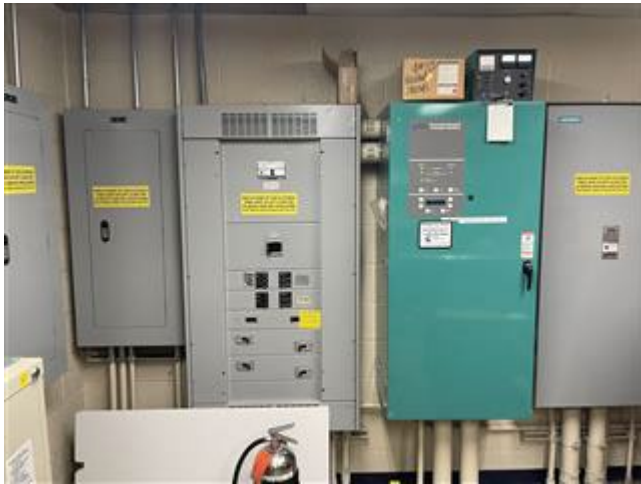
Electrical Switchgear. The electrical switchgear includes the ducts, switch boxes, disconnects, relays, fuses, and switches. The electrical switchgear dates to the original construction of the building. Electrical switchgear has a rated service life of 50 years or more. Electrical switchgear requires ongoing maintenance for proper operation and reliability.

The overall condition of the switchgear is good. We understand that replacement parts are still available for the equipment. As the switchgear continues to age, obtaining replacement parts can be expected to become more difficult. When parts no longer are available or when the condition of the switchgear deteriorates sufficiently, the Association will have to replace or upgrade the existing equipment. Therefore, we have included funding in the Reserve Analysis for distribution panel replacement on an incremental basis.

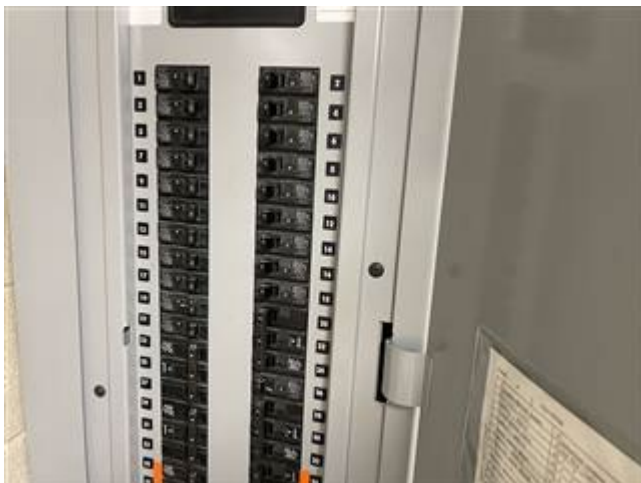
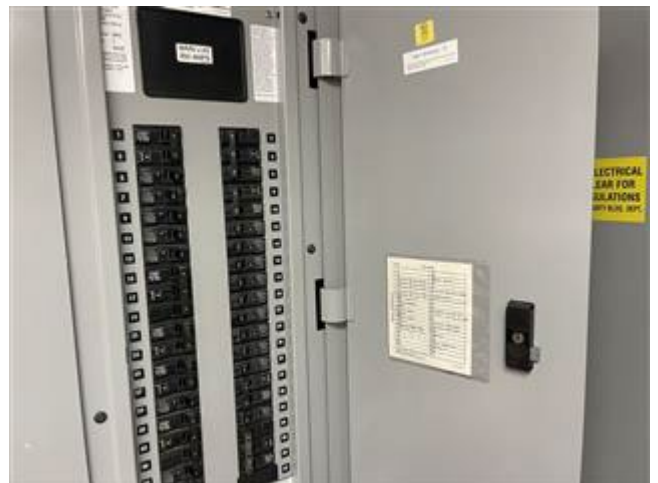
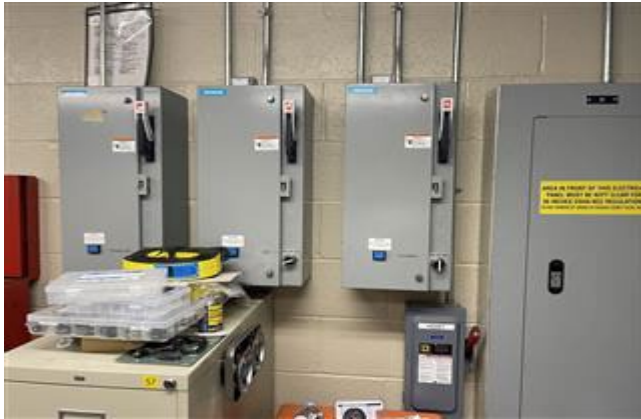
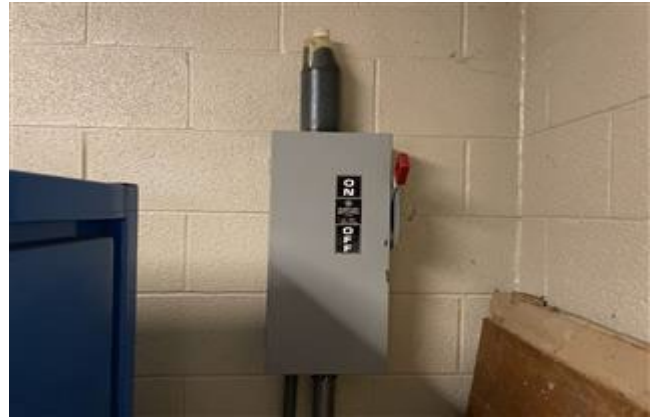
Electrical Distribution Panels. The building's electrical systems features a number of electrical distribution panels located throughout the facility. These panels separate the building's electrical power into separate identifiable circuits. All panels track back to the switchgear and have panel schedules identifying the circuits within the breaker panel. These panels date to the original construction of the building and have a rated service life of 50 years or more.

The overall condition of the distribution panels is good. As the distribution panel's age, obtaining replacement parts can be expected to become more difficult. When parts no longer are available, the Association will have to replace some of the existing panels. The replacement will have to be performed on an incremental basis, panel by panel. Therefore, we have included funding in the Reserve Analysis for distribution panel replacement on an incremental basis.

It is also recommended that outlets, sockets, switches, and minor fixtures be replaced at a maximum of every 30 years. These are not included in reserves.

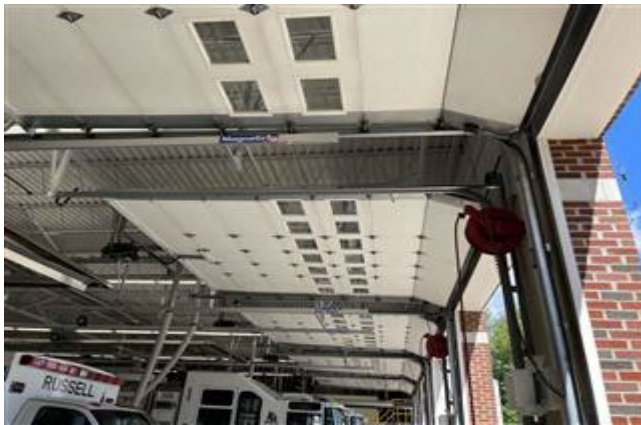
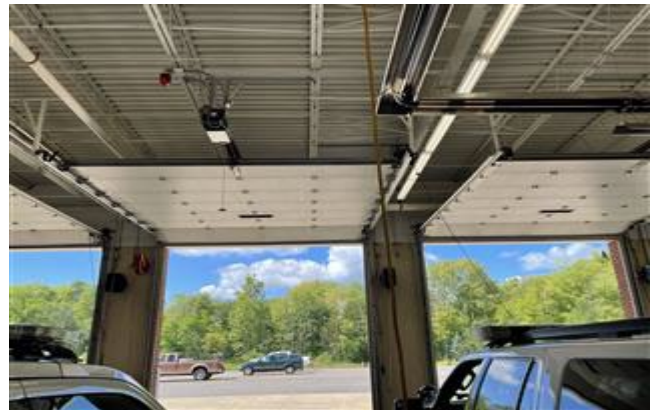
Overhead Doors. The building features overhead doors. The doors are in good working order.

Overhead doors should be maintained to the extent that they fully open and fully close. All tracks and rollers operate in a smooth continuous cycle free of binding and stops.

Safety features such as stops, return sensors, a close tension should be checked periodically. Automatic operators provide a one touch operation to open or close. These normally include operator motors, track or roller, and controls. The openers are reported to be in good condition.

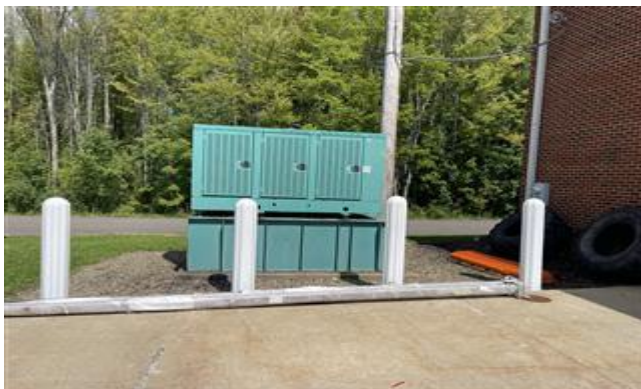
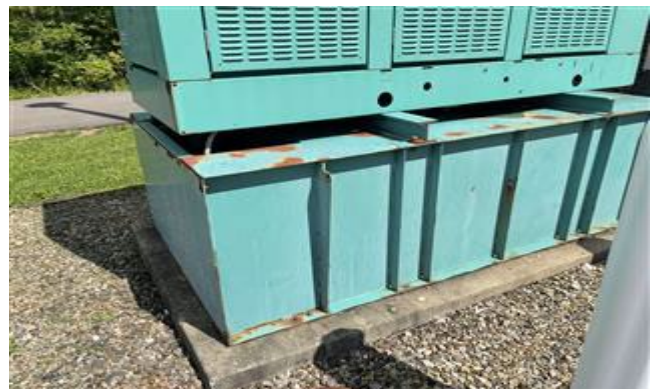
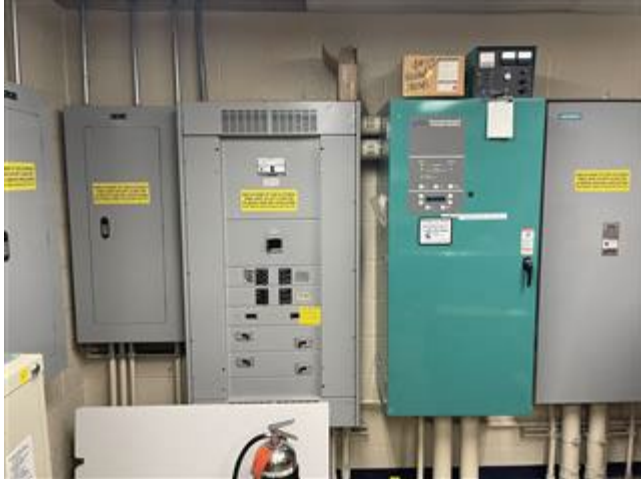
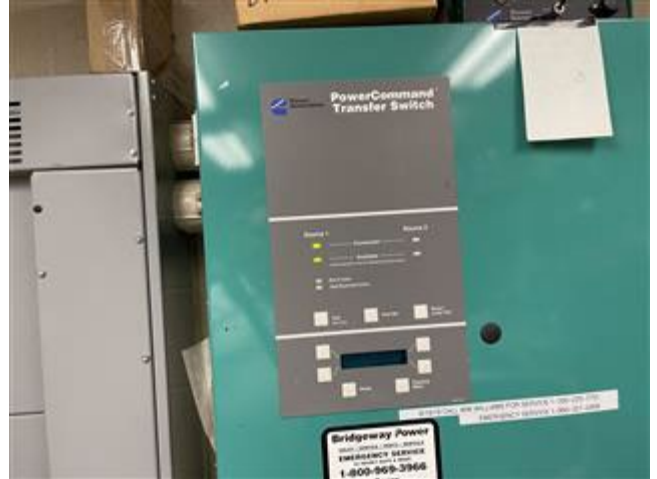
Emergency Generator. The facility features an emergency generator. The system operates on stand-by until needed. The generator includes a diesel engine, a fuel tank, voltage generator, control panel, and an enclosure.

The generator power is distributed to Automatic Transfer Switch (ATS) which powers designated panels. These panels are typically emergency panels that service necessary building features and safety features such as lighting, fire alarm, and elevators. Generators should be exercised regularly. Regular maintenance is required to keep the system functional.

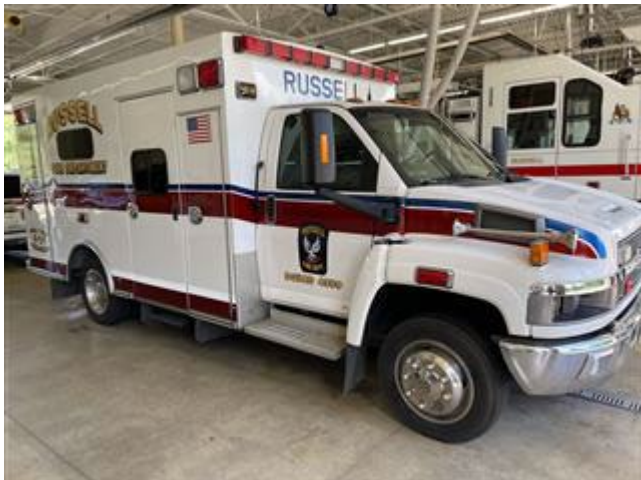
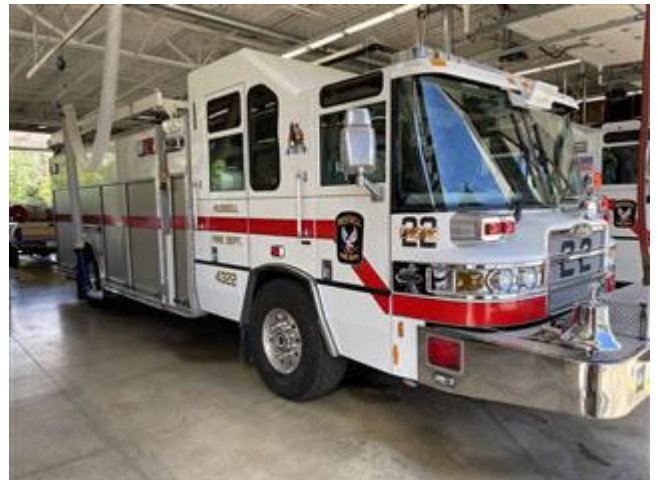
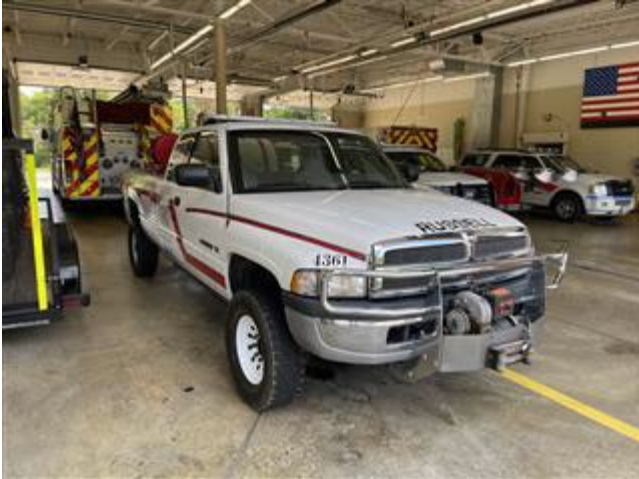
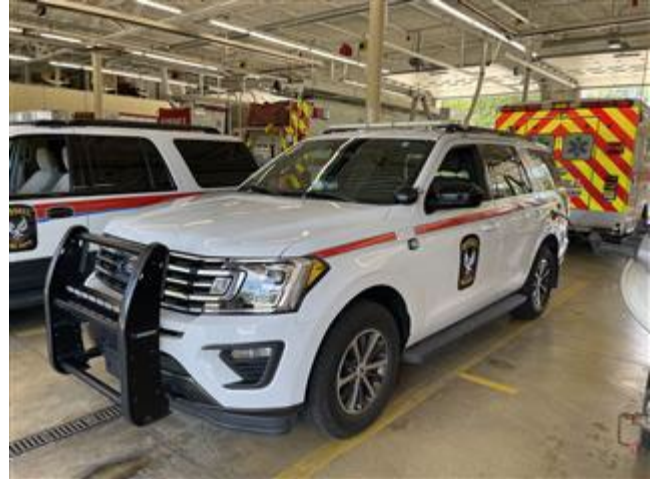
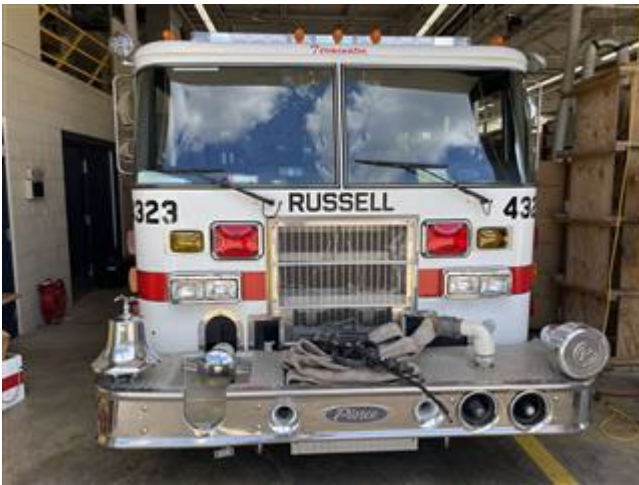
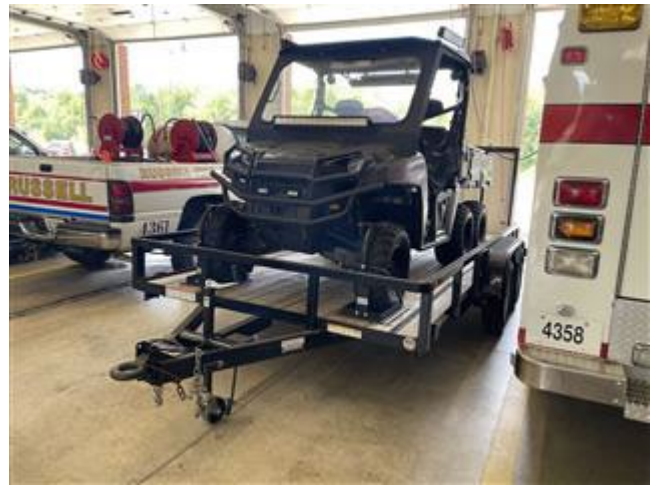
Vehicles. The Township features various vehicles to support Fire Station activities.

The vehicles were not evaluated as part of this study. Vehicles are included in the inventory as indicated by the Township. The vehicles are replaced on a rotating schedule.

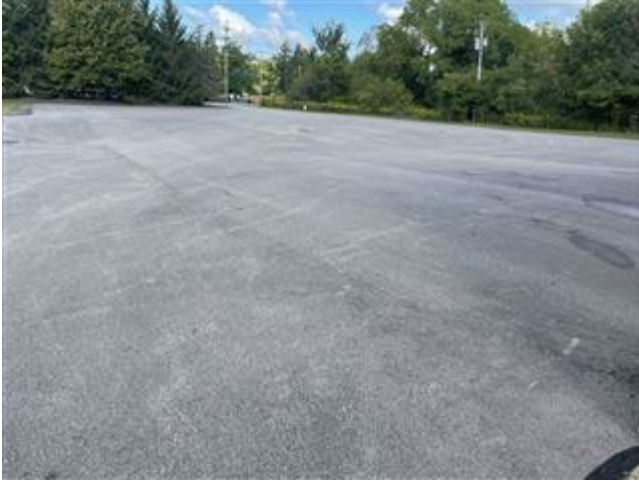
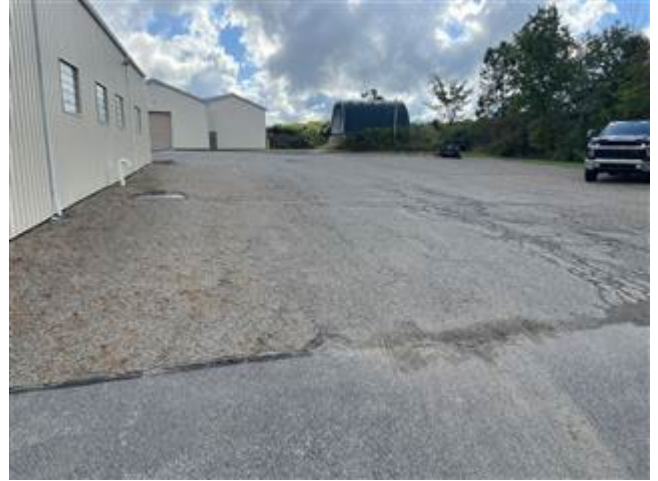
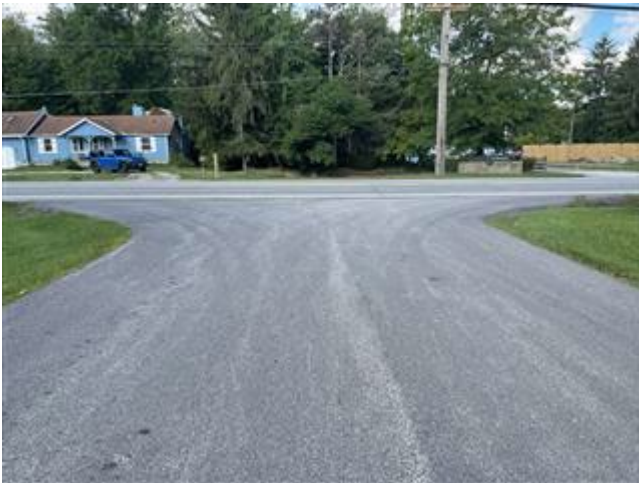
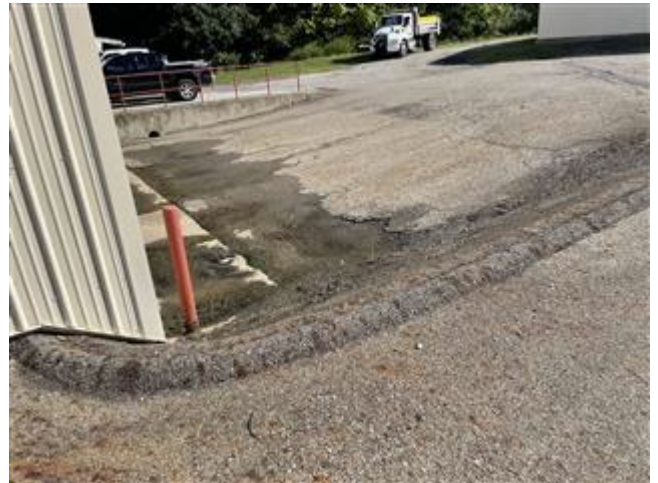
Parking Areas. The building features parking areas and drives lanes constructed of asphalt pavement. The pavements are in good condition.

- **Open Cracks.** There are multiple locations where open cracks are allowing water to penetrate to the asphalt base and the bearing soils beneath. Over time, water will erode the base and accelerate the deterioration of the asphalt pavement. If cracks extend to the base and bearing materials, remove the damaged areas, and replace defective materials. As a part of normal maintenance, clean and fill all other cracks.

- **Alligatoring.** There are multiple locations where the asphalt has developed a pattern of cracking known as alligatoring. The primary cause of alligatoring is an unstable base. Once these cracks extend through the asphalt, they will allow water to penetrate to the base, accelerating the rate of deterioration, and eventually leading to potholes. The only solution is to remove the defective asphalt, compact the base, and install new base materials and asphalt.

- **Improper Grading.** The asphalt pavement is not properly graded, resulting in the ponding of water. Proper grading of the asphalt pavement will require replacing portions of the asphalt. It may also require resetting improperly sloped curb and gutter segments that are not conveying water to the stormwater management system. If ponding is left unattended it can result in unsafe travel areas, by creating conditions for hydroplaning and pockets of ice to form.

- **Potholes.** Potholes have formed as the result of full-depth pavement failure, including base materials. The repair will require removal of the asphalt and base materials, installation and compaction of new base materials, and asphalt resurfacing.

- **Depressions.** There are areas where the asphalt surface is depressed due to deformation in the surface or underlying layers. These depressions may continue to grow with exposure to traffic. Water ponding is evident in several of these areas. Repair of these areas will require the removal of the asphalt and base material and reinstallation, by compacting the new base material and resurfacing with asphalt.

In an effort to maintain the condition of the pavement throughout the community and ensure the longest life of the asphalt, we recommend the Association adopts a systematic and comprehensive maintenance program that includes:

- **Crack Repair.** All cracks should be repaired with an appropriate compound to prevent water infiltration through the asphalt into the base. This repair should be done annually. Crack repair is normally considered a maintenance activity and is not funded from Reserves. Areas of extensive cracking or deterioration that cannot be made watertight should be cut out and patched.

- **Seal Coating.** The asphalt should be seal coated every five to seven years. For this maintenance, activity to be effective in extending the life of the asphalt, cleaning, and crack repair should be performed first.

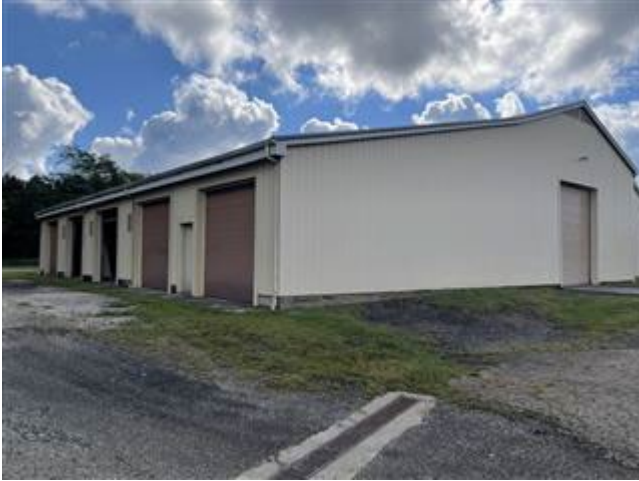
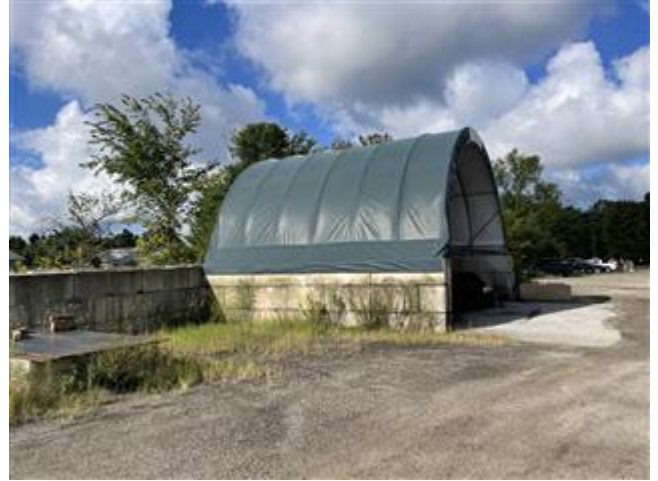
Gravel. The parking areas and drive lanes include gravel. Gravel replenishment is a maintenance item and is excluded from reserves.

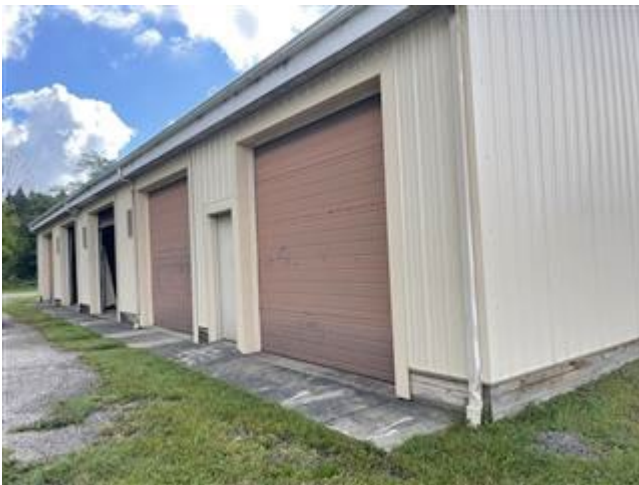
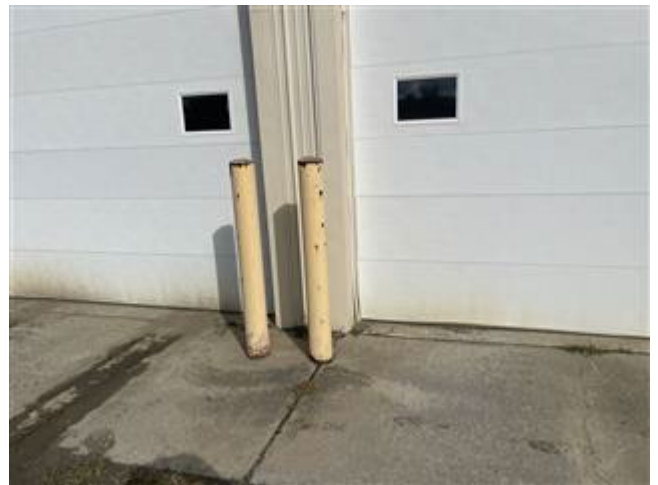
Concrete Work. The concrete work includes the Sidewalks, leadwalks, stairs, stoops, and other flatwork. The overall condition of the concrete work is fair with areas of defects consistent with the age of the installation.

Because it is highly unlikely that all of the concrete components will fail and require replacement in the period of the study, we have programmed funds for the replacement of these inventories and spread the funds over an extended timeframe to reflect the incremental nature of this work.

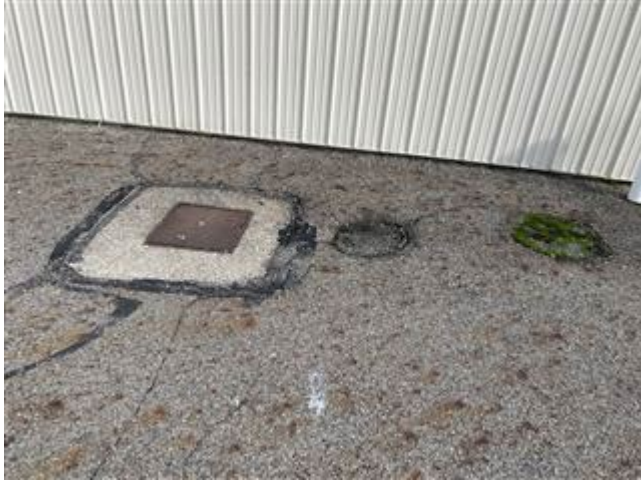
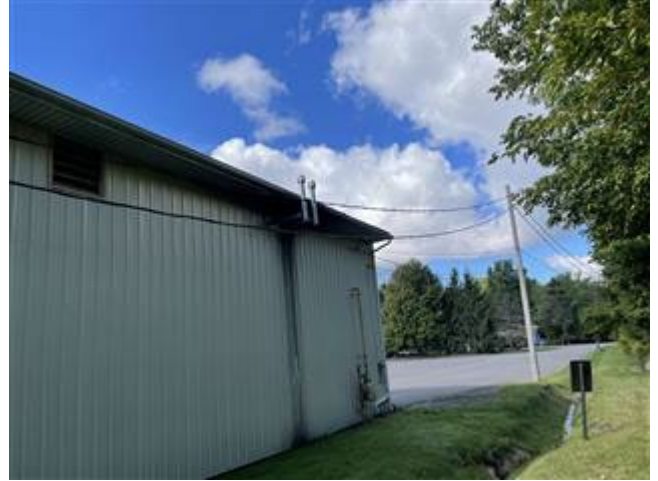
Stormwater Management. We have included an allowance for stormwater management. This allowance is intended to address drainage issues, wet areas, inlets, structures, etc.

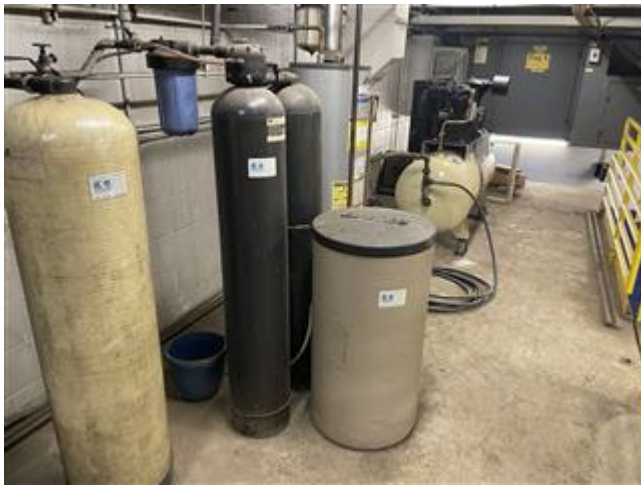
Well and Water Softener. The building features a groundwater well and septic system. We consider the system to include the good casing, well pump, and piping. These items are concealed underground and were not reviewed but we understand they are in good operating condition. The system also includes a water softener system which includes a water softener system, brine tank, and pressure tank. The water softener is reported to be in good condition.

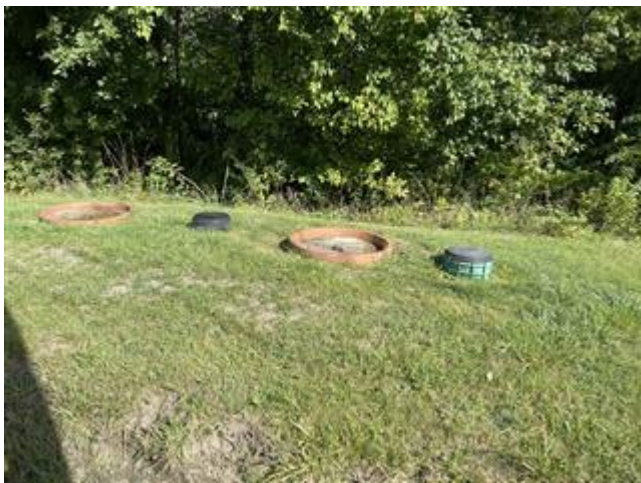
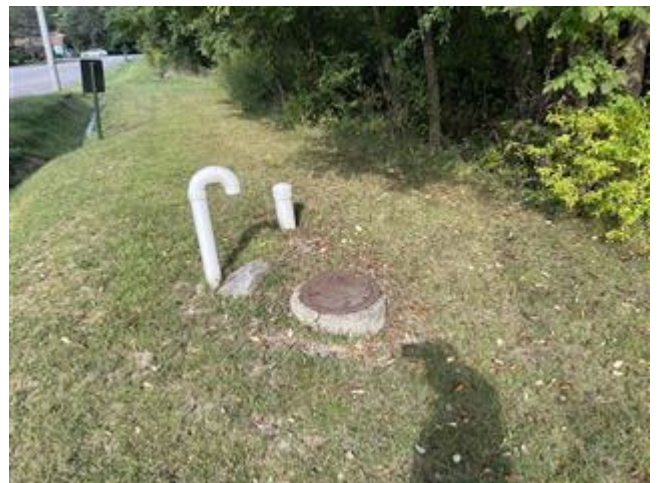
Septic System. The building features a septic system. The system includes a box, pump, valve, and leach bed. The system was concealed underground and not reviewed but is reported to be in good condition.

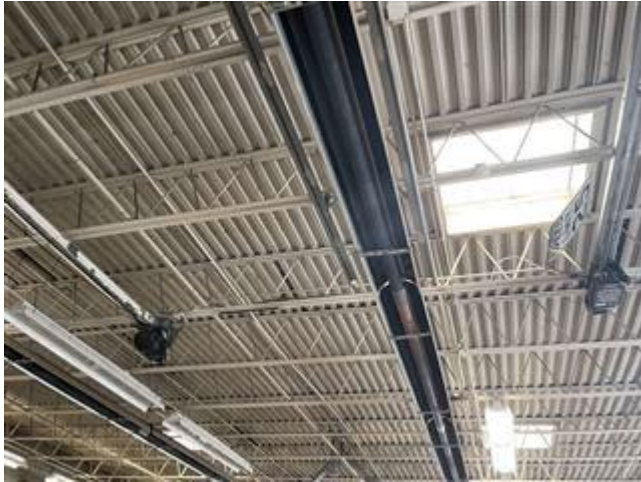
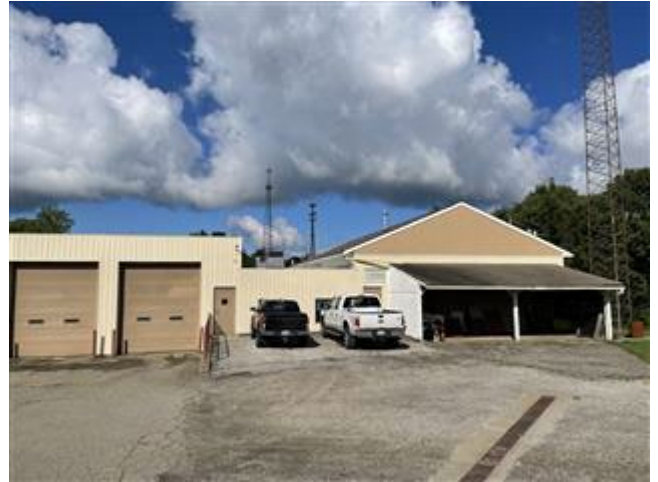
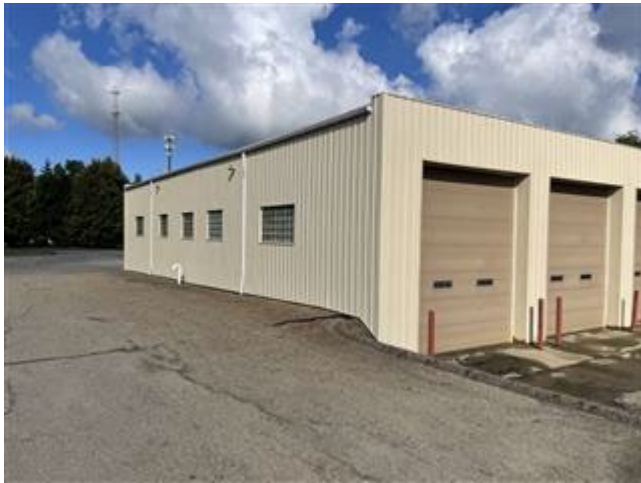
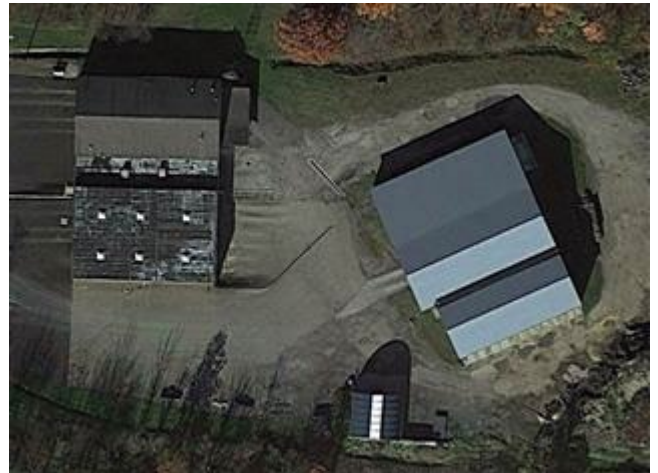
Building Roofing. The building features a pitched structure that is roofed in asphalt shingles. The roofing is in good condition.

The building features a pitched structure that is roofed in metal roofing. The roofing is new and in good condition.

The building features a flat roofing system. The roofing consists of a Built-Up Roofing system (BUR). The roofing is in fair condition.

Annual inspections are recommended, with cleaning, repair, and mitigation of vegetation performed as needed. Access, inspection, and repair work should be performed by contractors and personnel with the appropriate access equipment who are experienced in the types of roofing used for the facility.

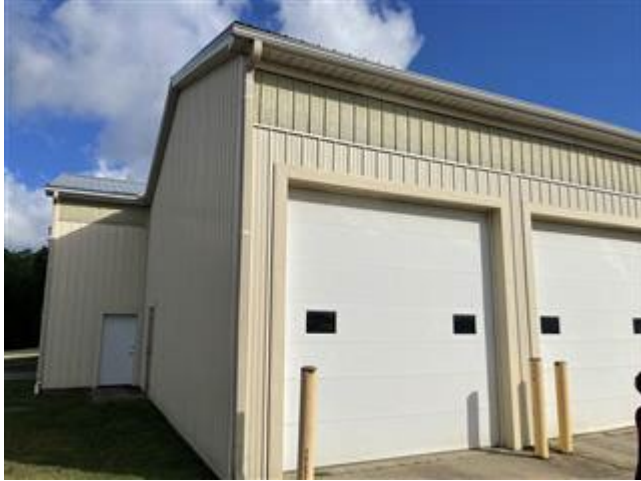
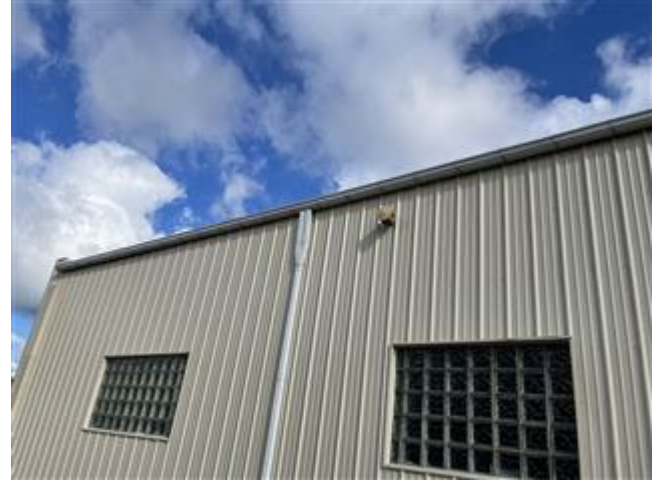
Gutters and Downspouts. The building features aluminum gutters and downspouts. The gutters and downspouts are in good condition.

It is recommended that all gutters be cleaned at least twice each year. If there are a large number of trees located close to a building, consider installing a gutter debris shield that will let water into the gutters but will filter out leaves, twigs, and other debris.

It is recommended that gutters and downspouts be installed on all buildings. It is also recommended that the discharge from the downspouts be extended at least ten feet away from the foundations.

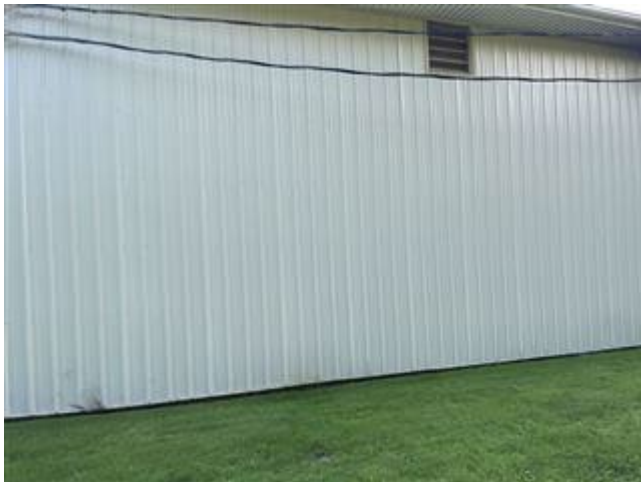
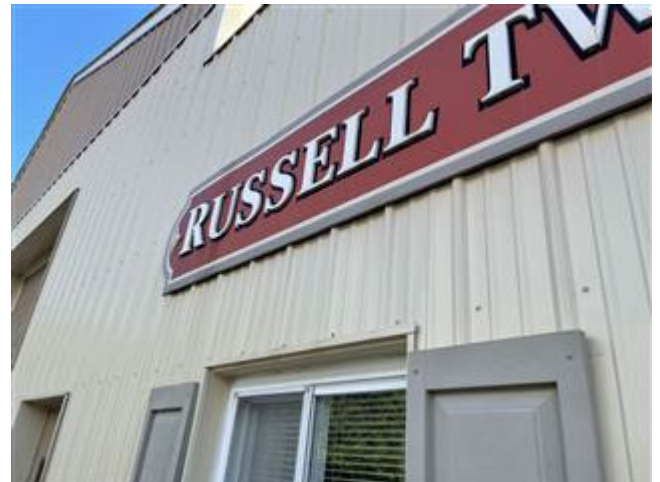
Siding and Trim. The building is sided in metal. The building exterior is in good condition. We have estimated that these exteriors will be replaced with cement fiber boards.

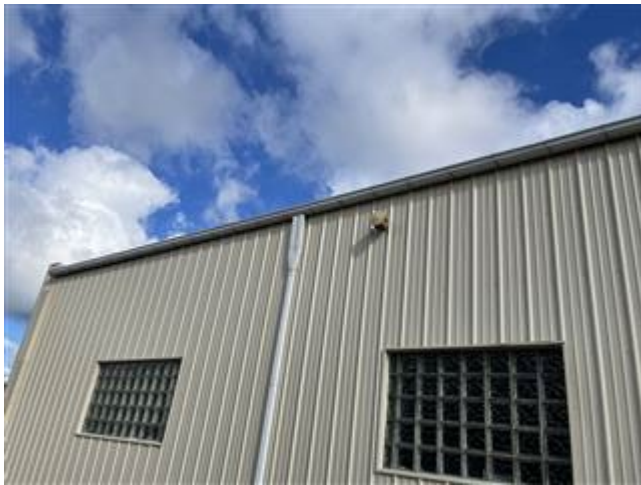
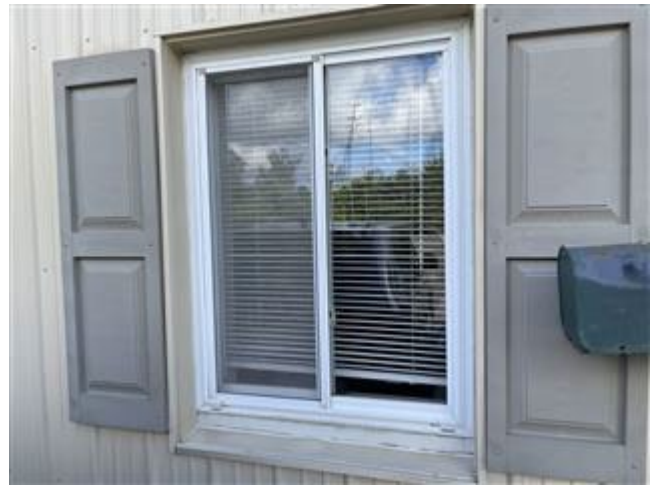
Windows. The community maintains the windows of the facility. The windows are generally in good condition.

In general, we recommend coordinating the replacement of the window units with other exterior work, such as siding and roof replacements. The weather tightness of the building envelope often requires wraps, transitional flashing, and caulking that should be performed in coordination with each other. Warranties and advantages in 'economy of scale' can often result in lower overall replacement costs and results that are more reliable. Lastly, coordinated replacements offer the opportunity to correct initial construction defects and improve the effectiveness of details with improved construction techniques and materials.

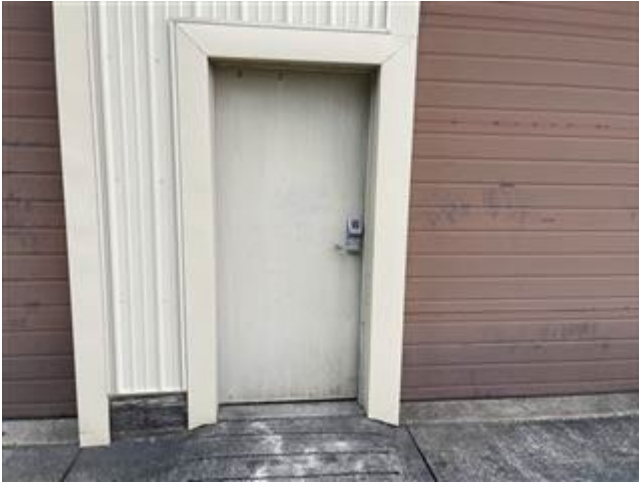
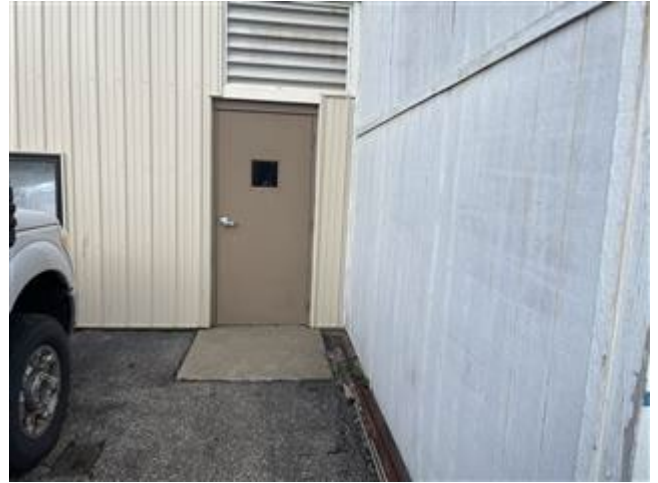
Exterior Doors. The Community maintains the exterior doors of the community building.
