LEVEL 2 REPLACEMENT RESERVE REPORT FY 2023 RUSSELL TOWNSHIP

RUSSELL TOWNSHIP

REPLACEMENT RESERVE REPORT

NOVELTY, OHIO
September 6, 2022
Revised December 8, 2022
Revised February 14, 2023

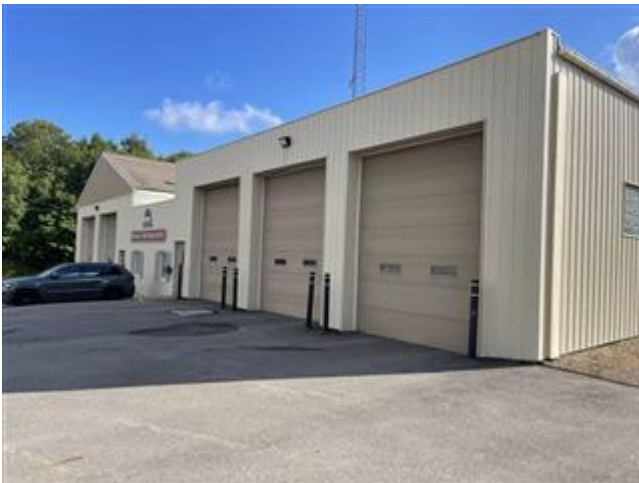
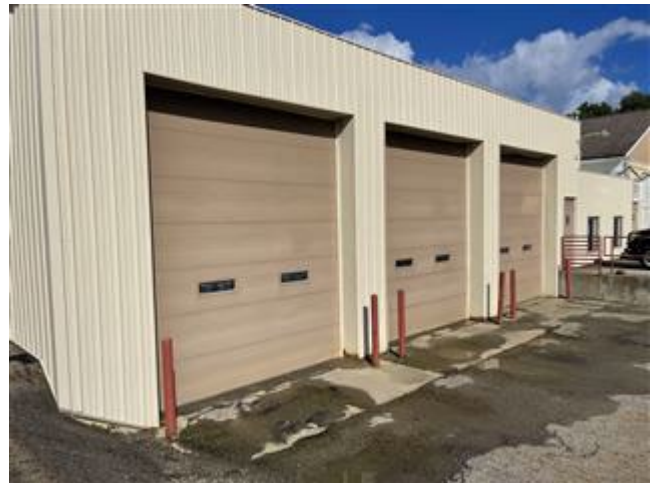
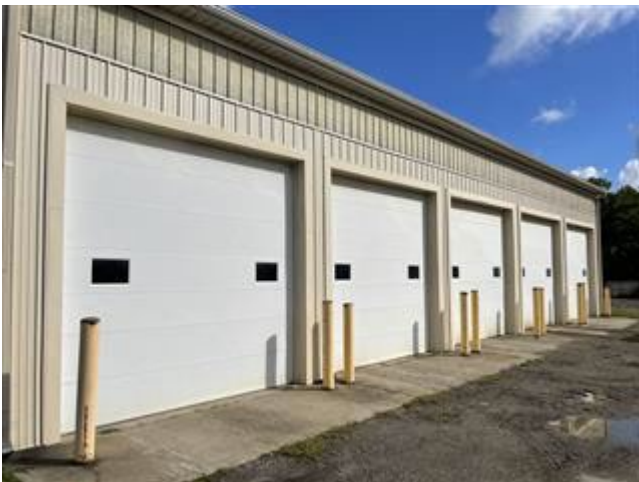
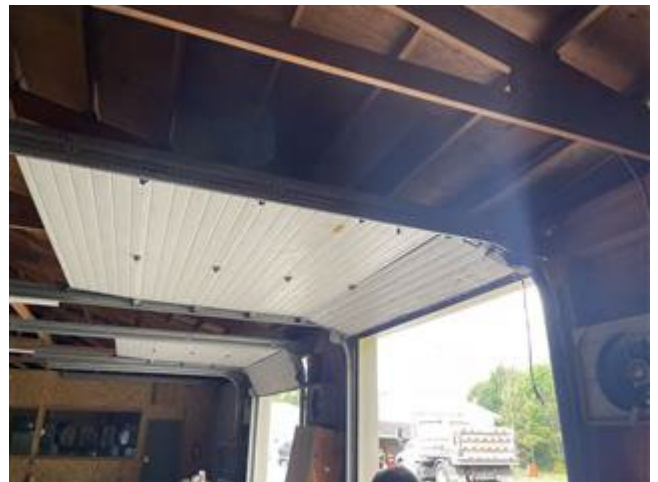
Overhead Doors. The building features overhead doors. The doors are in good working order.

Safety features such as stops, return sensors, and close tension should be checked periodically. Automatic operators provide a one touch operation to open or close. These normally include the operator motor, track or roller, and controls. The openers are reported to be in good condition.

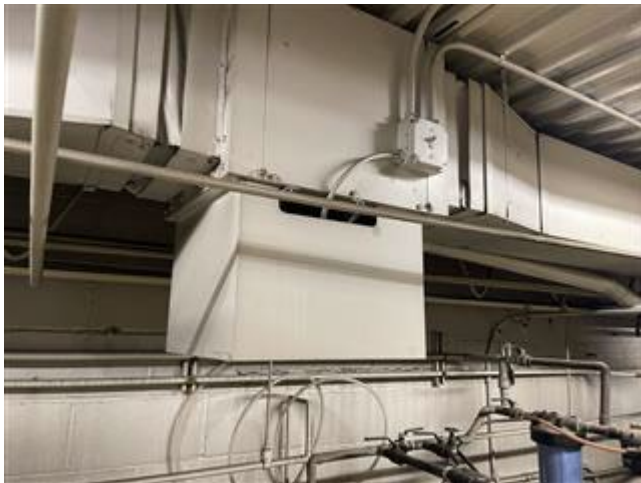
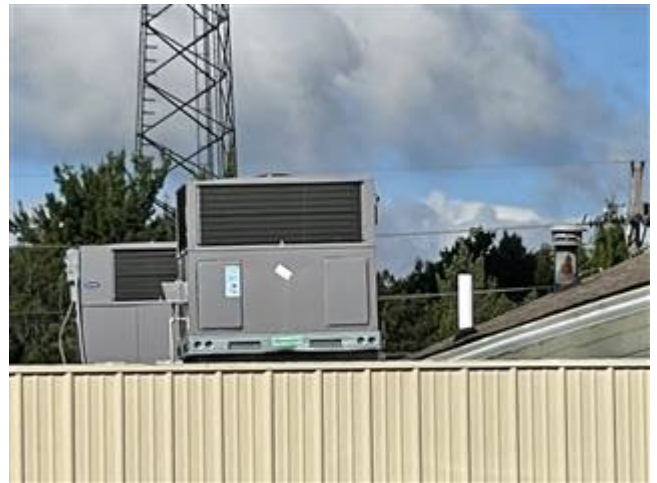
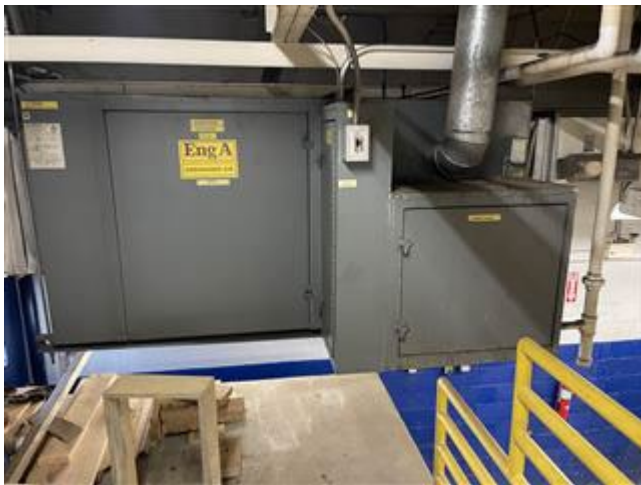
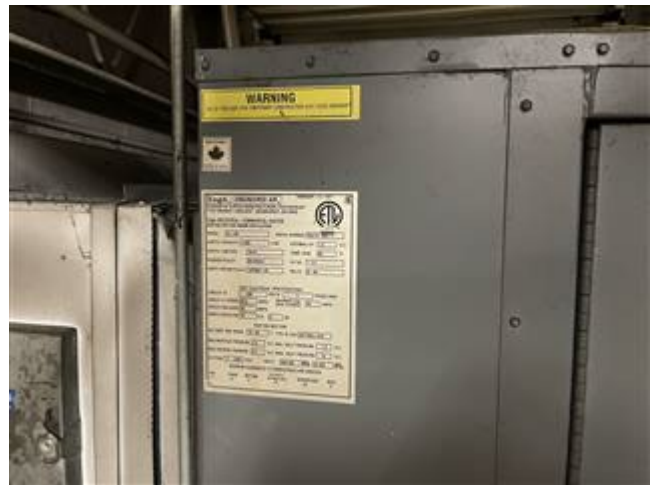
HVAC Systems. The heating ventilation and air conditioning (HVAC) of the facility are provided by furnace/compressor split systems. The HVAC is in good working order. Detailed inspection and testing of these systems are beyond the scope of this study.

The Association maintains a number of HVAC systems that use the refrigerant known as R22. This refrigerant will be phased out of production by the year 2020 and was generally phased out of use in new systems in 2010.

See the EPA, HCFC Phase-out Schedule on our website at <http://mdareserves.com/resources/links/building-system>. Since most of the community's AC systems rely on the old R22 refrigerant, we assume that the HVAC replacement will include upgrading to the new refrigerant, which is likely to require the replacement of the entire system, including the compressor, coil, and line-set.

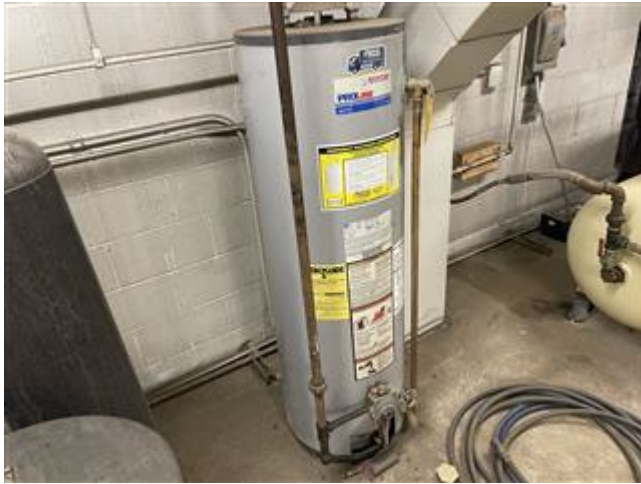
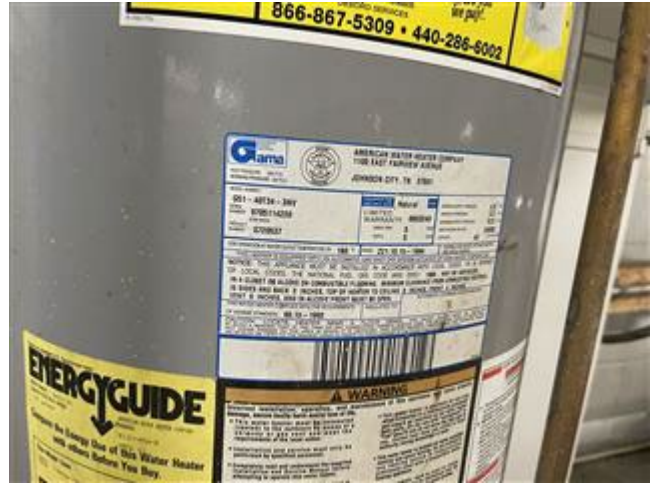
Domestic Hot Water. Domestic hot water is provided by a water heater tank which is in good condition.

Typically these types of systems have a service life of 12-15 years. This system should be serviced periodically to provide the most reliable service.

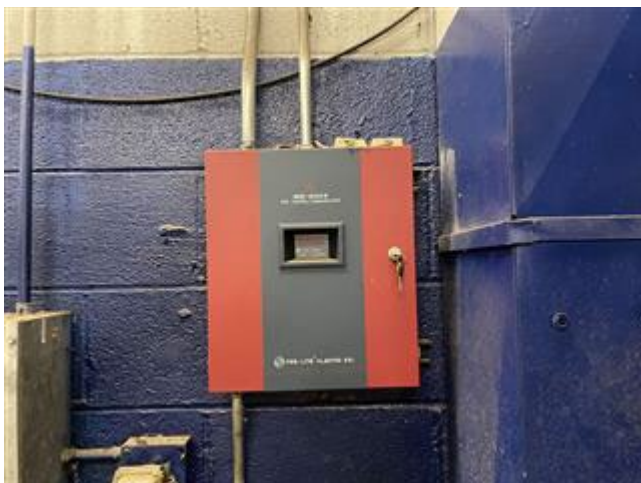
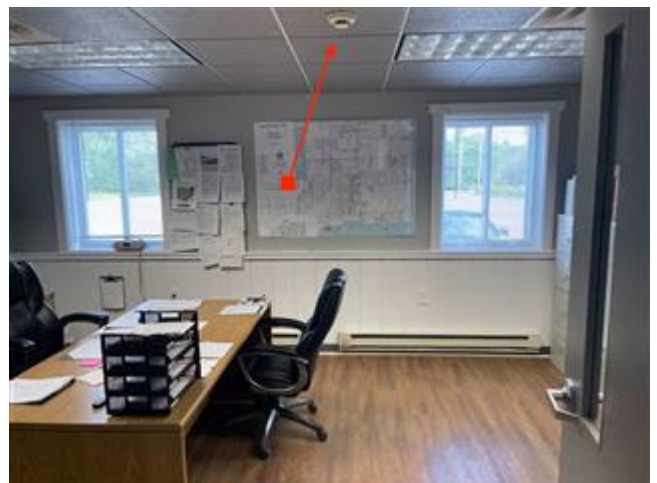
Fire Alarm Control Panel (FACP). The FACP provides the function of central processing and notifying channel for emergencies. Every device in the building is programmed into the FACP. Furthermore, the FACP initiates the alarm. Please note the type of alarm is determined by the system settings. The Association should review how the system is programmed with the system engineer.

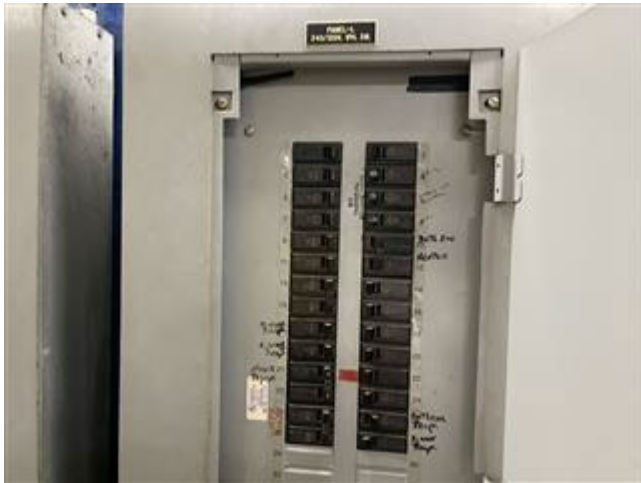
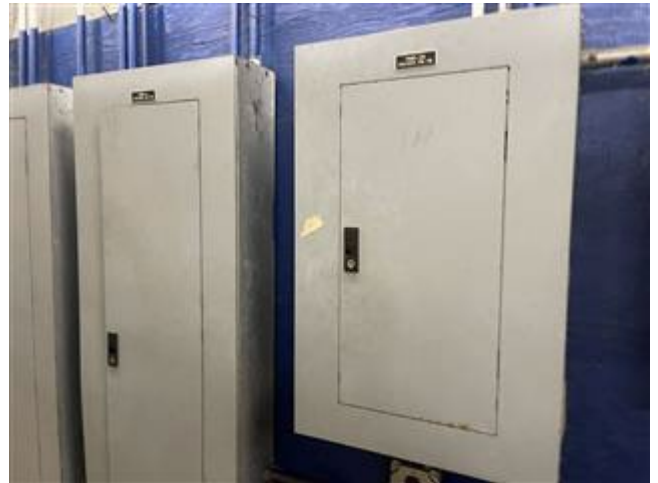
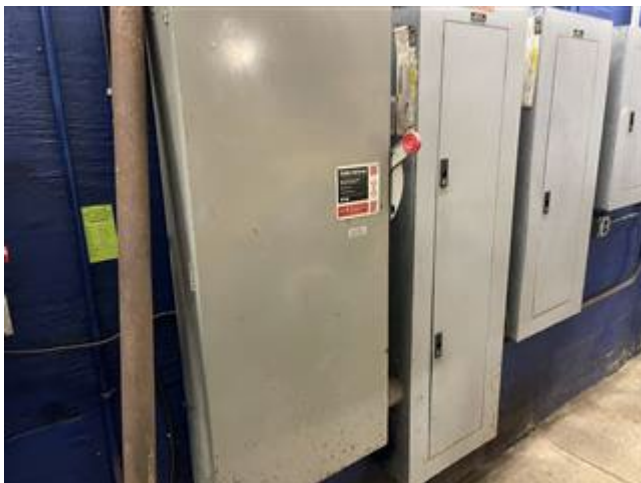
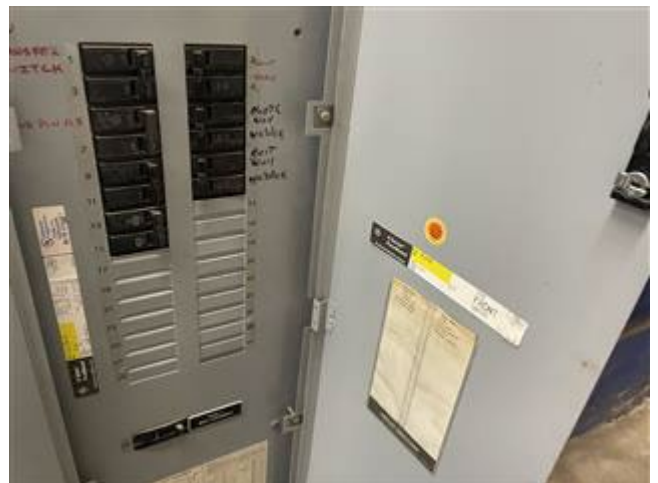
Electrical Distribution Panels. The building's electrical systems feature a number of electrical distribution panels located throughout the facility. These panels separate the building's electrical power into separate identifiable circuits. All panels track back to the switchgear and have panel schedules identifying the circuits within the breaker panel. These panels date to the original construction of the building and have a rated service life of 50 years or more.

The overall condition of the distribution panels is good. As the distribution panel's age, obtaining replacement parts can be expected to become more difficult. When parts no longer are available, the Association will have to replace some of

the existing panels. The replacement will have to be performed on an incremental basis, panel by panel. Therefore, we have included funding in the Reserve Analysis for distribution panel replacement on an incremental basis.

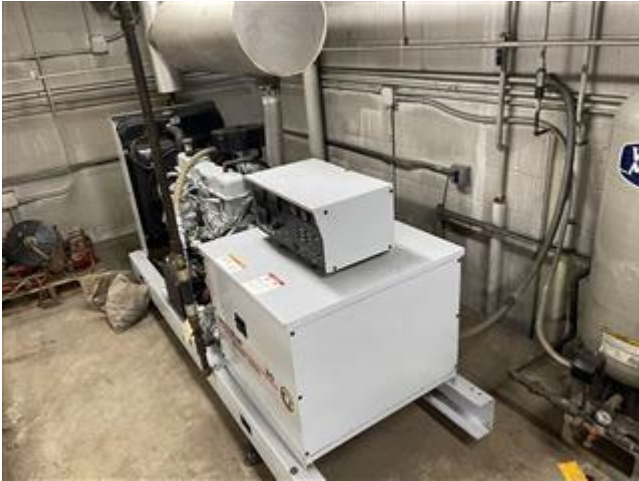
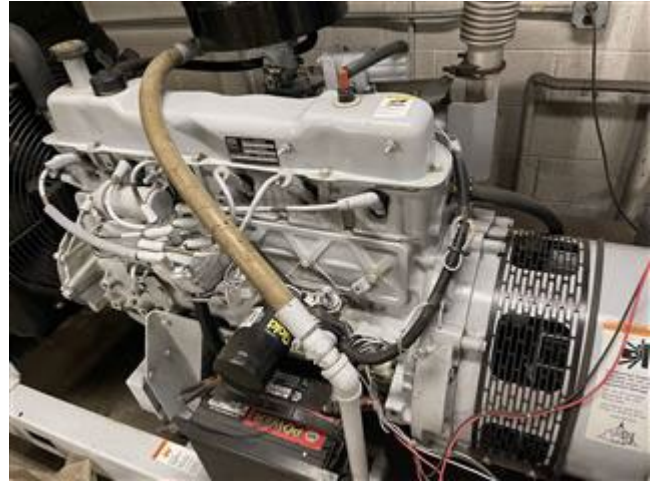
Emergency Generator. The facility features an emergency generator. The system operates on standby until needed. The generator includes a natural gas engine, voltage generator, control panel, and an enclosure.

The generator power is distributed to Automatic Transfer Switch (ATS) which powers designated panels. These panels are typically emergency panels that service necessary building features and safety features such as lighting, fire alarm, and elevators. Generators should be exercised regularly. Regular maintenance is required to keep the system functional.

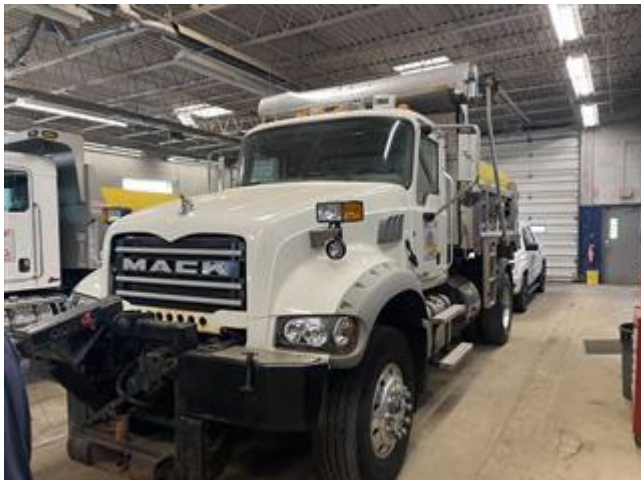
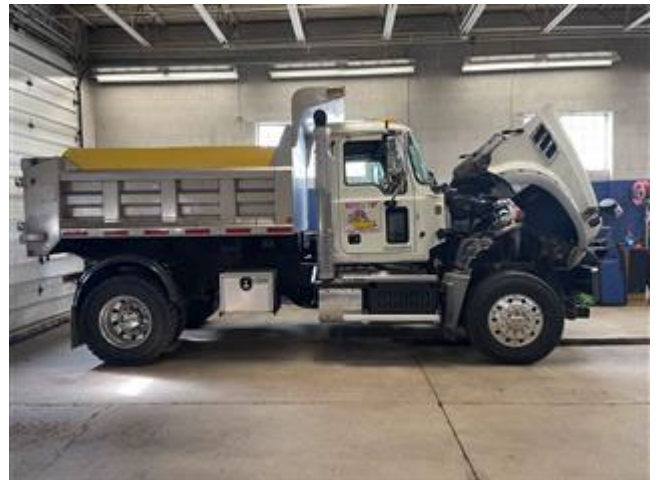
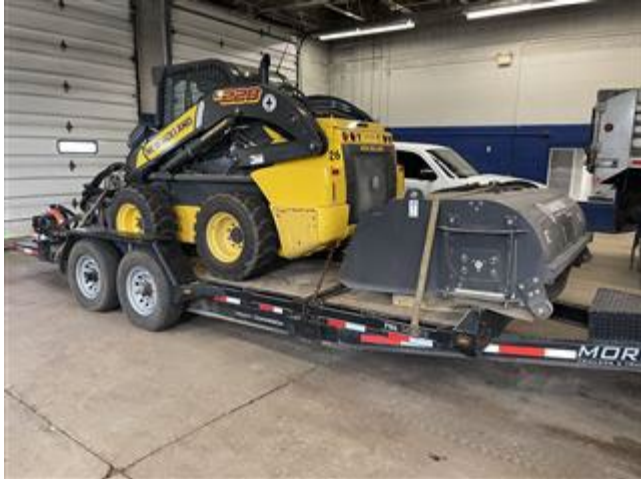
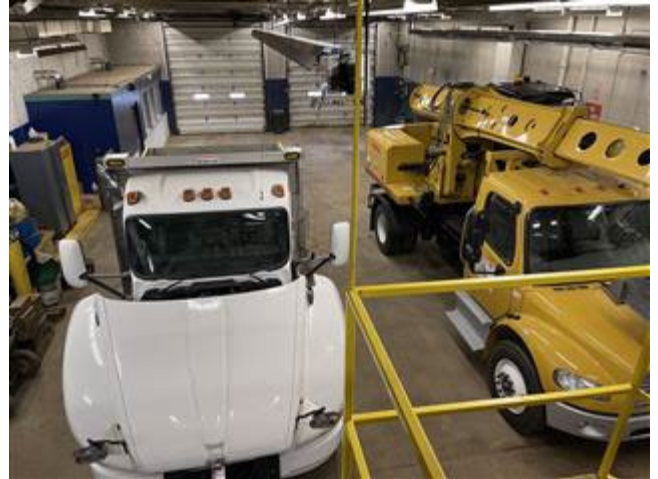
Vehicles. The Township features various vehicles to support road department activities.

The vehicles were not evaluated as part of this study. Vehicles are included in the inventory as indicated by the Township. The vehicles are replaced on a rotating schedule.
